Report: Deficiency Report
Function: Test, Adjust, & Balance
Date: 12/09/2024
Completed By: National TAB

PROJECT
12-09-24 CULVERS ALBERTVILLE, AL

500 Mathis Mill RD.

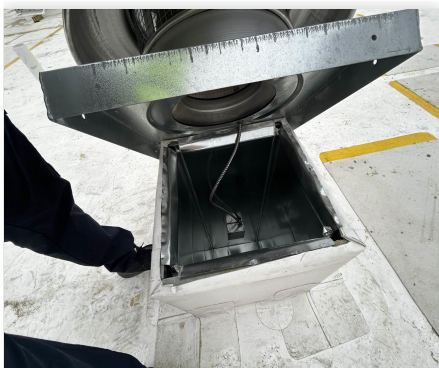
Issue Name : PRV-1 BACKDRAFT DAMPER
Description : Gravity damper is not installed in fan duct drop as per plan. Recommend having mechanical install damper as per plan. See M204> "PRV-1 RESTROOM: SELECTED OPTIONS AND ACCESSORIES".
Created By : National TAB **Assigned To :** National TAB - Kristopher Passley
Status : Open
Priority : Urgent **Asset Tag :**
Originated Date : 12/10/2024 - Kristopher Passley - National TAB

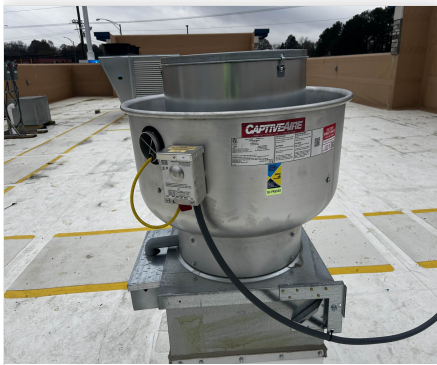
Issue Name : PRV-2
Description : Fan motor is modulating continuously and over amping. Troubleshooting with Captive-Aire tech support was unsuccessful. Recommend electrician or Captive-Aire Tech. check fan wiring and motor for issues.
Created By : National TAB **Assigned To :** National TAB - Kristopher Passley
Status : Open
Priority : Urgent **Asset Tag :**
Originated Date : 12/10/2024 - Kristopher Passley - National TAB
