TAB Punch List - CFA 02665

Prepared by Will T

May 22, 2025

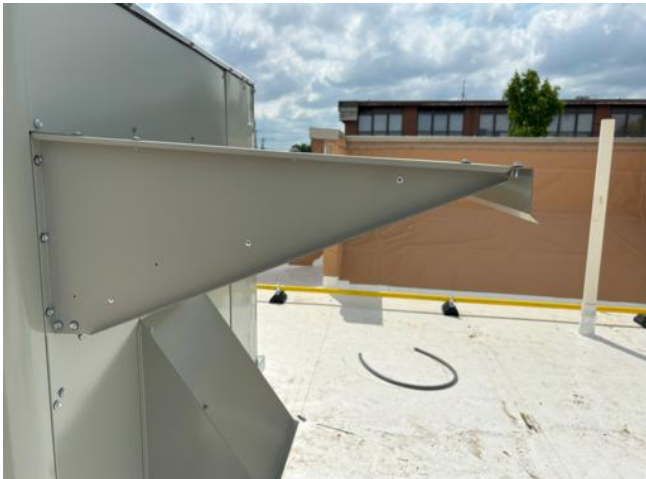
#80 [UNIT 524] [NEW] AC-3 economizers assembly

AC-3 economizer assembly is not completed. Parts are inside of the unit.

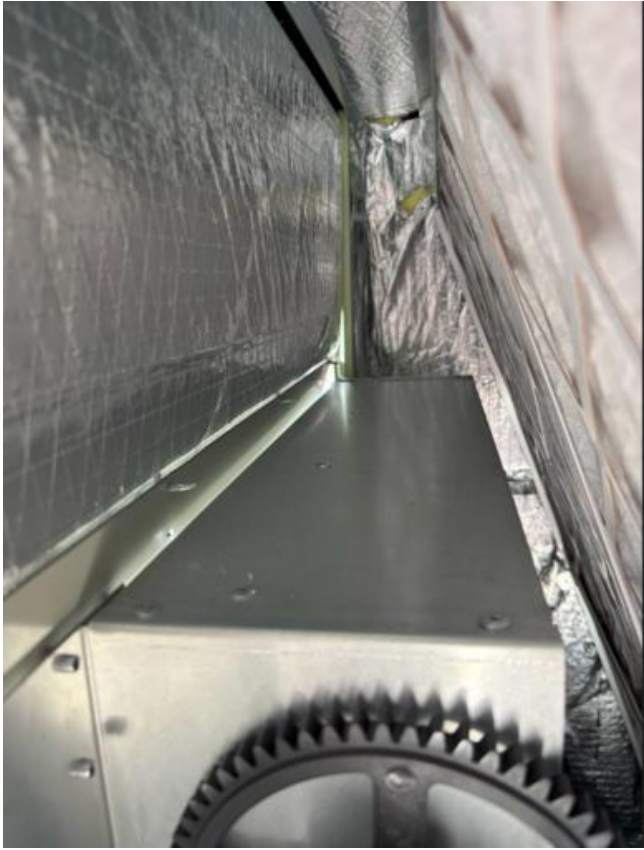
#79 [UNIT 524] [NEW] AC-5 economizers.

AC-5 economizer assembly has a gap on the inside of the unit. This needs to be sealed to prevent outside air infiltration.

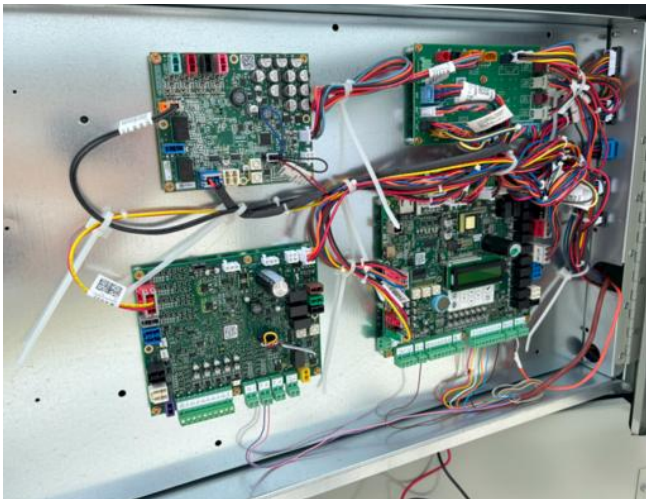
#62 [UNIT 503] [NEW] Trane equipment missing FAT field kits.

Trane equipment does not have additional manufacturer supplied, field installed relays, delay timer, or discharge temperature controller with FAT scheduled in design.

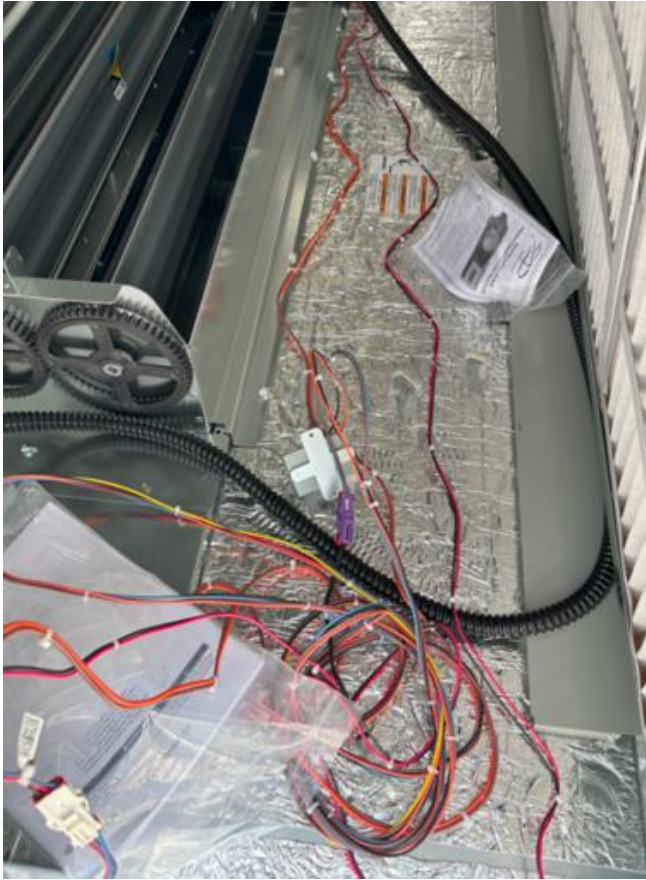
#61 [UNIT 999] [NEW] - AC-1 sensors

AC-1 sensor installation not complete. Mechanical contractor aware and is seeking Trane's advice on where they should be installed.

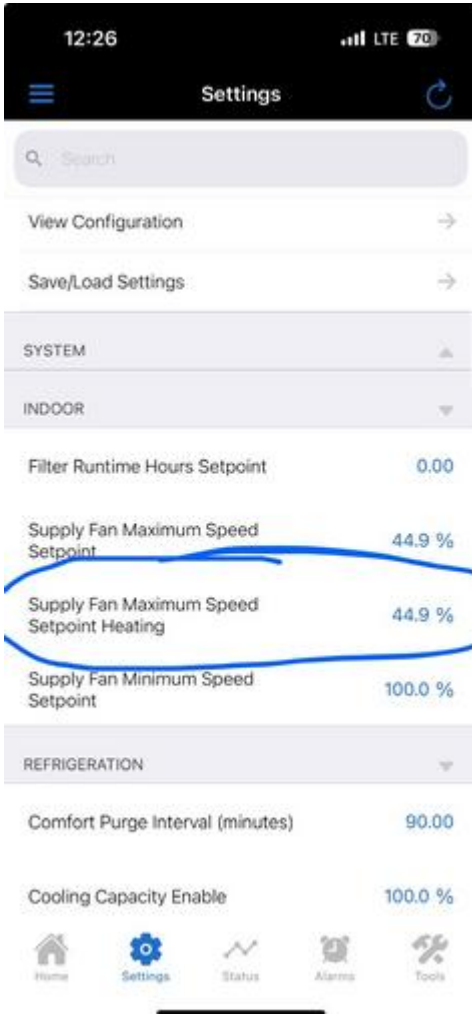
#55 [UNIT 999] [NEW] - Trane Symbio settings

Some Trane units are showing a heat CFM on the Symbio app. This is not typical for Chick-fil-A RTU's. Ensure that the units are configured properly.

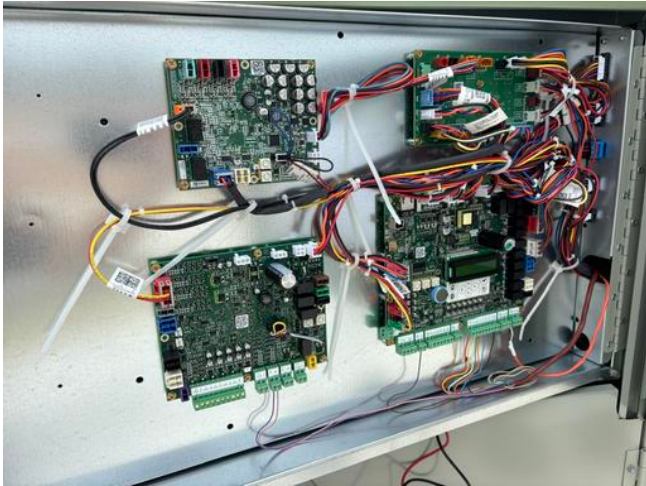
#48 [CNTL 999] [NEW] - Trane control wiring

Wiring from Suncoast panel to Trane unit needs to be reviewed. The wires are currently run from P/P1 to terminal J8 but based on previous experience these need to be run to J20 for proper economizer operation. Currently AC's 1 and 4 economizers do not close during unoccupied mode.

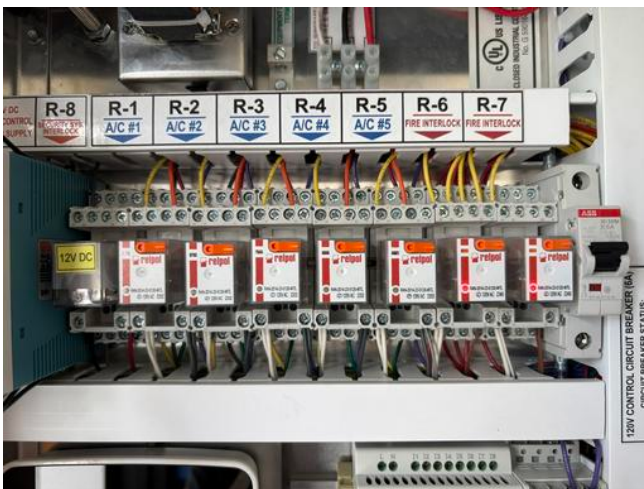
#47 [CNTL 514] [NEW] SEC ice cube wiring/sequence.

Ice cube relays are not wired properly from the factory. Contact Suncoast for instructions on how to re-wire these correctly. Currently AC's 1 and 4 economizers do not close during unoccupied mode.

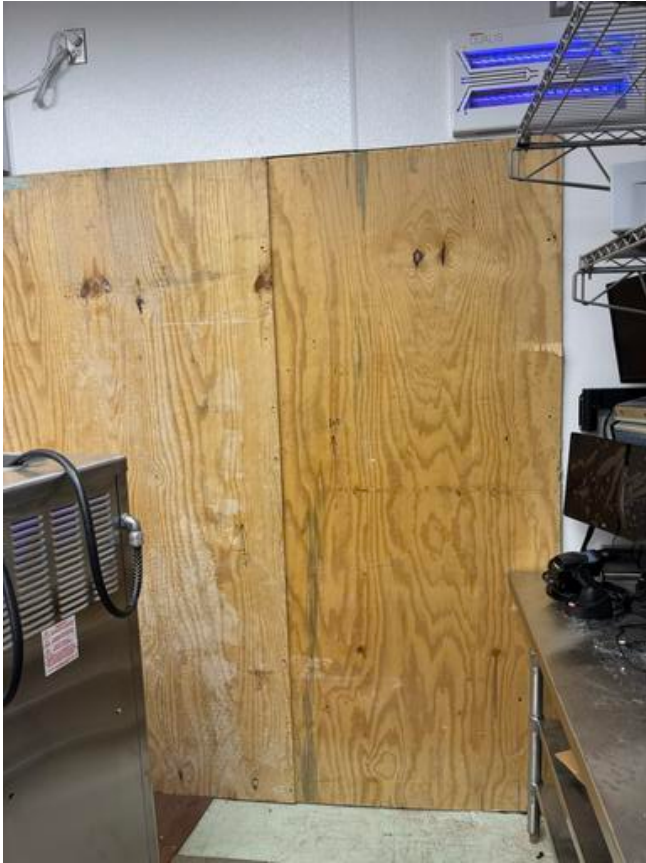
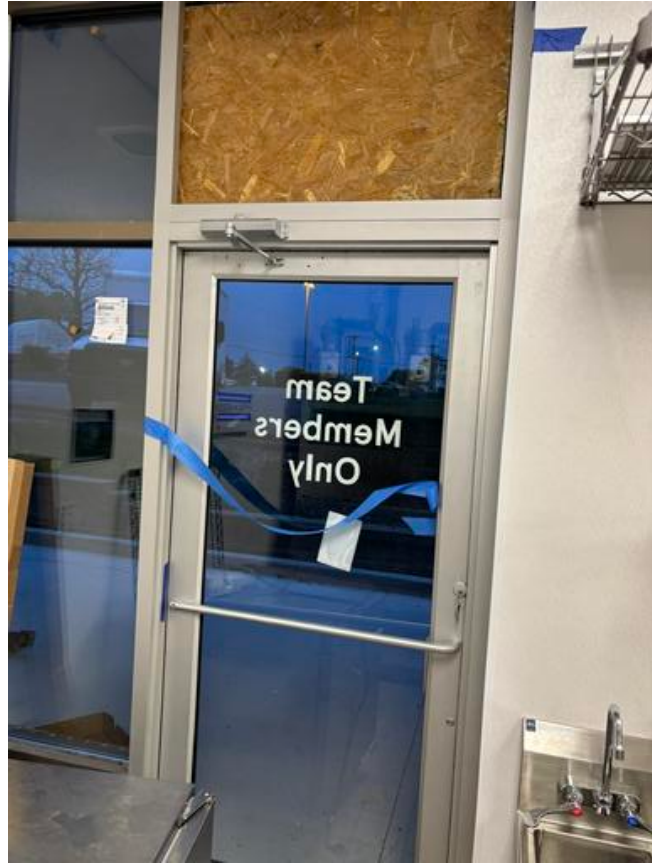
#45 [SITE 003] [NEW] CRITICAL – Glass or exterior doors. (FSU)

Exterior glass / door installations not completed at time of TAB inspection, unable to obtain accurate building pressure.

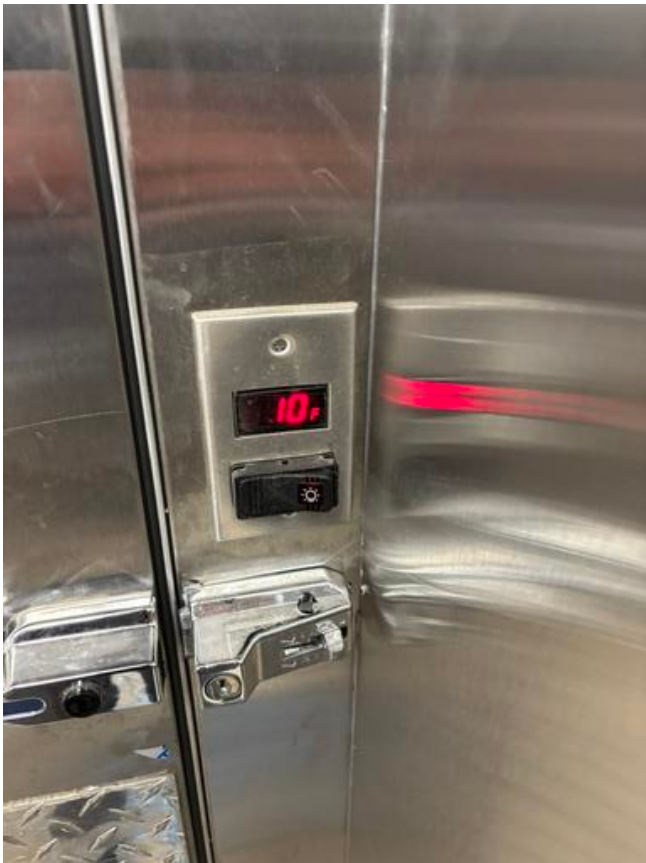
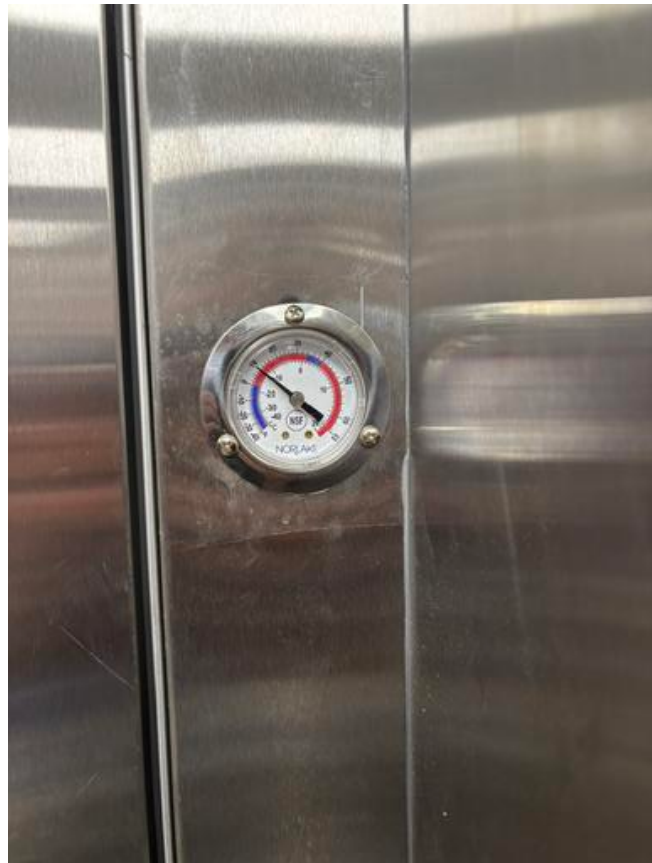
#44 [REFG 500] [NEW] WIF temperatures.

Walk in freezer is not operating at 0 degrees.

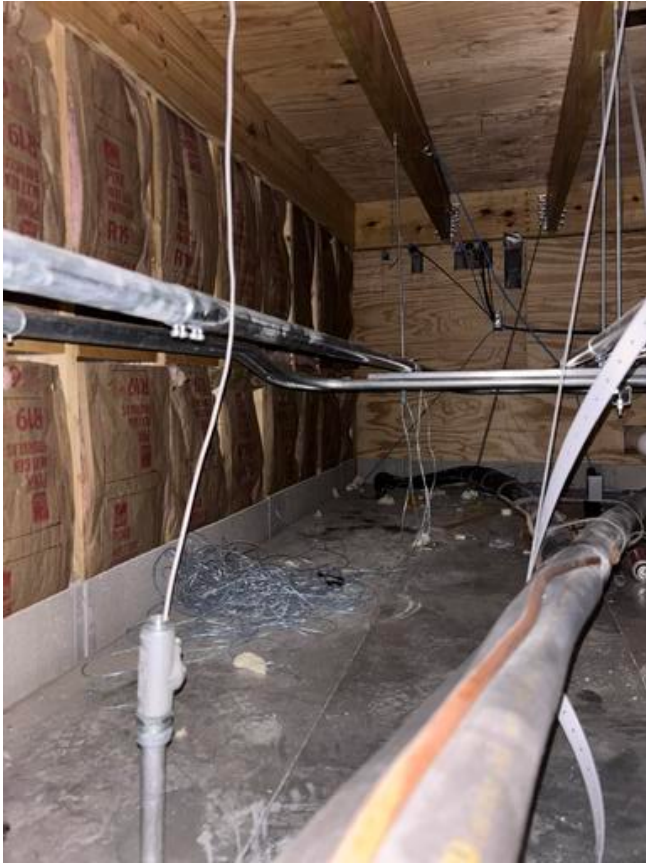
#43 [REFG 508] [NEW] WIC/WIF panel penetrations.

Access is difficult above walk ins but appears that WIF/ WIC penetrations are not sealed inside with silicone and above ceiling panel with 2 layers of 1/4" foam tape 12" above panel at time of inspection.

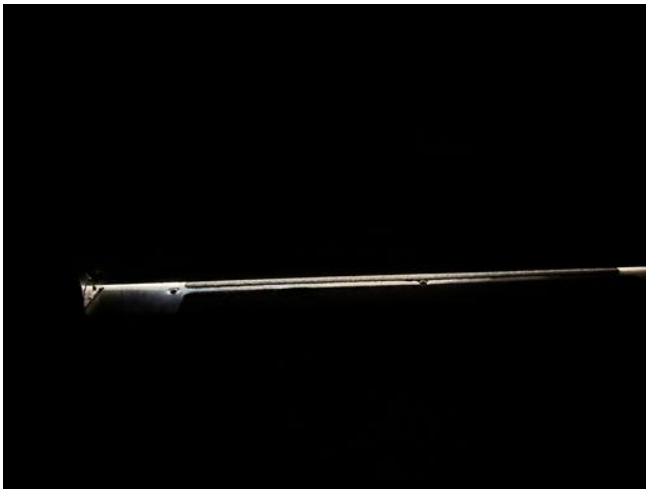
#42 [REFG 506] [NEW] WIF door sweep vs threshold.

WIF door sweep is not sealed tightly with threshold when door is closed. No light should be present inspecting from the inside out with box lights off.

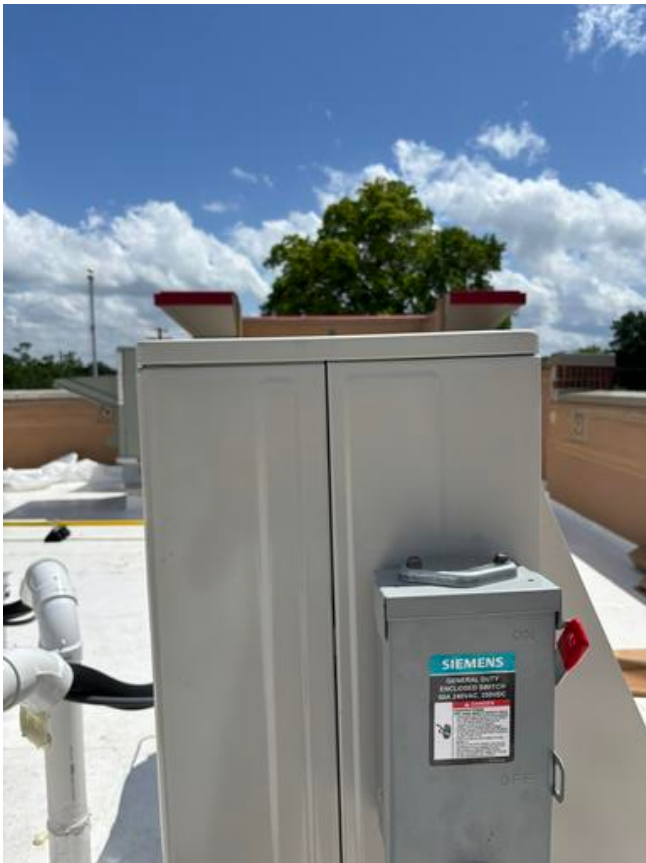
#41 [UNIT 519] [NEW] AHU-6 condenser does not appear level.

AHU-6 condenser is not level

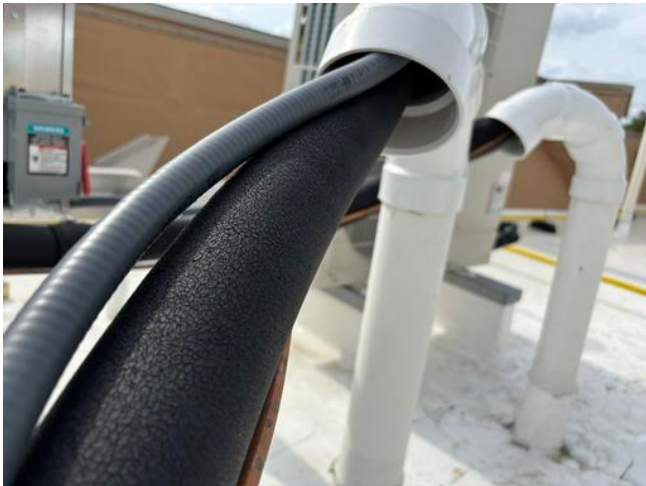
#40 [REFG 511] [NEW] PVC pipe chase (gooseneck) installation.

PVC pipe chase risers are not constructed to drawing or is not sealed with spray foam to prevent weather/pest infiltration.

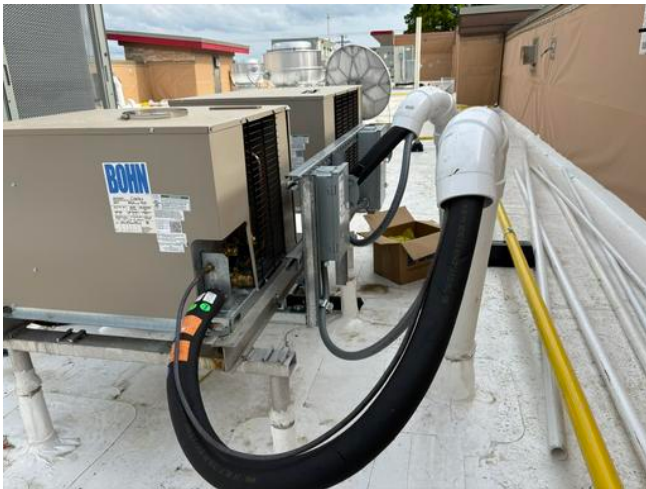
#39 [REFG 514] [NEW] Condenser anchoring.

Condensers are not properly anchored to equipment stands. See detail 4 on sheet M401

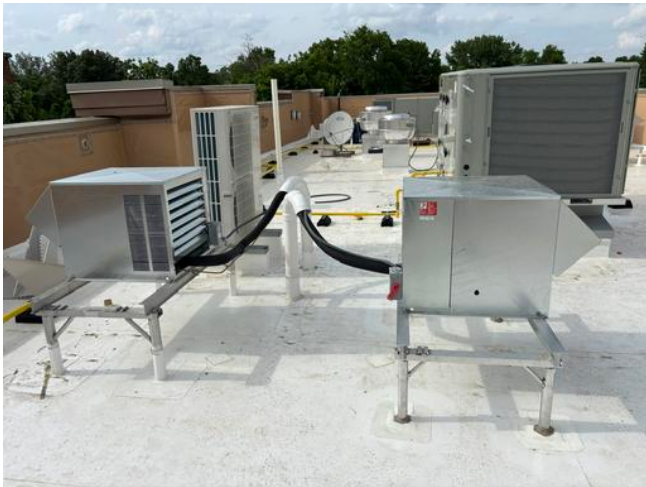
#38 [REFG 999] [NEW] - Ice machine condenser locations

Ice machine condenser locations do not match the drawing.

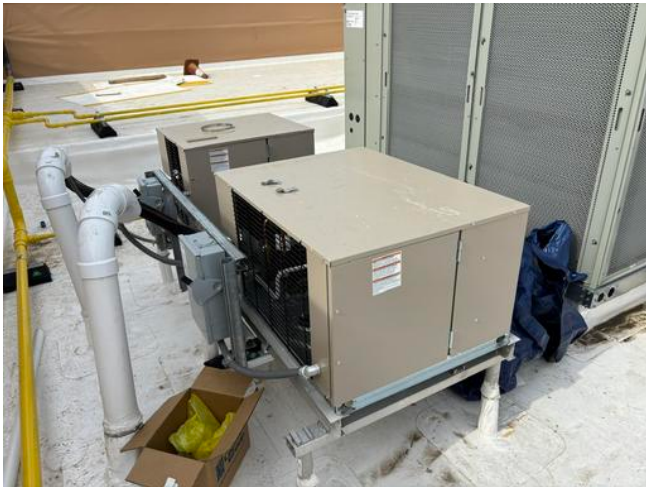
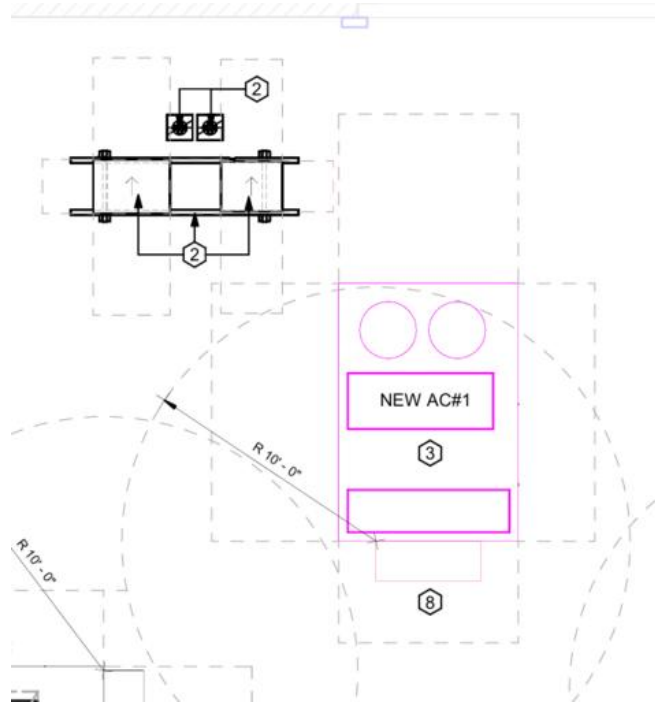
#37 [REFG 999] [NEW] - WIC/WIF Condensing unit locations

WIF/WIC condenser locations do not match the drawing

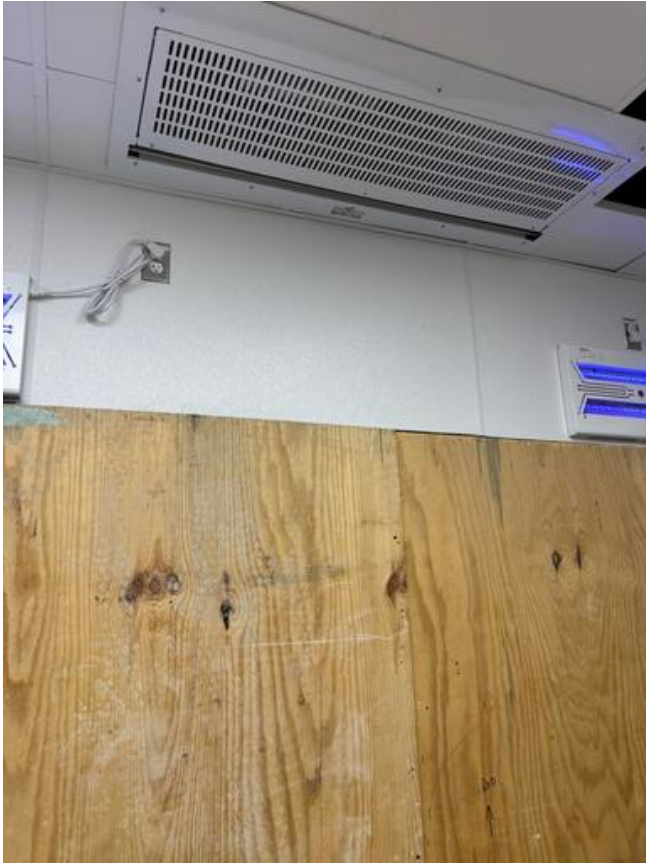
#35 [CURT 506] [NEW] Air curtain installation.

Air door 1 should be installed
6" from the exterior wall.
Ensure that Air door 3 is 1-6"
from exterior wall.

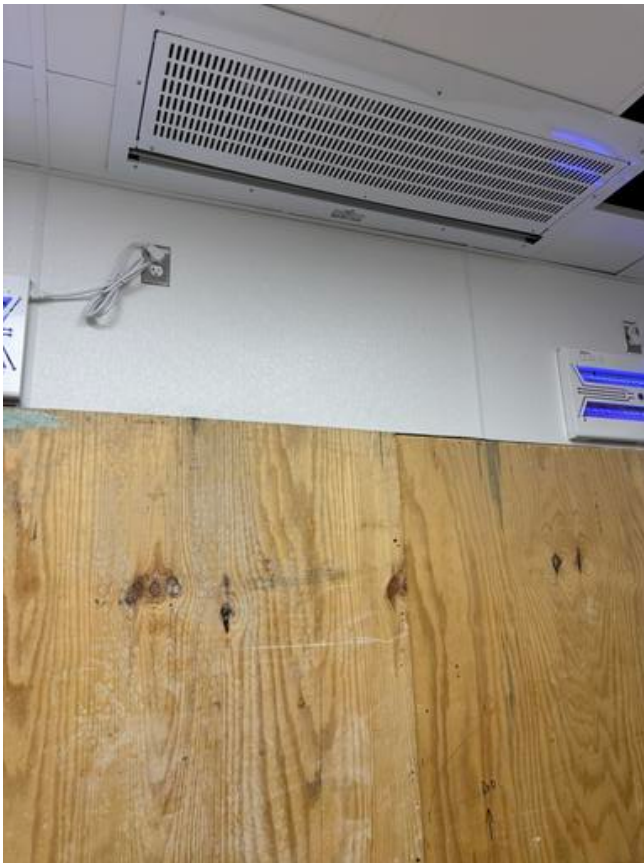
#34 [CURT 502] [NEW] Air curtain diverter box.

Air curtain diverter box is not installed on AD-1

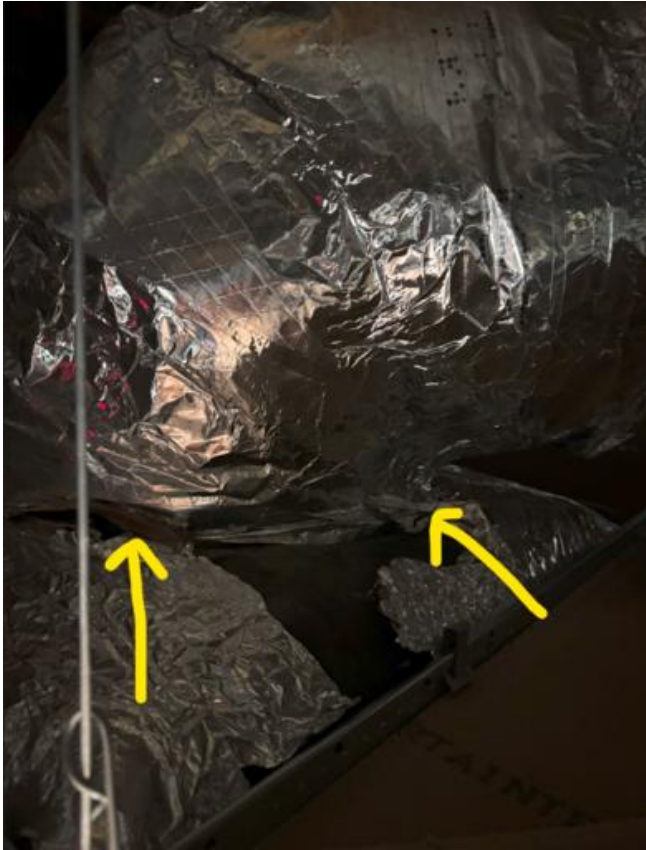
#33 [DUCT 999] [NEW] - Insulation taping at diffusers

Ductwork riser insulation is not taped to the tops of the diffusers

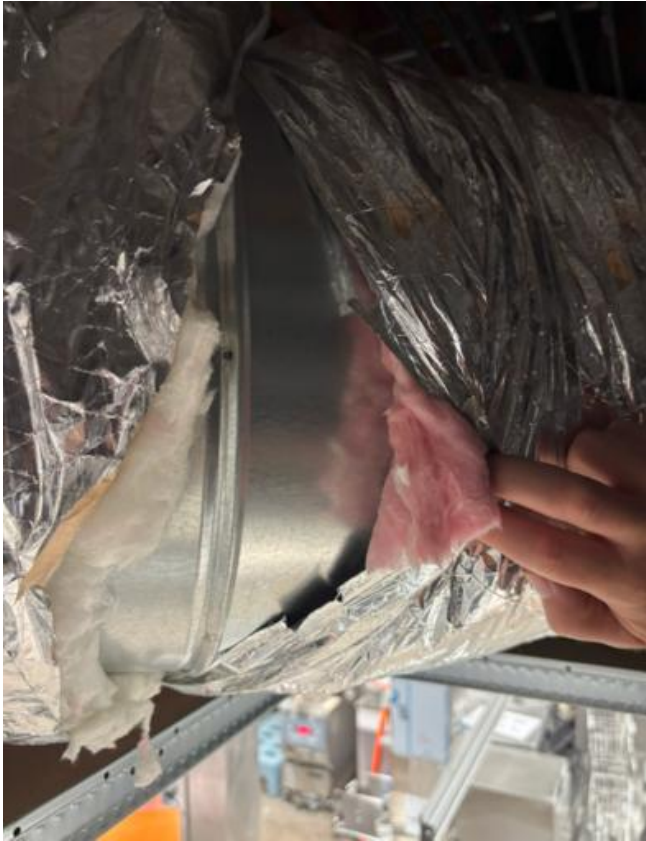
#32 [DUCT 499] [NEW] CRITICAL - Ductwork sealant

Spot checked and found that ductwork is not installed at all rigid connections including connections to diffusers. All ductwork needs to be sealed.

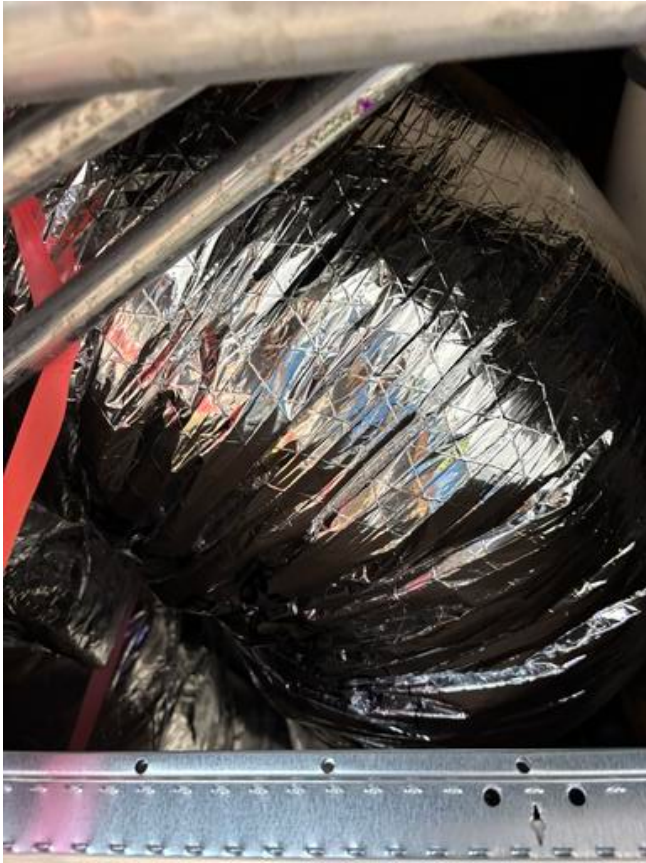
#30 [DUCT 499] [NEW] CRITICAL - Return AC-1 R3 ductwork

Return grille on the dining
AC uses flex as a 90 degree
transition after the damper.
Rigid duct required.

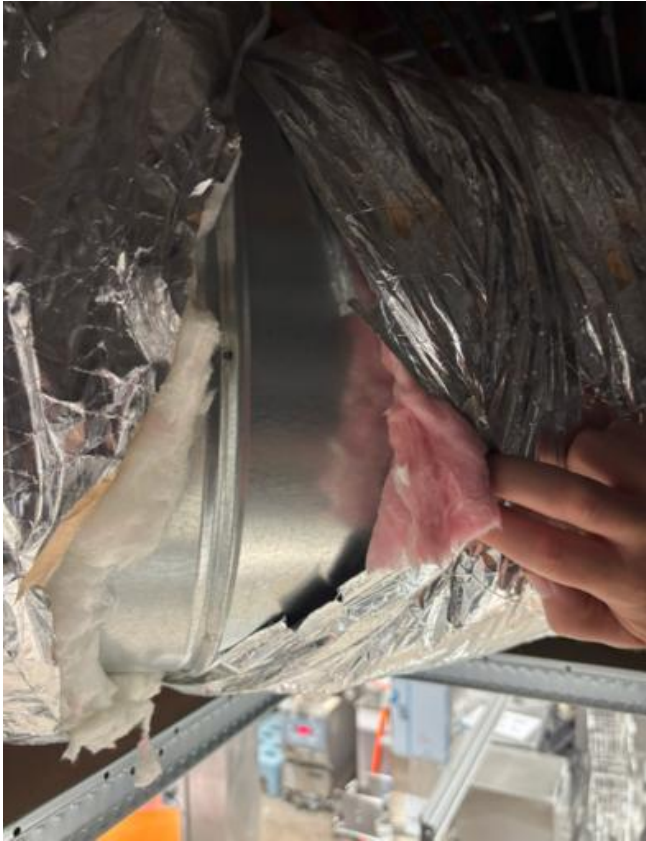
#29 [DUCT 006] [NEW] CRITICAL – Flex duct installation.

Ensure flex inner core is taped and banded, along with tape or banding on outer insulation jacket.

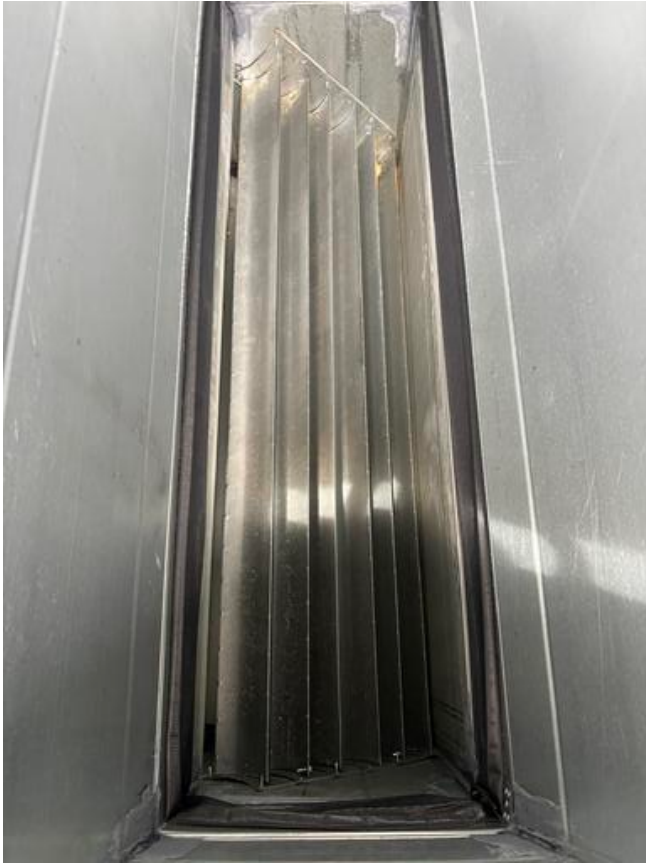
#28 [DUCT 001] [NEW] CRITICAL – Double thickness turning vanes.

Double thickness turning vanes are installed on the supply ductwork for AC-1. Airflow for the unit is within design and the static pressure in the supply duct is not excessive. Seek engineer and CFA approval.

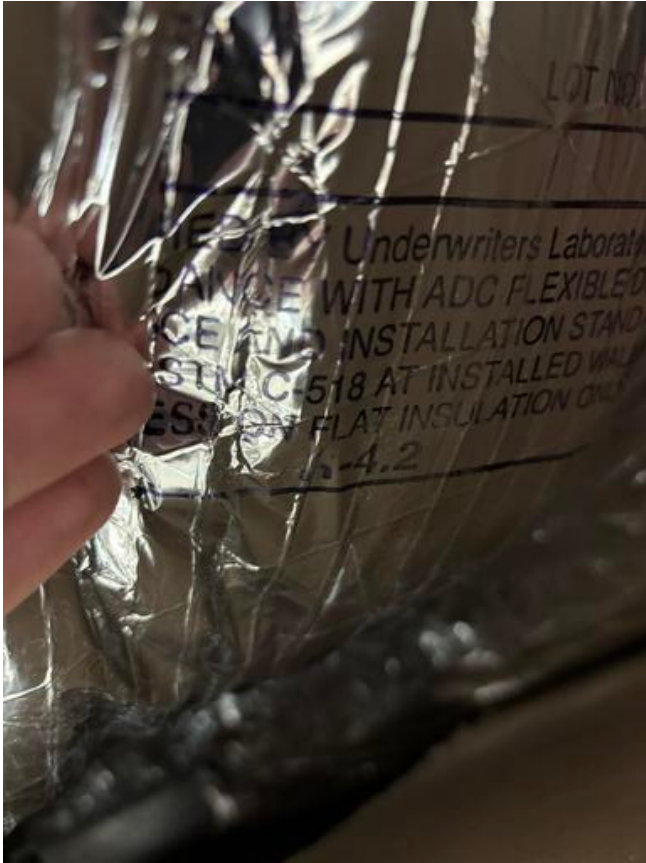
#27 [DUCT 499] [NEW] CRITICAL - Flex / HVAC ductwork insulation

Flex ductwork is R-4.2 but the plans call for R-6. Unable to confirm the rating for the external insulation on the HVAC so the rating on this needs to be provided by the mechanical contractor.

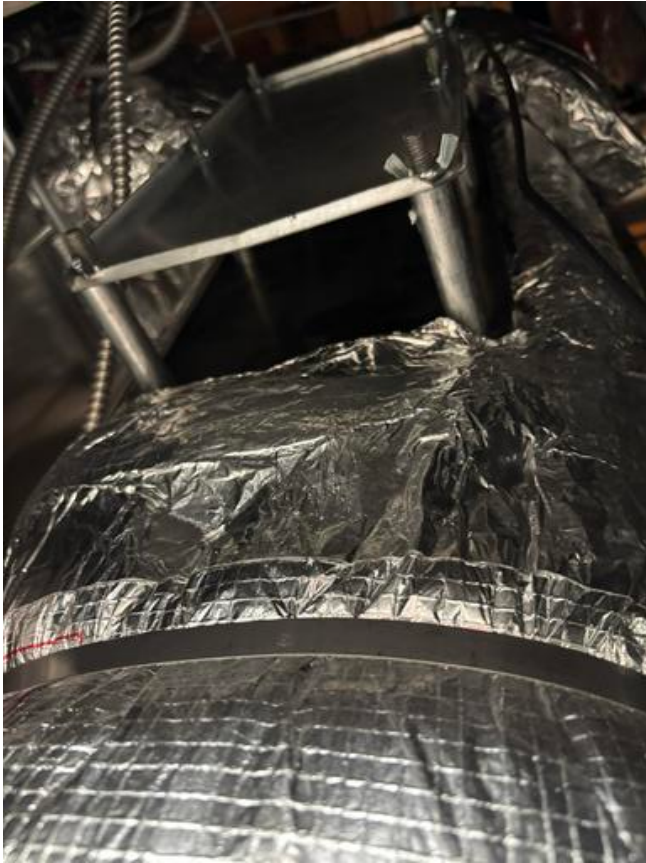
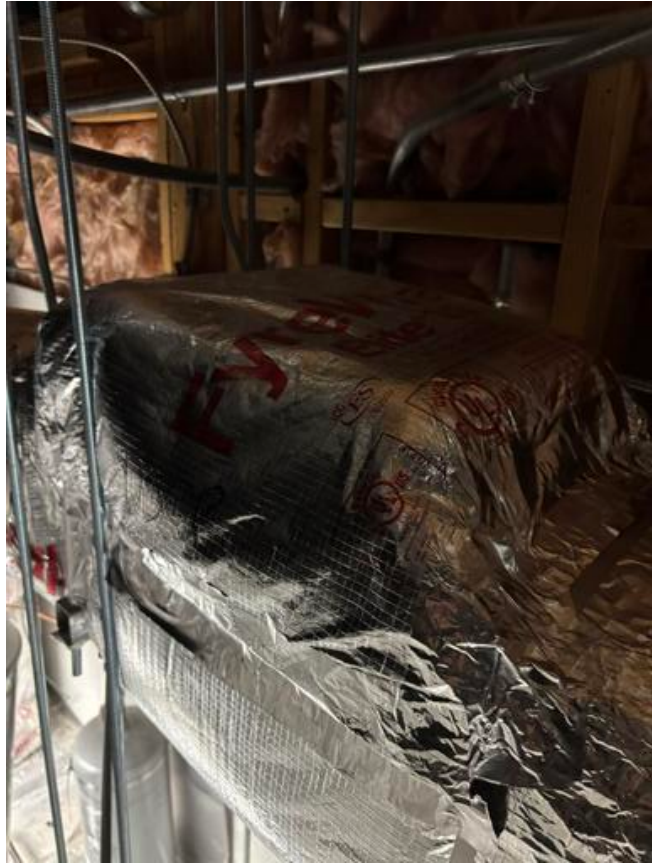
#26 [EXHA 001] [NEW] CRITICAL – Grease duct access doors.

Grease access doors are covered with insulation. Also hood 3 access door is missing insulation.

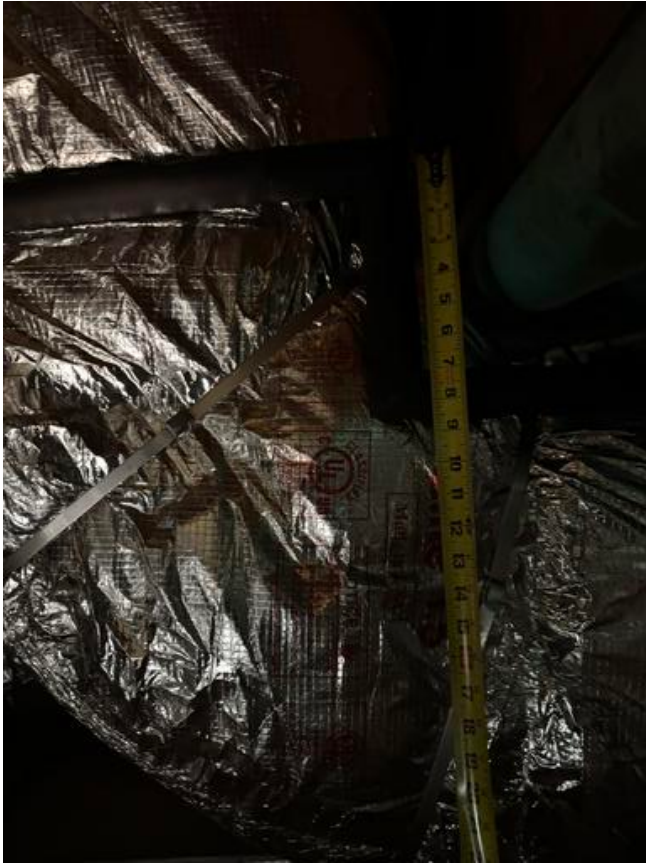
#25 [EXHA 003] [NEW] CRITICAL – Incorrect grease exhaust duct ells.**Status**

Grease ductwork not constructed with long radius centerline $R=3W/2$ fittings per specification. Short radius, mitered ells, and offsets greater than 45 degrees are not allowed. Discussing with the mechanical contractor there was no clearance above the ceiling due to piping/conduit to install per design. Airflow and static pressure for all hoods is within design. Seek engineer and Chick-fil-A approval.

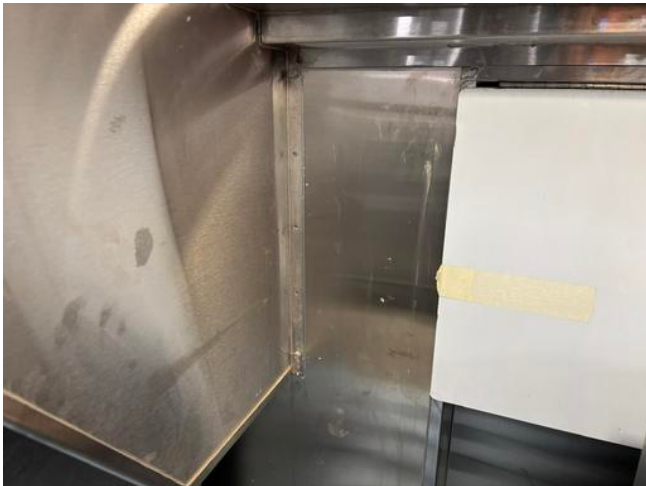
#24 [HOOD 509] [NEW] Hood back panes.

Hoods are to be secured to back panes via pre-punch holes with stainless steel screws. Not secured at all pre-punch holes.

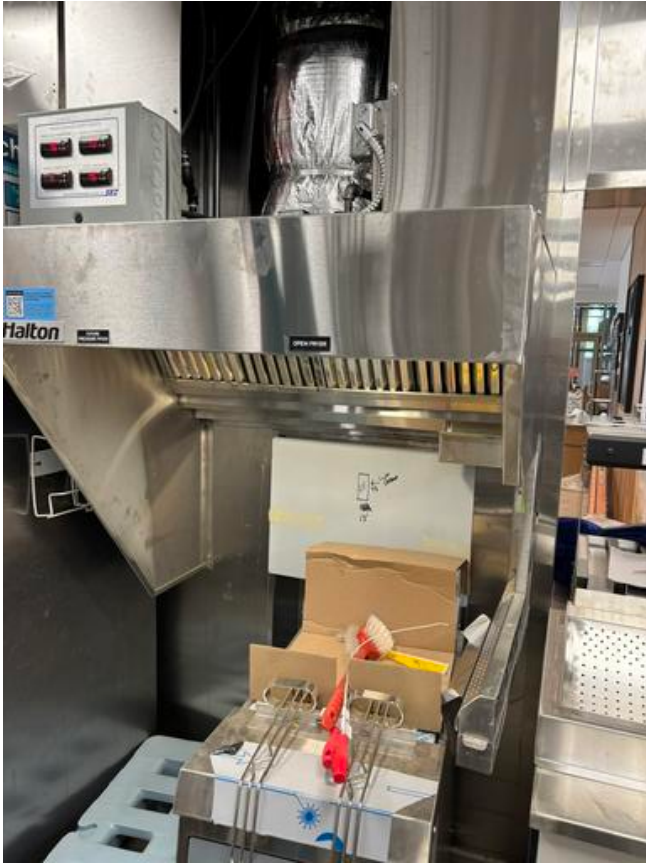
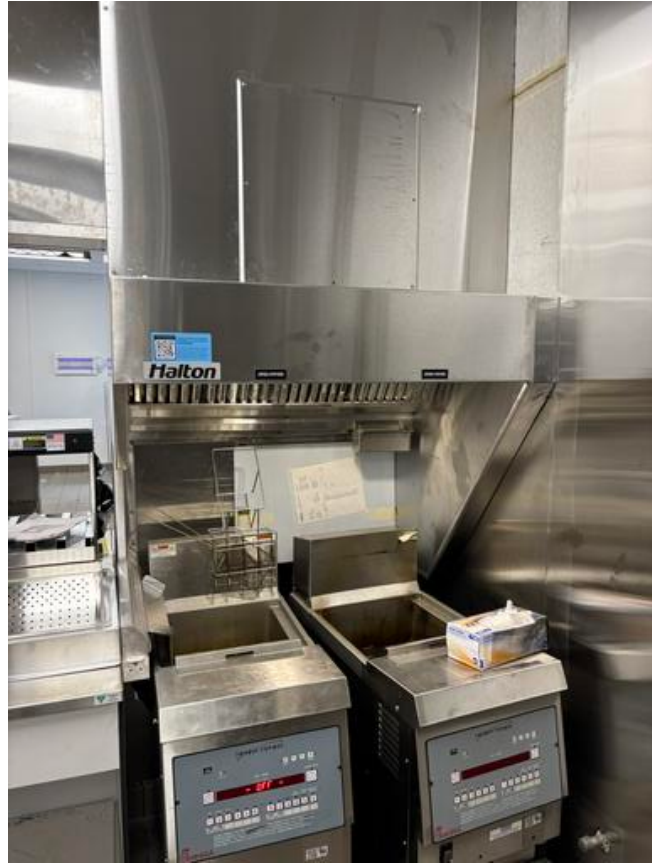
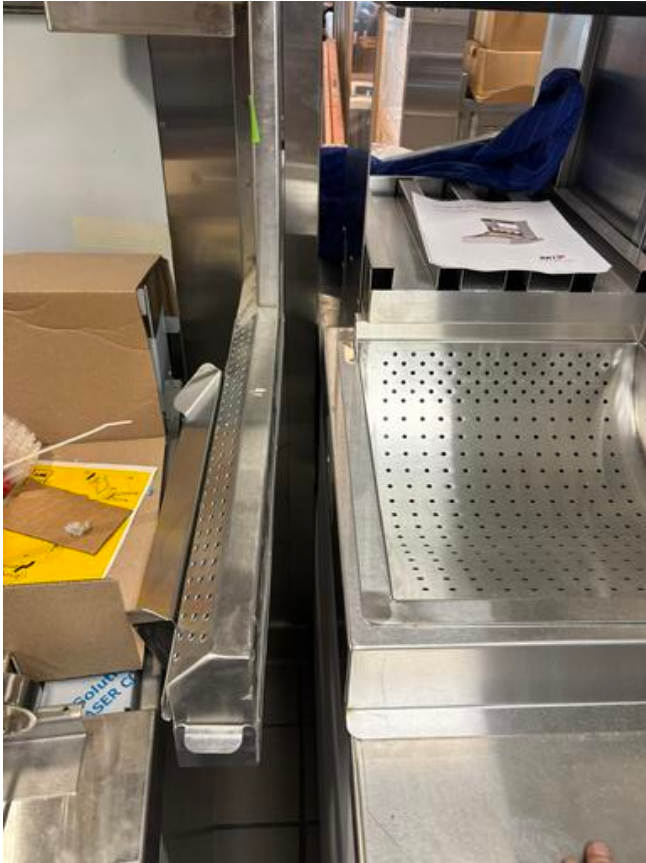
#22 [HOOD 508] [NEW] Sidejet arm angle bracket.

The Halton supplied angle bracket that connects the integral sidejet arm to the counter for hoods 2 and 3 is missing. Secure bracket to arm and bracket to counter underneath removeable fry dump via stainless steel rivets.

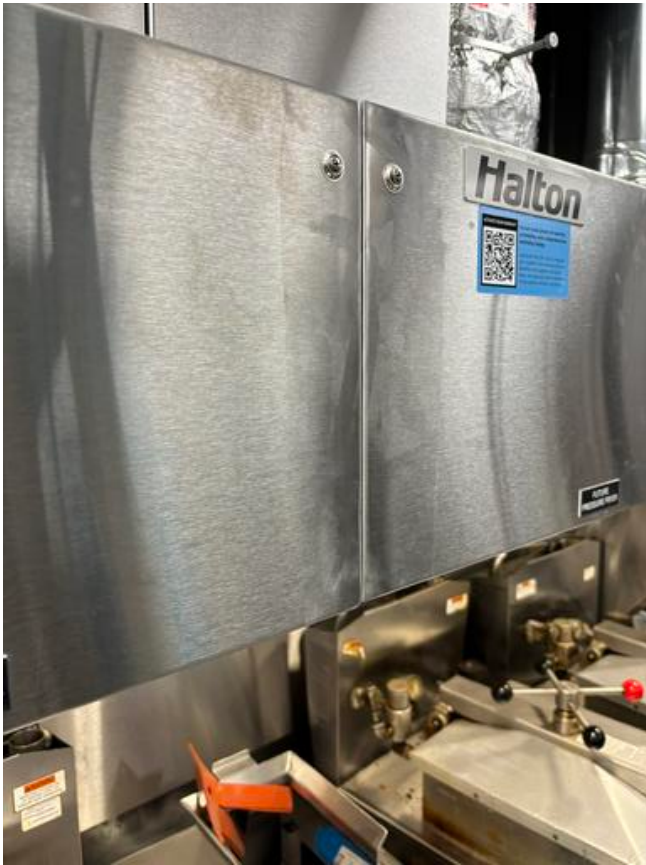
#21 [HOOD 511] [NEW] Hood 1L/1R hardware.

Hoods 1L/1R are missing the splice brackets that are to be installed at their midpoint connection seams.

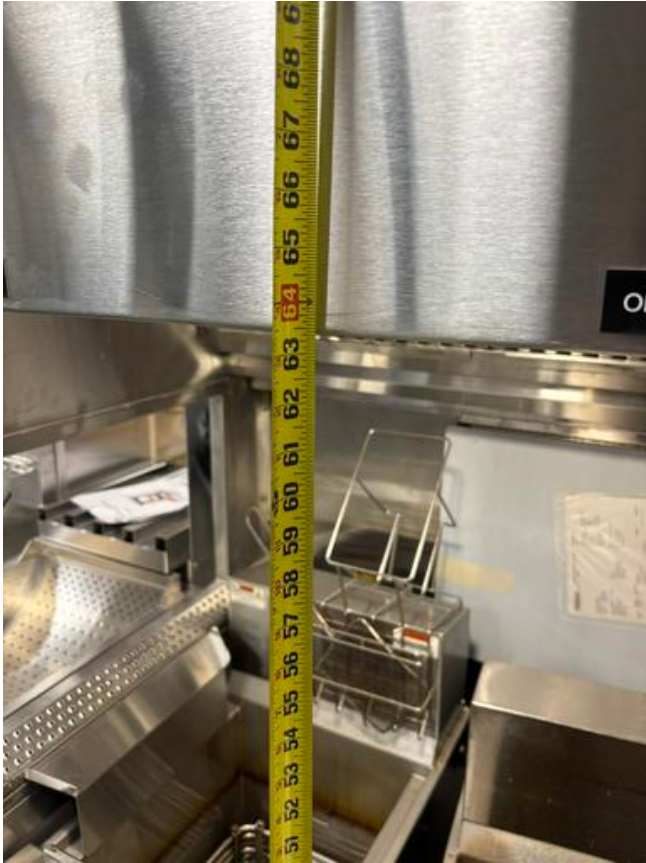
#20 [HOOD 006] [NEW] CRITICAL – Improper hood height.

Hood 2 is hung at 63.5" AFF.
Confirm with Halton and
Chick-fil-A that this deviation
will not interfere with
performance or operations.

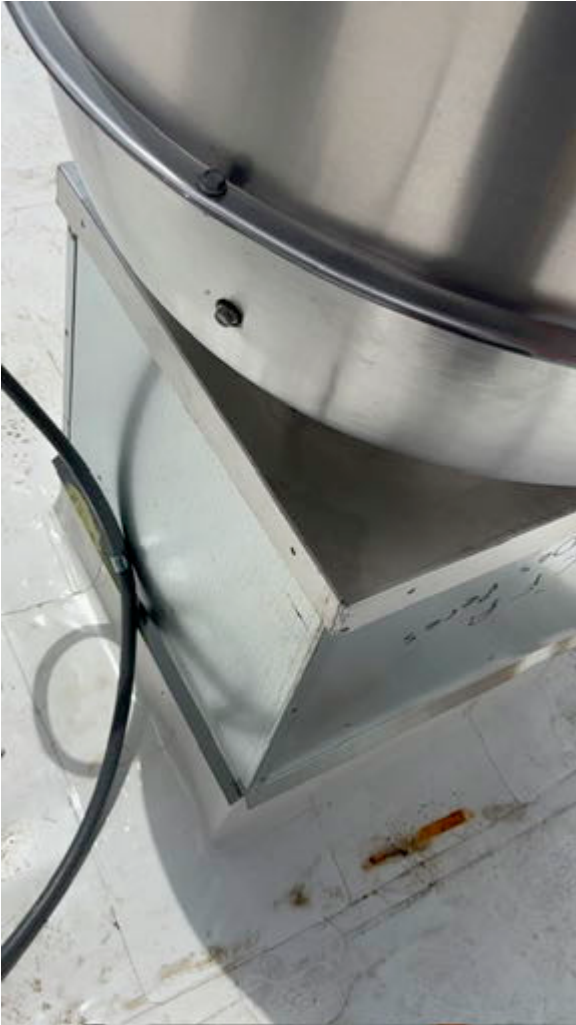
EF-2 and EF-4 are not secured to the curbs. They are also do not sit flush on the curbs. EF-1 hinge kit is not secured to the curb.

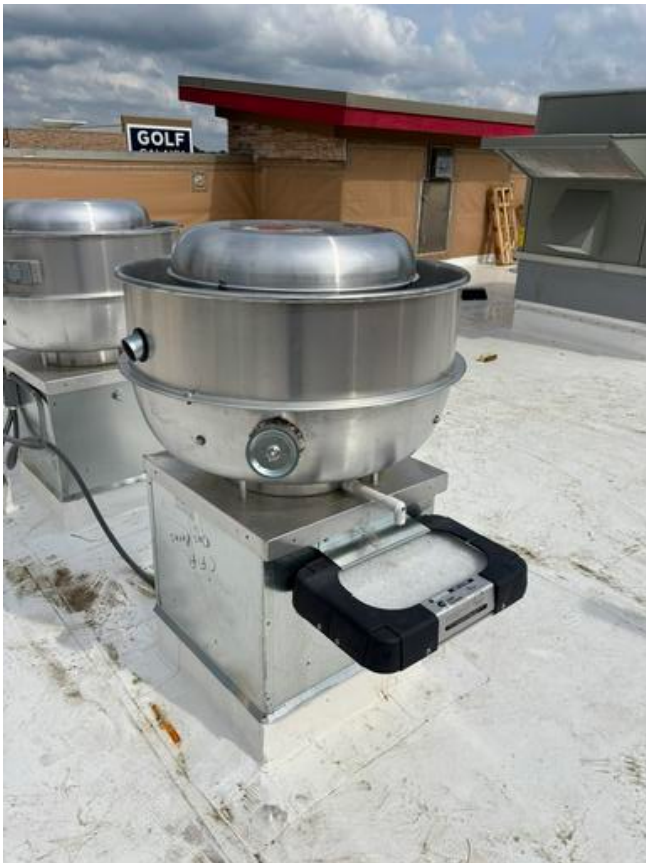
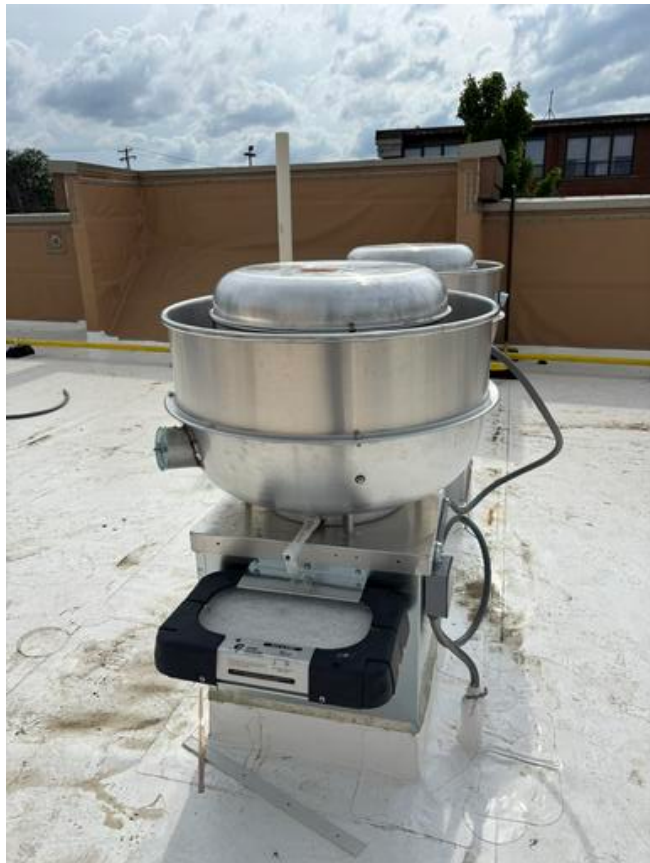
Hinge kits not installed on
EF-2 and EF-4

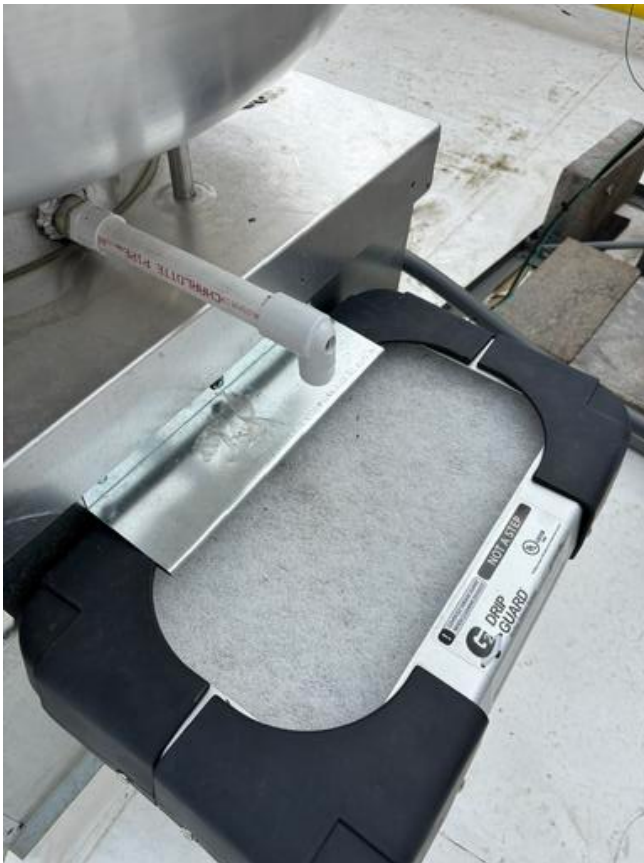
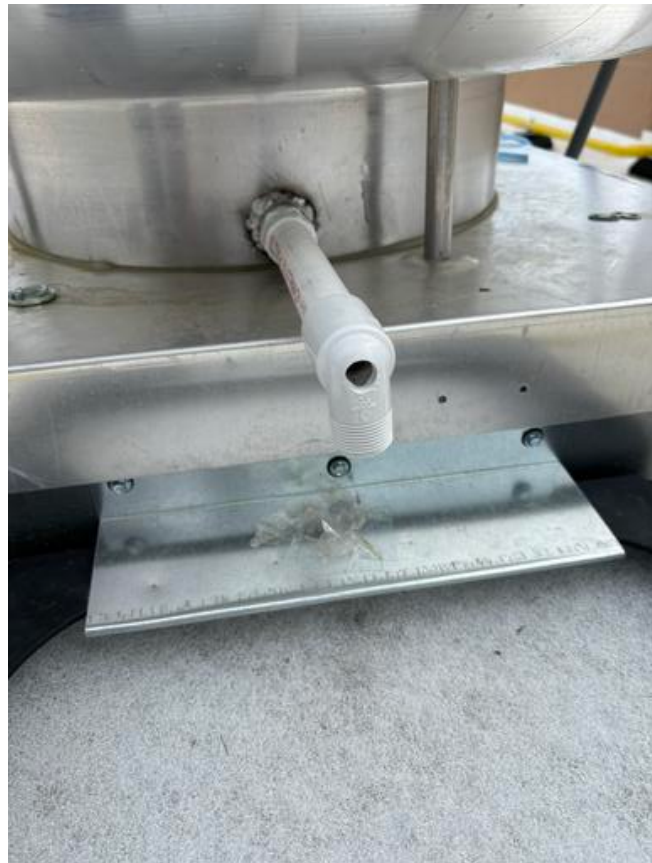
Drains needs to be piped to the center of the drip guard.

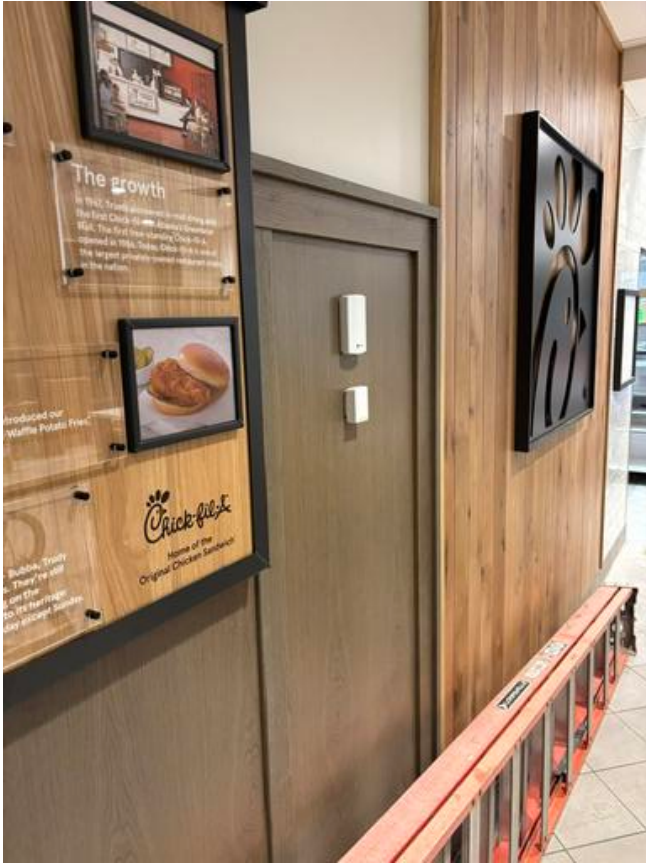
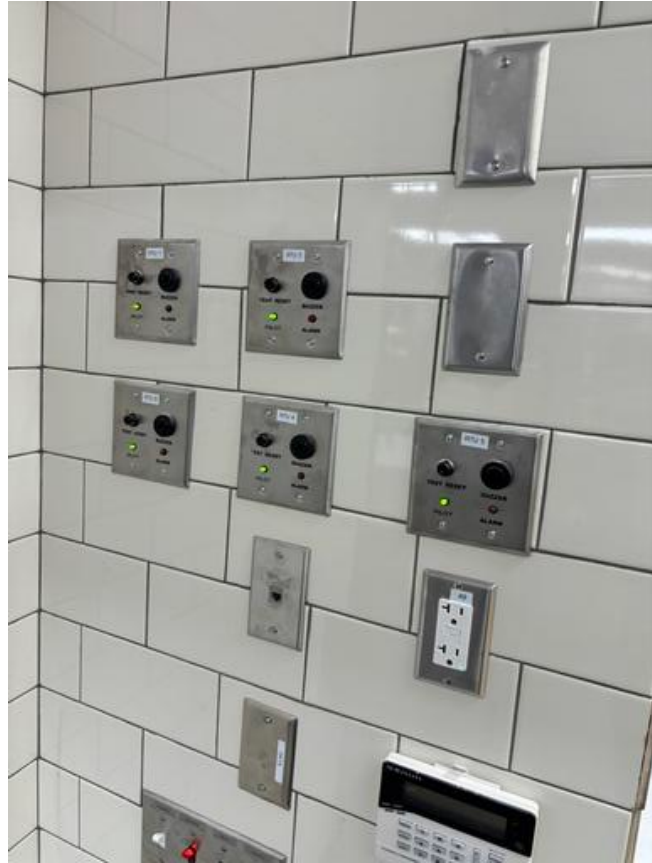
Label all sensors, humidistats, and annunciators per the specification on the control wiring detail.
