TAB Punch List - CFA 02665

Prepared by Will T

May 22, 2025

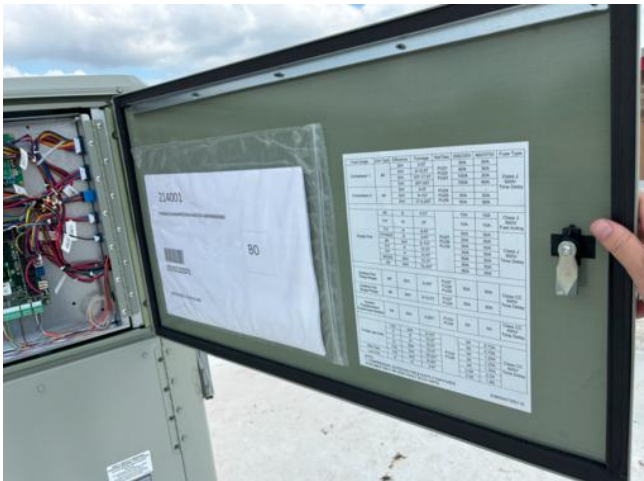
Equipment missing laminated copy of controls detail low voltage wiring diagrams.

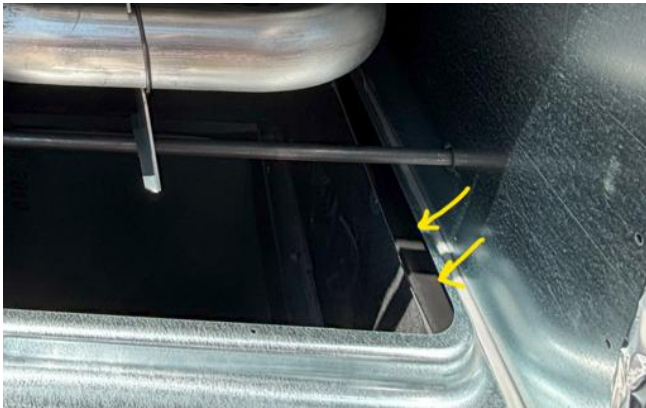
#9 [UNIT 001] [NEW] CRITICAL – Equipment is leaking air.

AC-4 has small gap at connection of the ductwork to the RTU. Appears the duct is not completely aligned with the RTU.

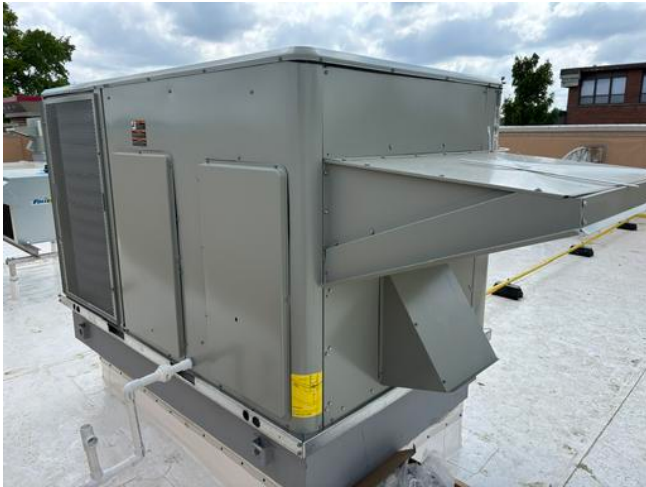
Condensate drain installation not completed.

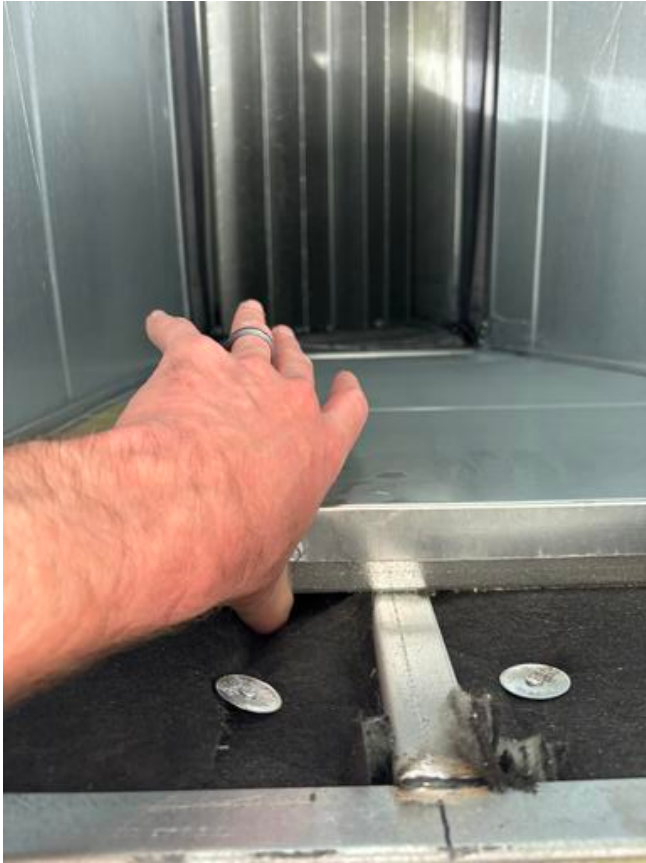
#7 [UNIT 001] [NEW] CRITICAL – Equipment is leaking air.

AC-1 has an area inside the curb where air could leak. Needs flashing and to be sealed.

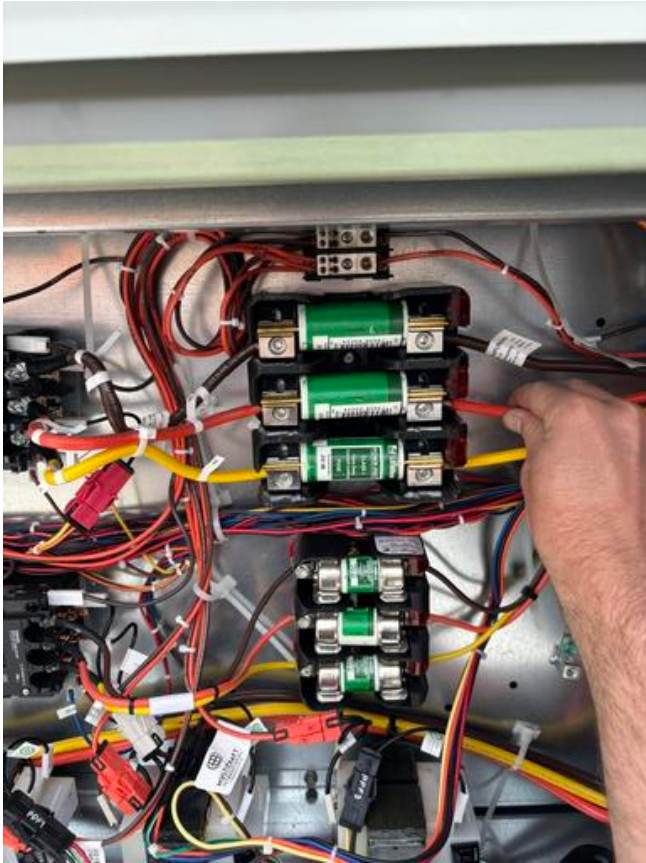
Electrical connection found loose from the factory on AC-1. Needs to be tightened

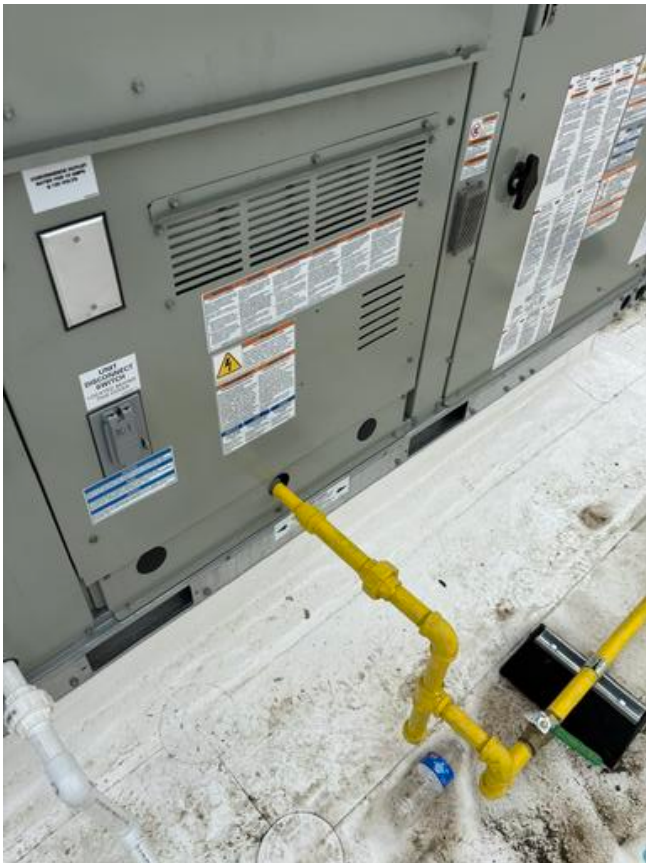
Gas piping grommets not installed on all AC's

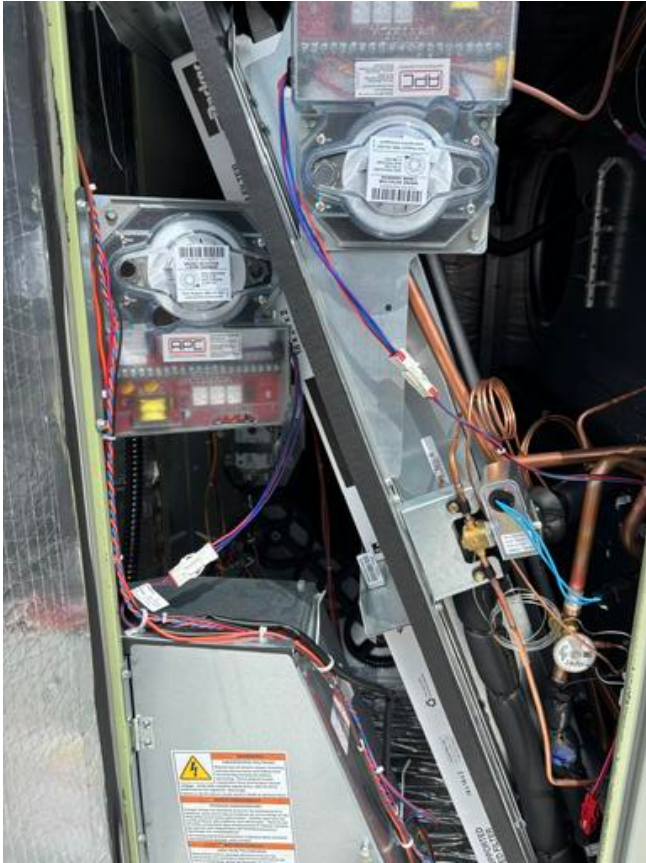
Smoke detector on AC-3 blocking filters from being removed. Smoke detector needs to be moved.

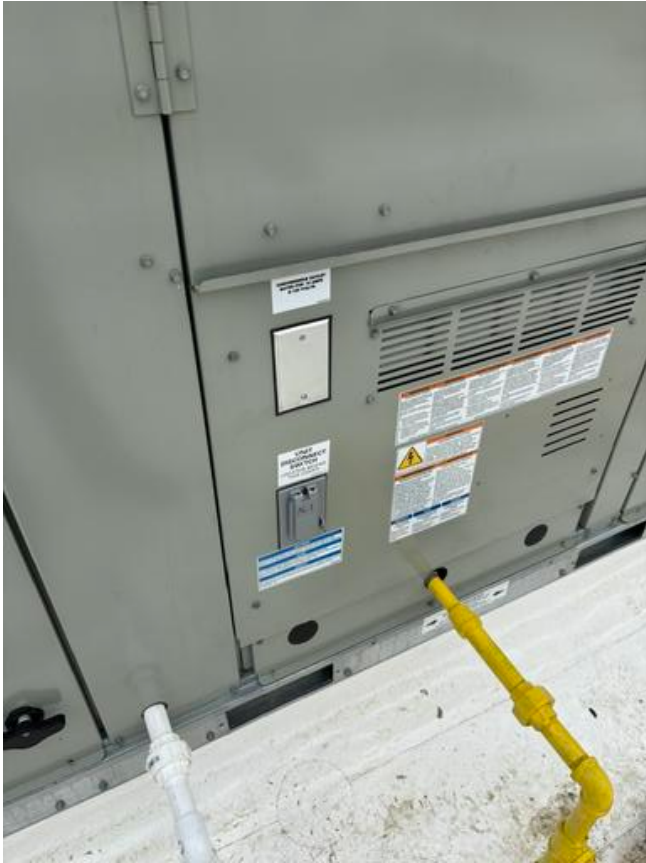
GFI outlet not installed on AC-1. Confirm all GFI's are powered.

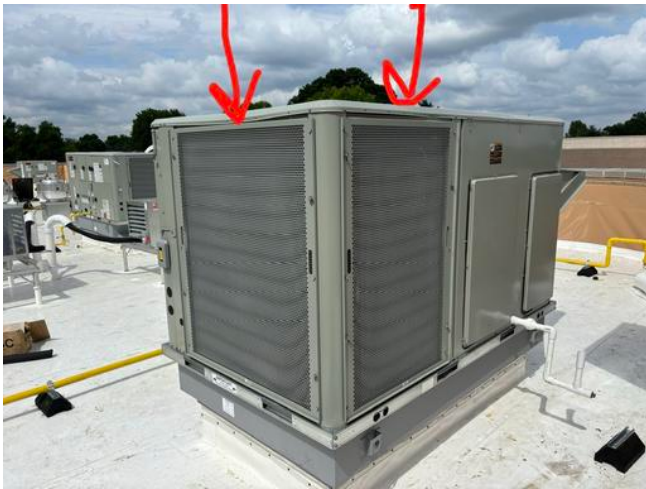
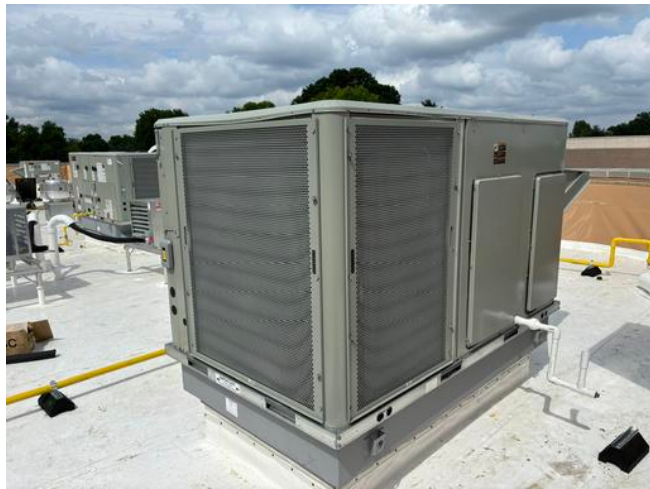
#1 [UNIT 513] [NEW] Equipment is damaged

AC-4 has some external damage
