Report: REMARKS
Function: Test, Adjust, & Balance
Date: 10/14/2025
Completed By: National TAB

PROJECT
10-06-25 QT #1423 TOLLESON, AZ

Issue List

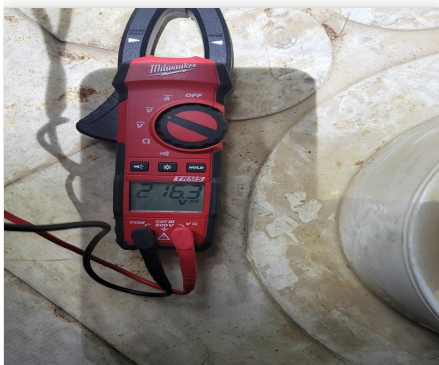
Issue Name : EF3 APPEARS TO BE OVER-VOLTED
Description : EF3 reads 216.3V, unit and motor rated for 208V.
Created By : National TAB **Assigned To :** National TAB - Dan Hertenstein
Status : Open
Priority : Medium **Asset Tag :** EF3
Originated Date : 10/17/2025 - Christine Weale - National TAB
