Report: TAB Report
Function: Test, Adjust, & Balance
Date: 10/09/2025
Completed By: National TAB

PROJECT
10-06-25 CAVA NEWTOWN, PA

Project: 10-06-25 CAVA NEWTOWN, PA

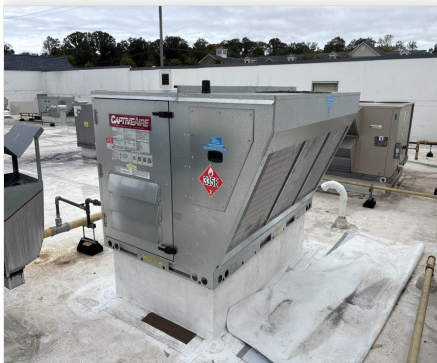
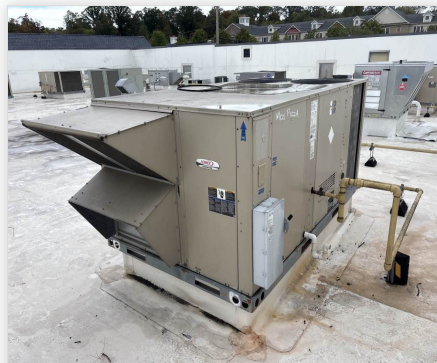
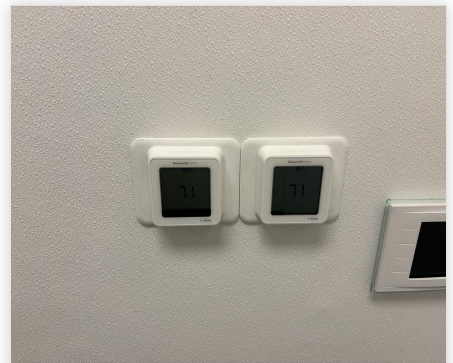
Issue Name : All Assets and Thermostats: No ID Tags
Description : No ID tags installed on any of the rooftop assets or on the thermostats.
Install ID tags.
Created By : National TAB **Assigned To :** National TAB - Brianna Biggs
Status : Open
Priority : Low **Asset Tag :**
Originated Date : 10/08/2025 - Ryan Smith - National TAB

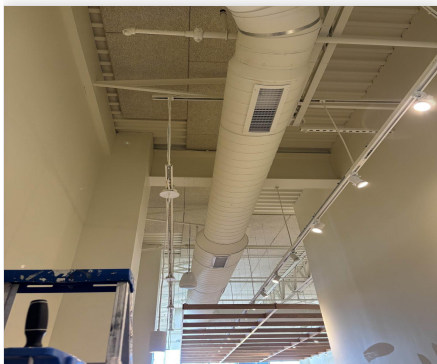
Issue Name : Diffusers 2-10 and 2-11: Drafting
Description : Can feel air draft when standing directly beneath these diffusers. Dampers have been fully closed, but are not able to fully block air.
Created By : National TAB **Assigned To :** National TAB - Brianna Biggs
Status : Open
Priority : Medium **Asset Tag :**
Originated Date : 10/09/2025 - Ryan Smith - National TAB

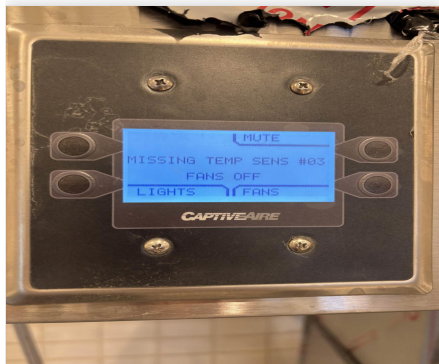
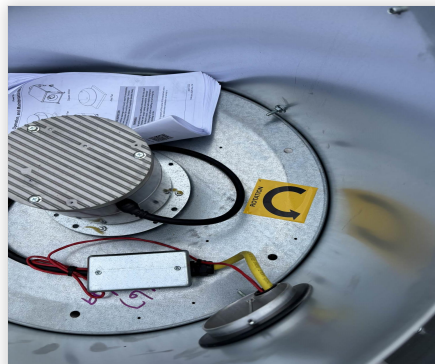
Issue Name : HD1, KEF1: Motor Overramping Unable to Decrease
Description : Motor overramping in KEF1. Unable to control fan speed from HD1 HMI. Troubleshoot according to manufacturer instruction.
Created By : National TAB **Assigned To :** National TAB - Brianna Biggs
Status : Open
Priority : High **Asset Tag :**
Originated Date : 10/09/2025 - Ryan Smith - National TAB

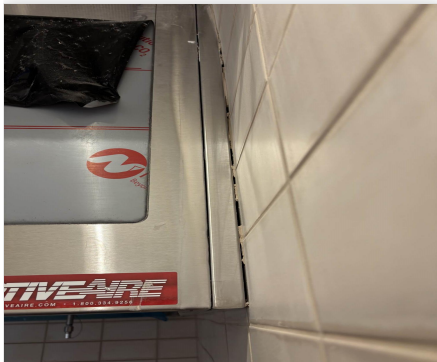
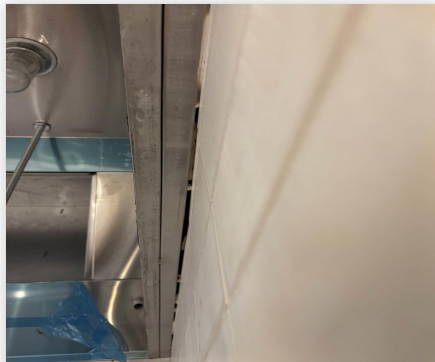
Issue Name : HD1: Caulking Degraded
Description : Hood caulking to wall on back, side, and front has degraded. Gaps can accumulate grease. Recaulk.
Created By : National TAB **Assigned To :** National TAB - Brianna Biggs
Status : Open
Priority : Low **Asset Tag :**
Originated Date : 10/08/2025 - Ryan Smith - National TAB

Caulk is applied (less than 1/8" thick) from the hood against all wall surfaces or between connecting side to side hoods to prevent grease accumulation inside any crevice. Fail

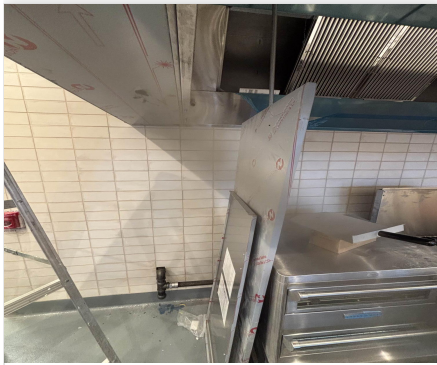
Issue Name : HD1: Hood End Panel Not Installed
Description : Install according to manufacturer directions.
Created By : National TAB **Assigned To :** National TAB - Brianna Biggs
Status : Open
Priority : Low **Asset Tag :**
Originated Date : 10/08/2025 - Ryan Smith - National TAB

End panels are installed Fail

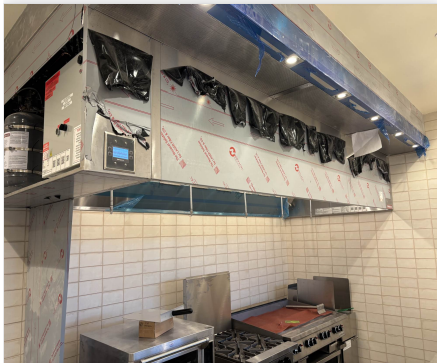
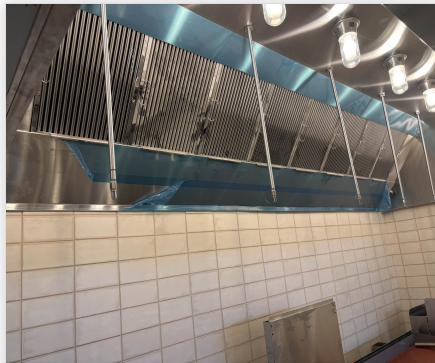
Issue Name : HD1: Plastic Film Still Installed
Description : Plastic protective film is still on hood. Remove film.
Created By : National TAB **Assigned To :** National TAB - Brianna Biggs
Status : Open
Priority : Low **Asset Tag :**
Originated Date : 10/08/2025 - Ryan Smith - National TAB

All protective film has been peeled away from the wall or other areas of impingement to assure it can be easily and fully removed prior to cleaning. Fail

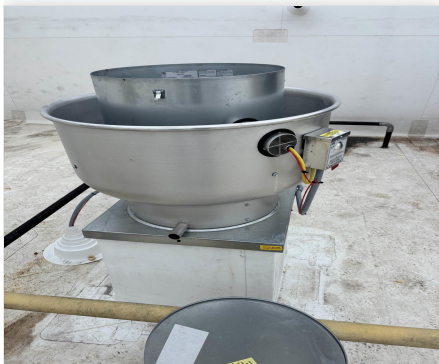
Issue Name : KEF1: Grease Cup Not Installed
Description : Grease cup not installed on KEF1 curb. Install according to manufacturer instructions.
Created By : National TAB **Assigned To :** National TAB - Brianna Biggs
Status : Open
Priority : Low **Asset Tag :**
Originated Date : 10/08/2025 - Ryan Smith - National TAB

No grease cup installed.

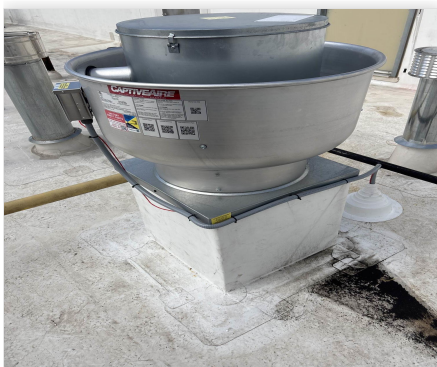
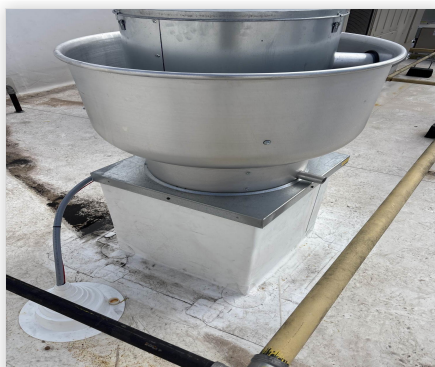
Issue Name : KEF1: Hinge Kit Not Installed
Description : Hinge kit for KEF1 not installed. Unable to collect pressure data. Install according to manufacturer directions.
Created By : National TAB **Assigned To :** National TAB - Brianna Biggs
Status : Open
Priority : High **Asset Tag :**
Originated Date : 10/08/2025 - Ryan Smith - National TAB

No hinge kit installed. Unable to test wiring length.

No hinge kit installed.

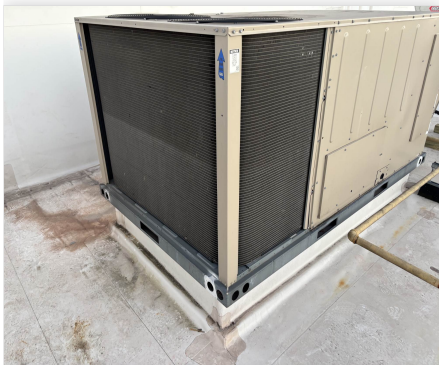
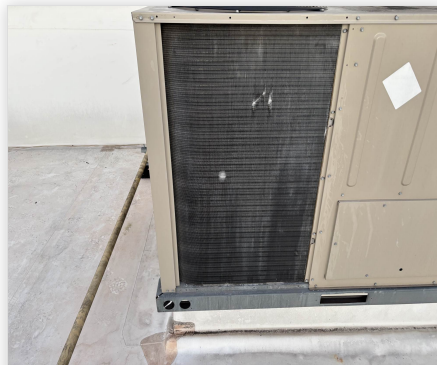
Issue Name : RTU1, RTU2: No Hail Guards
Description : Neither of the RTUs have hail guards on the condenser fins.
Created By : National TAB **Assigned To :** National TAB - Brianna Biggs
Status : Open
Priority : Low **Asset Tag :**
Originated Date : 10/09/2025 - Ryan Smith - National TAB

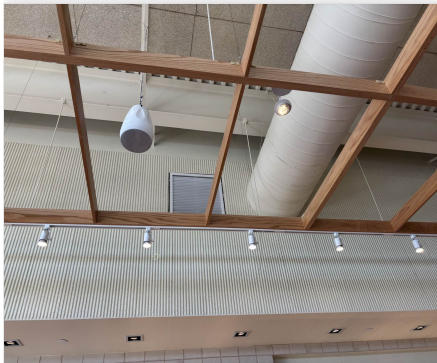
Issue Name : RTU2: Noise from Return Grille
Description : Return grille in dining area makes whining sound.
Created By : National TAB **Assigned To :** National TAB - Brianna Biggs
Status : Open
Priority : High **Asset Tag :**
Originated Date : 10/09/2025 - Ryan Smith - National TAB

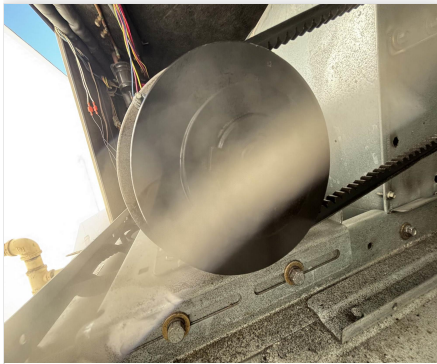
Issue Name : RTU2: Supply Flow is High
Description : Supply flow for RTU2 is high. Motor pulley has been fully reduced. Unable to further reduce supply flow. Attempted proportional balancing. Install smaller motor pulley or larger fan pulley.
Created By : National TAB **Assigned To :** National TAB - Brianna Biggs
Status : Open
Priority : Urgent **Asset Tag :**
Originated Date : 10/09/2025 - Ryan Smith - National TAB

- [1] MOTOR PULLEY HAS BEEN FULLY REDUCED. FURTHER REDUCTION IN AIRFLOW WOULD REQUIRE INSTALLING A DIFFERENT PULLEY. DIFFUSERS HAVE BEEN ADJUSTED PROPORTIONALLY.
- [2] AIR DAMPERS IN DINING AREA SIDEWALL DIFFUSERS DO NOT SIGNIFICANLTLY CHANGE AIRFLOW. UNABLE TO SHIFT AIRFLOW TO DIFFUSERS IN BACK HALLWAY. CONFIRMED THERE IS SUFFICIENT AIRFLOW IN ENCLOSED AREAS. WILL NOT CAUSE COMFROT, NOISE, OR VIBRATION ISSUES.

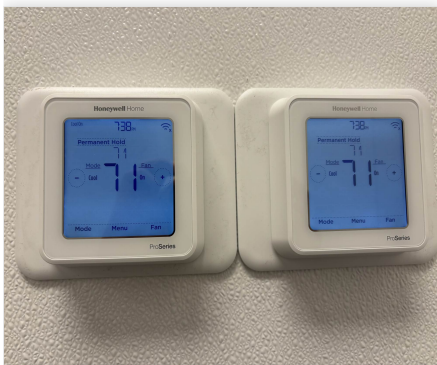
Issue Name : Thermostats: Unable to Program
Description : Unable to program thermostats. They are home thermostats. They do not accommodate programming for occupied vs unoccupied. They cannot automatically switch between cooling and heating.
Created By : National TAB **Assigned To :** National TAB - Brianna Biggs
Status : Open
Priority : High **Asset Tag :**
Originated Date : 10/09/2025 - Ryan Smith - National TAB
