Report: Punchlist
Function: Test, Adjust, & Balance
Date: 10/08/2025
Completed By: National TAB

PROJECT
10-06-25 CAVA NEWTOWN, PA

2938 EAGLE RD

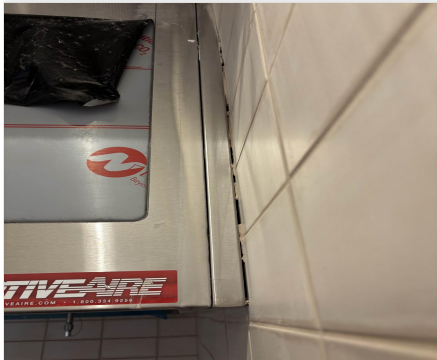
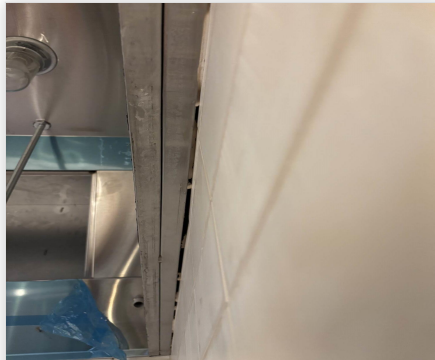
Issue Name : HD1: Caulking Degraded
Description : Hood caulking to wall on back, side, and front has degraded. Gaps can accumulate grease. Recaulk.
Created By : National TAB **Assigned To :** National TAB - Brianna Biggs
Status : Open
Priority : Low **Asset Tag :**
Originated Date : 10/08/2025 - Ryan Smith - National TAB

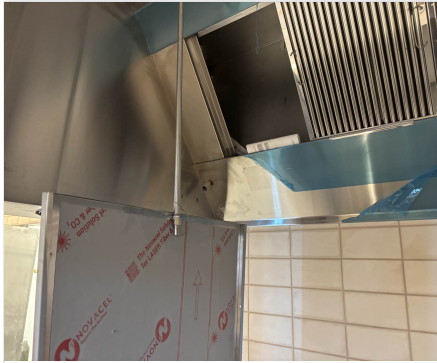
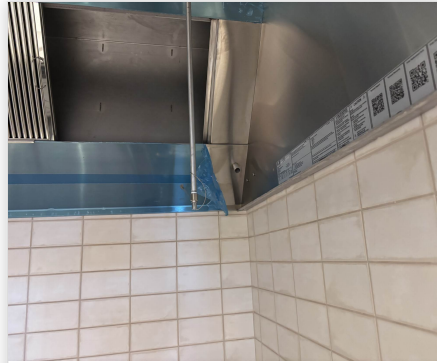
Issue Name : HD1: Grease Cups Not Installed
Description : Grease cups not installed on hood. Find or order and install.
Created By : National TAB **Assigned To :** National TAB - Brianna Biggs
Status : Open
Priority : Low **Asset Tag :**
Originated Date : 10/08/2025 - Ryan Smith - National TAB

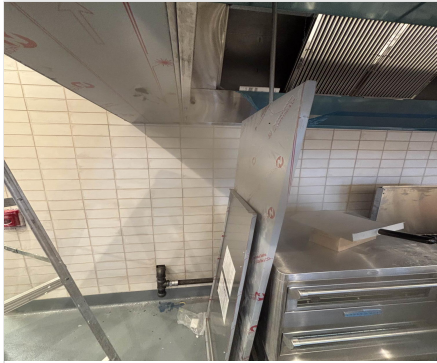
Issue Name : HD1: Hood End Panel Not Installed
Description : Install according to manufacturer directions.
Created By : National TAB **Assigned To :** National TAB - Brianna Biggs
Status : Open
Priority : Low **Asset Tag :**
Originated Date : 10/08/2025 - Ryan Smith - National TAB

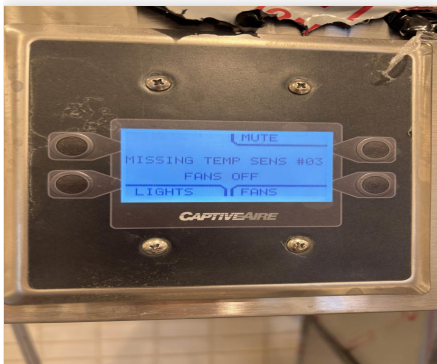
Issue Name : HD1: MISSING TEMPT SENS #03
Description : Hood is showing a fault called Missing Temp Sens #03. Troubleshoot and repair according to manufacturer guidance.
Created By : National TAB **Assigned To :** National TAB - Brianna Biggs
Status : Open
Priority : Low **Asset Tag :**
Originated Date : 10/08/2025 - Ryan Smith - National TAB

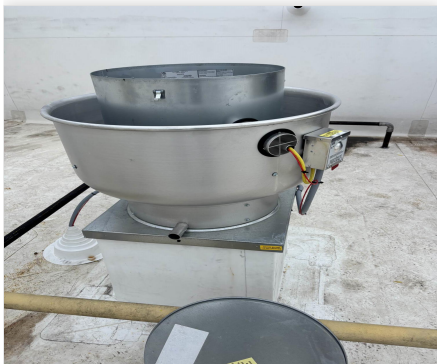
Issue Name : KEF1: Grease Cup Not Installed
Description : Grease cup not installed on KEF1 curb. Install according to manufacturer instructions.
Created By : National TAB **Assigned To :** National TAB - Brianna Biggs
Status : Open
Priority : Low **Asset Tag :**
Originated Date : 10/08/2025 - Ryan Smith - National TAB

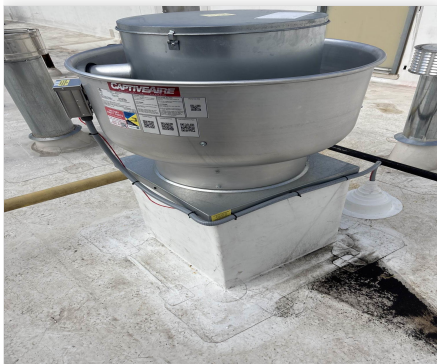
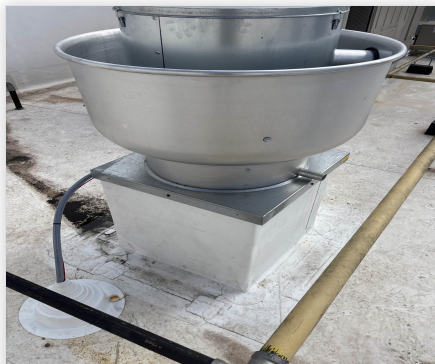
Issue Name : KEF1: Hinge Kit Not Installed
Description : Hinge kit for KEF1 not installed. Install according to manufacturer directions.
Created By : National TAB **Assigned To :** National TAB - Brianna Biggs
Status : Open
Priority : High **Asset Tag :**
Originated Date : 10/08/2025 - Ryan Smith - National TAB

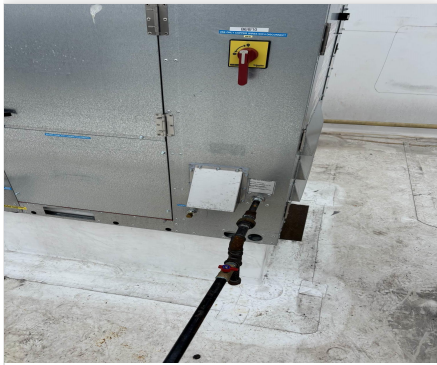
Issue Name : MAU1: Gas Valve Closed
Description : Gas valve for MAU1 is closed. Open valve and perform burner startup.
Created By : National TAB **Assigned To :** National TAB - Brianna Biggs
Status : Open
Priority : Low **Asset Tag :**
Originated Date : 10/08/2025 - Ryan Smith - National TAB

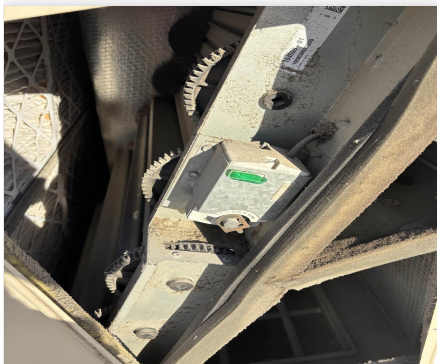
Issue Name : RTU1: Economizer Not Functional
Description : Economizer of RTU2 not functional. Unable to set OA. Service according to manufacturer guidance.
Created By : National TAB **Assigned To :** National TAB - Brianna Biggs
Status : Open
Priority : High **Asset Tag :**
Originated Date : 10/08/2025 - Ryan Smith - National TAB

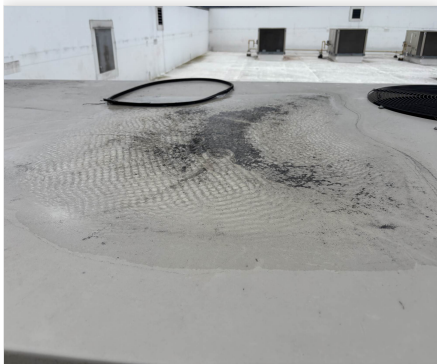
Issue Name : RTU2: Vibration Issue
Description : RTU2 vibrates loudly. Vibrations are strong enough to work belt loose overnight. Service according to manufacturer guidance.
Created By : National TAB **Assigned To :** National TAB - Brianna Biggs
Status : Open
Priority : High **Asset Tag :**
Originated Date : 10/08/2025 - Ryan Smith - National TAB
