Report: RENEW

Function: Test, Adjust, & Balance

Date: 11/17/2022

11-14 FREDDY'S - EDWARDSVILLE, IL - RENEW 2FB (5)

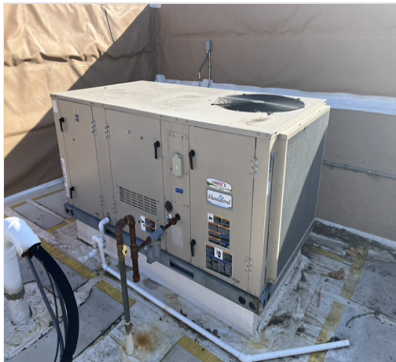
RTU1 (TAKE PICTURE OF UNIT)

LENNOX / LGH048H4ET4Y

329

30%

-0.42" MA 0.28" DISCHARGE

4.5/4.5/4.5
