**Report: RENEW
Function: Test, Adjust, & Balance
Date: 11/17/2022**

**PROJECT
11-14 FREDDY'S - EDWARDSVILLE, IL -
RENEW 2FB (5)**

Project: 11-14 FREDDY'S - EDWARDSVILLE, IL - RENEW 2FB (5)

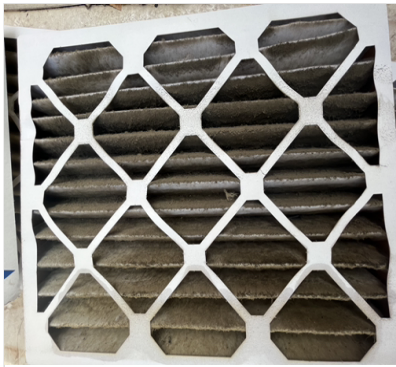
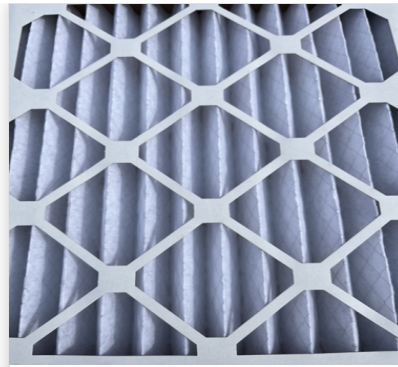
RTU 1 FINAL FILTER (BEFORE AND AFTER)

Changed

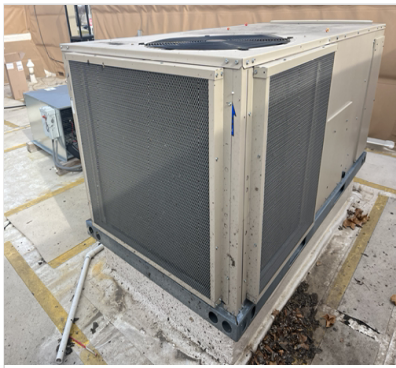
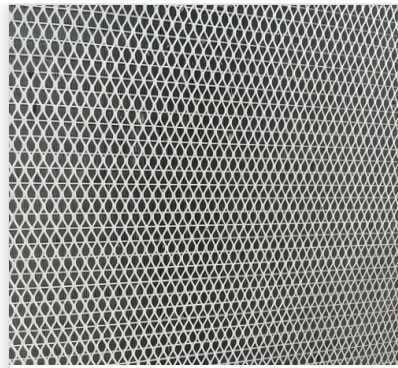
RTU 1 CONDENSOR COIL (BEFORE AND AFTER)

Not cleaned due to freezing temperatures.

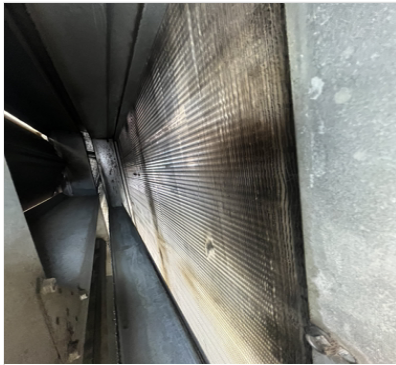
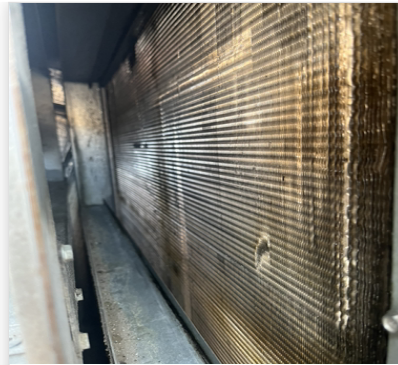
RTU 1 EVAPORATOR COIL (BEFORE AND AFTER)

Wiped down, but did not use water due to freezing temps.

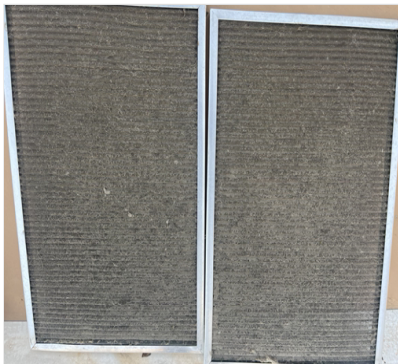
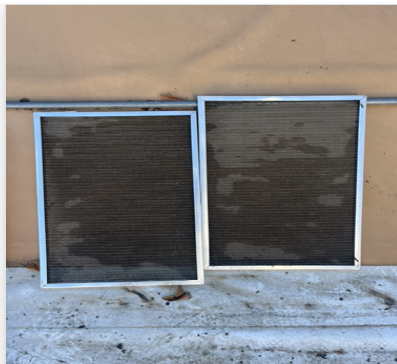
RTU 2 OA MESH FILTER (BEFORE AND AFTER)

Cleaned

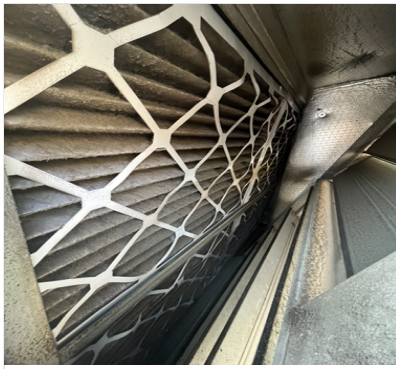
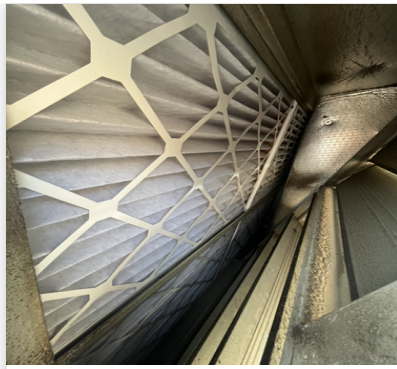
RTU 2 FINAL FILTER (BEFORE AND AFTER)

Changed

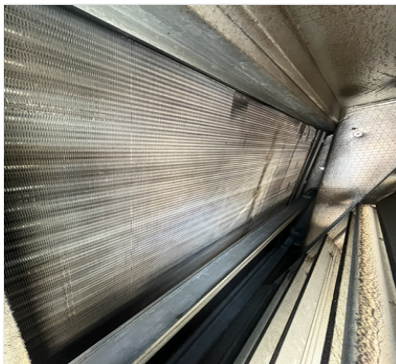
RTU 2 EVAPORATOR COIL (BEFORE AND AFTER)

Wiped down, but did not use water due to freezing temps.

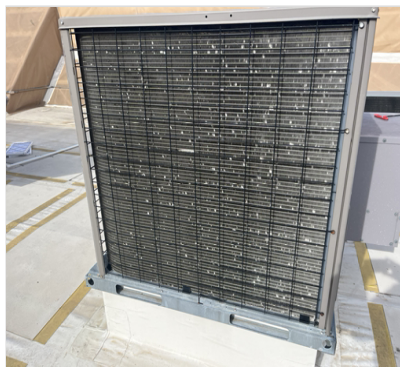
RTU 3 CONDENSOR COIL (BEFORE AND AFTER)

Did not clean due to below freezing temperatures.

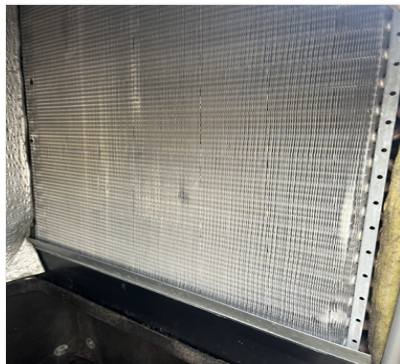
RTU 3 EVAPORATOR COIL (BEFORE AND AFTER)

Wiped down, but did not use water due to freezing temps.

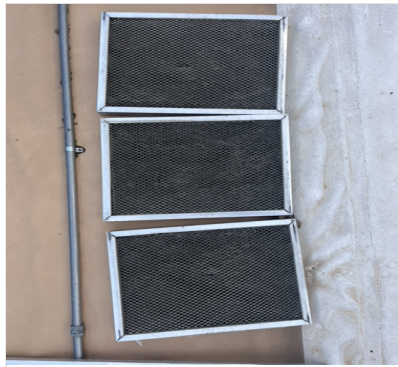
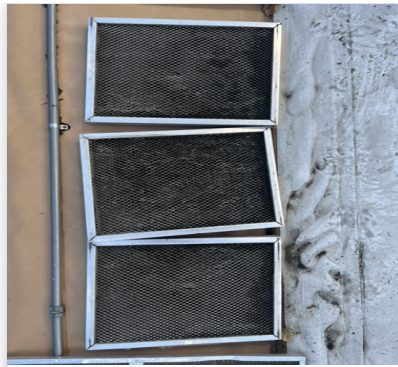
MUA (BEFORE / AFTER)

MAU: The intake filters had slight dirt accumulation. They were washed.

Cleaned

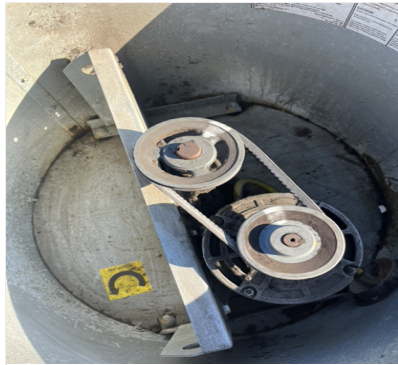
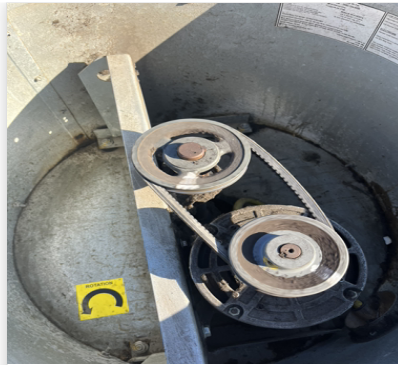
EXHAUST FAN KEF1 MOTOR HOUSING CLEANED

Wiped down

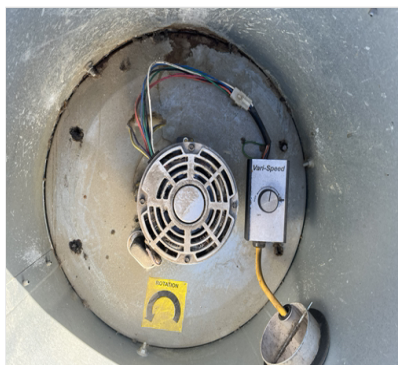
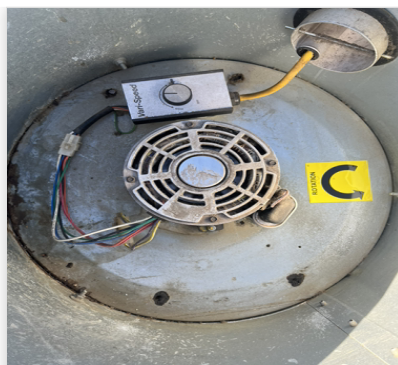
EXHAUST FAN KEF2 MOTOR HOUSING CLEANED

Wiped down
