Report: RENEW
Function: Test, Adjust, & Balance
Date: 11/17/2022

11-14 FREDDY'S - EDWARDSVILLE, IL - RENEW 2FB (5)

Project: 11-14 FREDDY'S - EDWARDSVILLE, IL - RENEW 2FB (5)

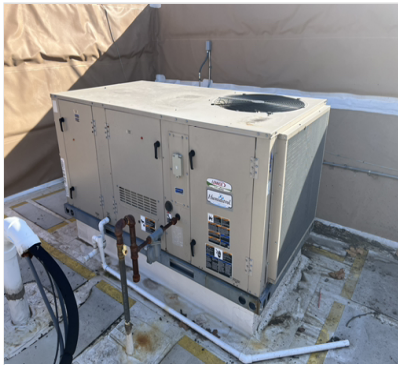
RTU1 (TAKE PICTURE OF UNIT)

OA CFM	329
OA DAMPER POSITION	30%
FAN SUCTION AND DISCHARGE PRESSURE	-0.42" MA 0.28" DISCHARGE
BLOWER MOTOR RLA / FLA	4.5/4.5/4.5

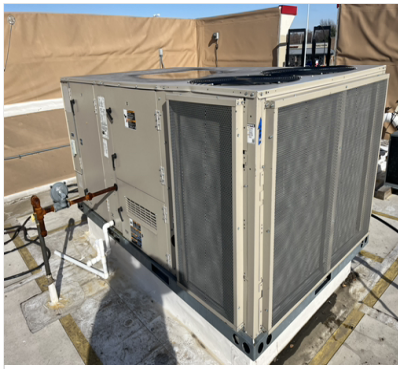
RTU2 (TAKE PICTURE OF UNIT)

OA CFM	789
OA DAMPER POSITION	41%
FAN SUCTION AND DISCHARGE PRESSURE	-0.58" MA 0.36" DISCHARGE
BLOWER MOTOR RLA / FLA	4.0/4.0/4.0

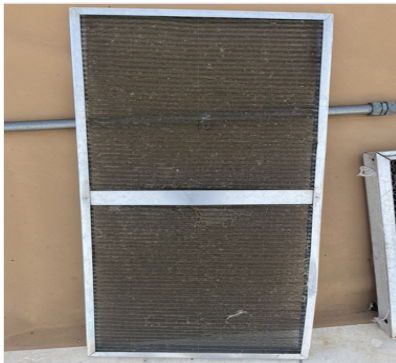
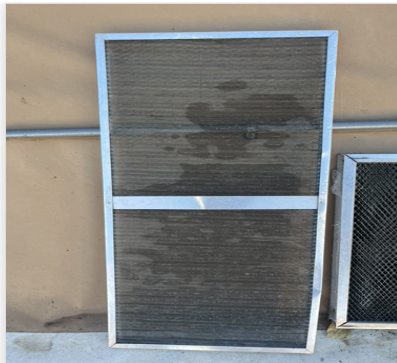
RTU 1 O.A. FILTER (BEFORE AND AFTER)

Cleaned

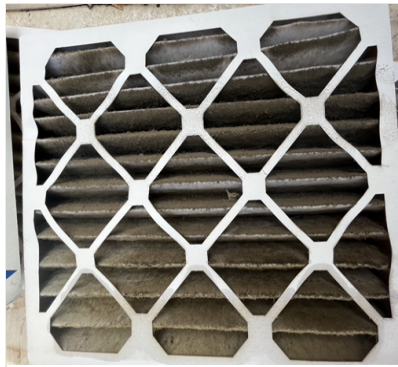
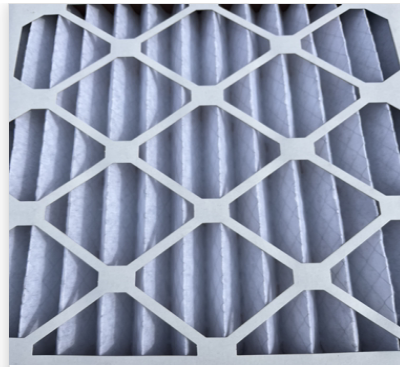
RTU 1 FINAL FILTER (BEFORE AND AFTER)

Changed

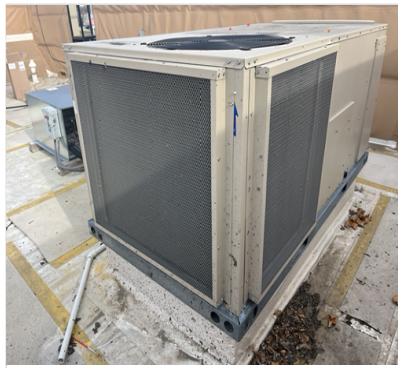
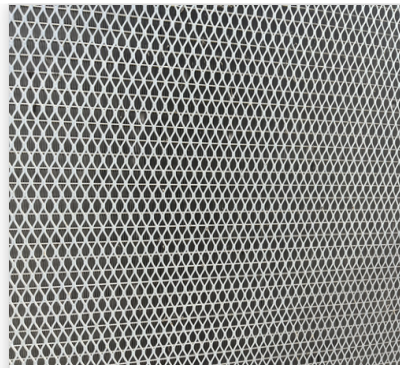
RTU 1 CONDENSOR COIL (BEFORE AND AFTER)

Not cleaned due to freezing temperatures.

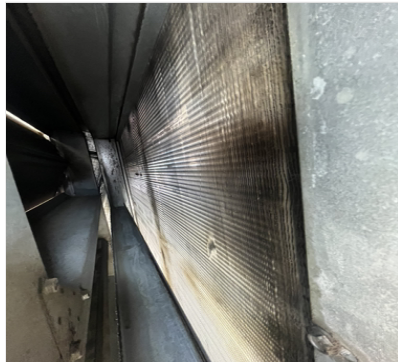
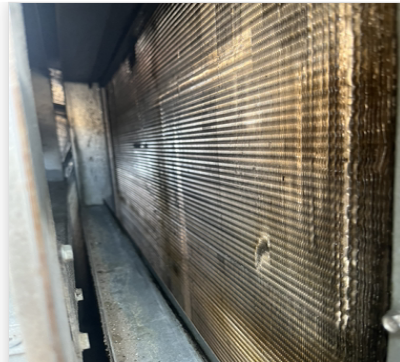
RTU 1 EVAPORATOR COIL (BEFORE AND AFTER)

Wiped down, but did not use water due to freezing temps.

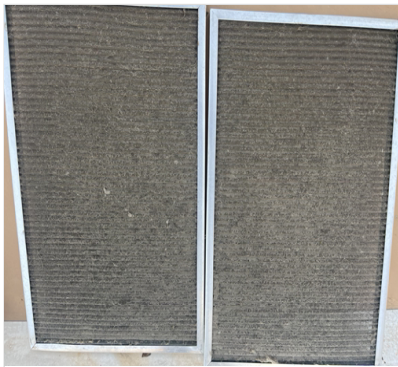
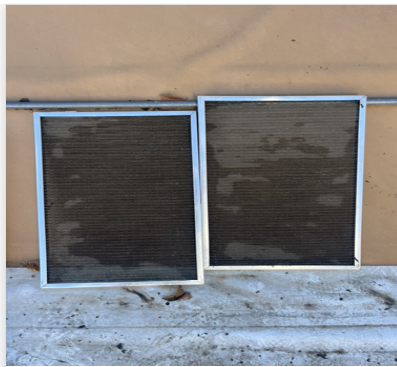
RTU 2 OA MESH FILTER (BEFORE AND AFTER)

Cleaned

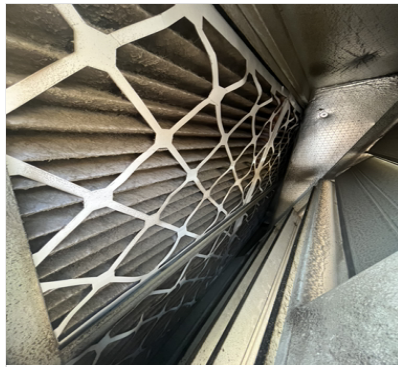
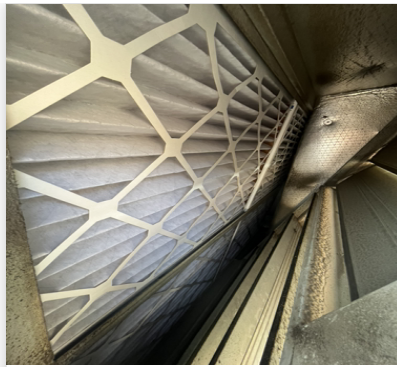
RTU 2 FINAL FILTER (BEFORE AND AFTER)

Changed

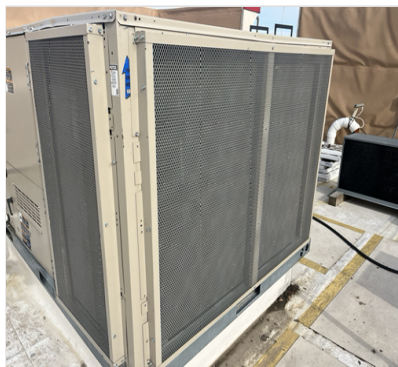
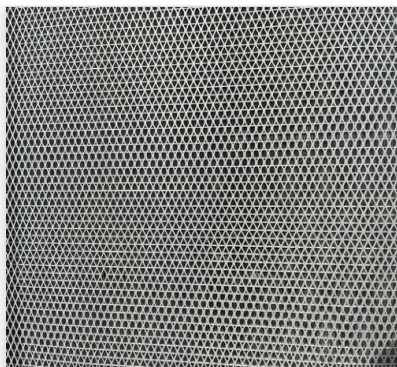
RTU 2 CONDENSOR COIL (BEFORE AND AFTER)

Not cleaned due to freezing temperatures.

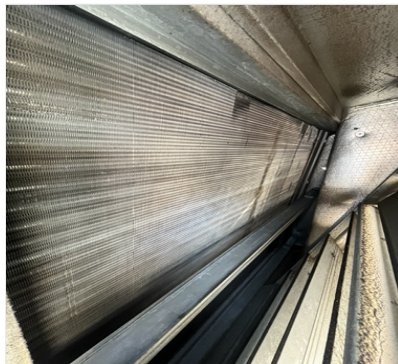
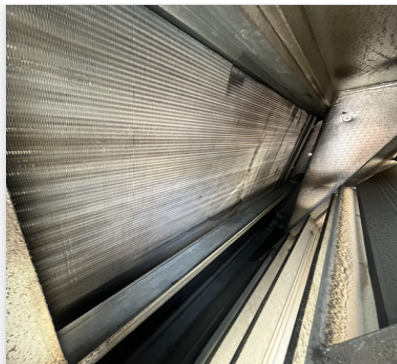
RTU 2 EVAPORATOR COIL (BEFORE AND AFTER)

Wiped down, but did not use water due to freezing temps.

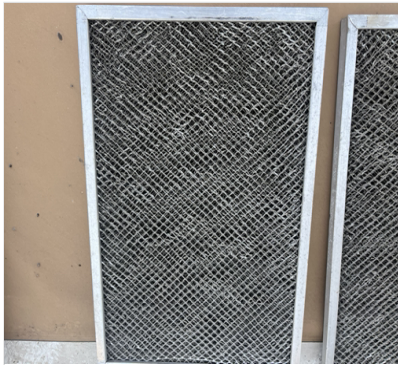
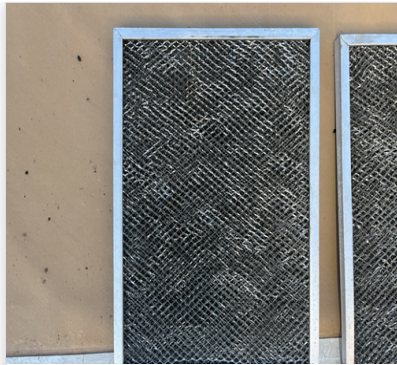
RTU 3 OA MESH FILTER (BEFORE AND AFTER)

Cleaned

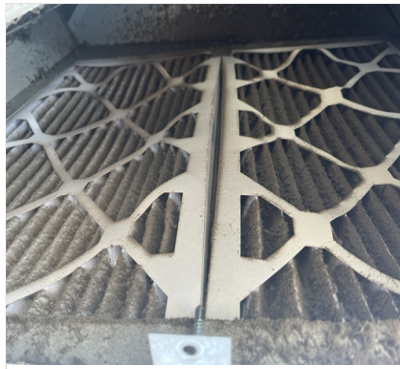
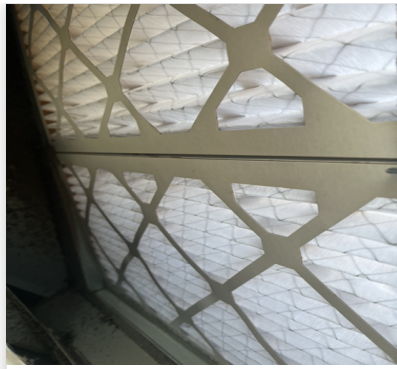
RTU 3 FINAL FILTER (BEFORE AND AFTER)

Changed

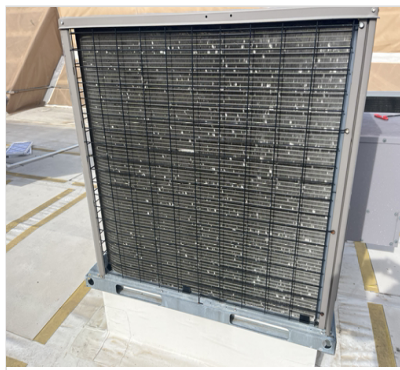
RTU 3 CONDENSOR COIL (BEFORE AND AFTER)

Did not clean due to below freezing temperatures.

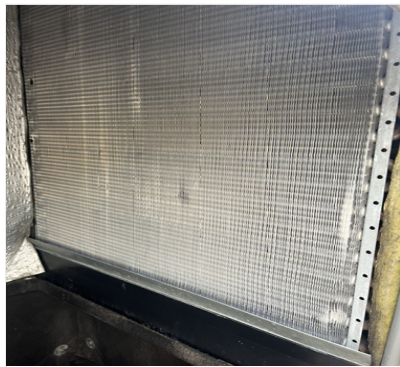
RTU 3 EVAPORATOR COIL (BEFORE AND AFTER)

Wiped down, but did not use water due to freezing temps.

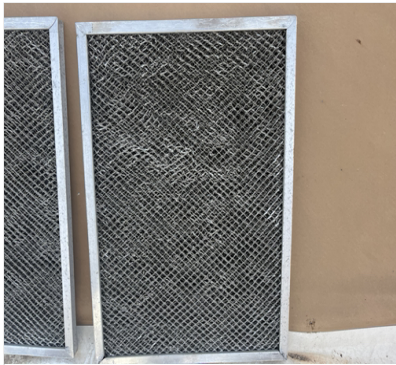
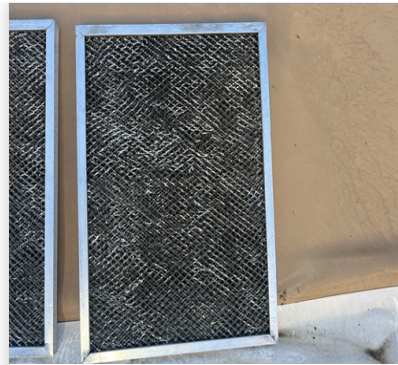
RTU 4 O.A. FILTER (BEFORE AND AFTER)

Cleaned

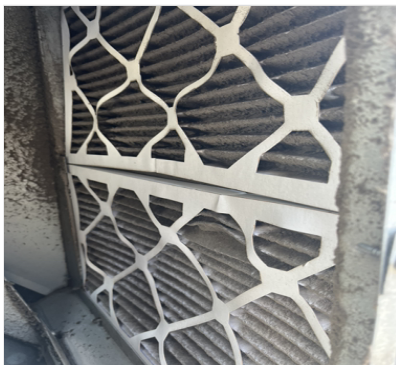
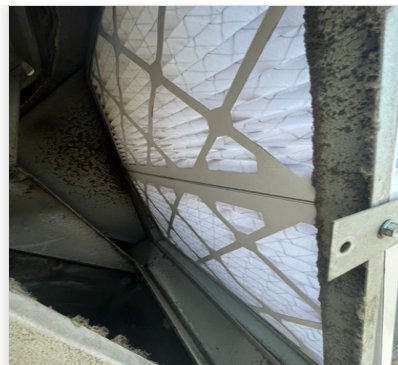
RTU 4 FINAL FILTER (BEFORE AND AFTER)

Changed

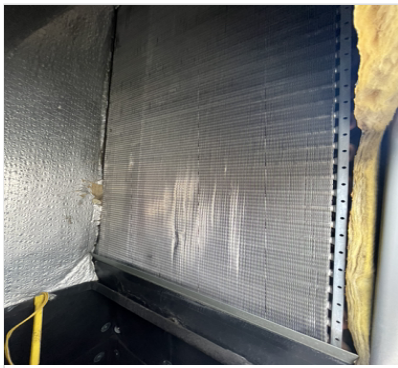
RTU 4 EVAPORATOR COIL (BEFORE AND AFTER)

Wiped down, but did not use water due to freezing temps.

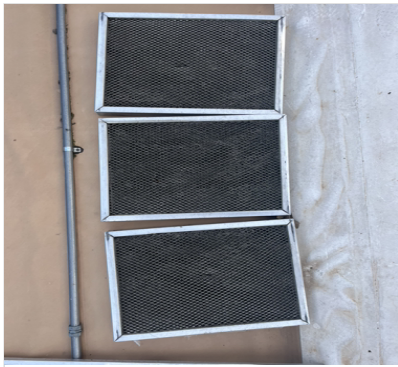
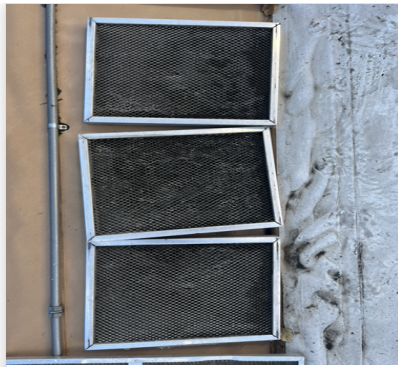
MUA (BEFORE / AFTER)

Cleaned

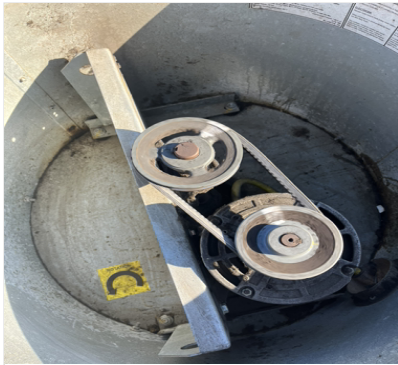
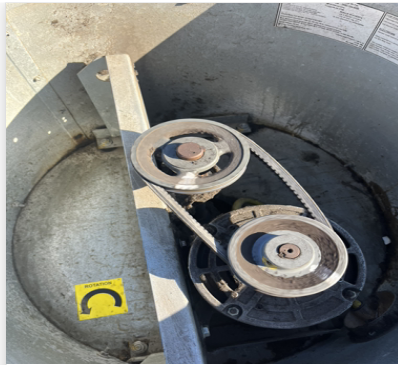
EXHAUST FAN KEF1 MOTOR HOUSING CLEANED

Wiped down

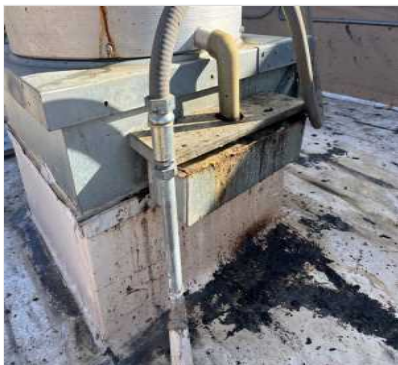
EXHAUST FAN KEF1 GREASE CUP PROPERLY INSTALLED

Installed, but full of grease

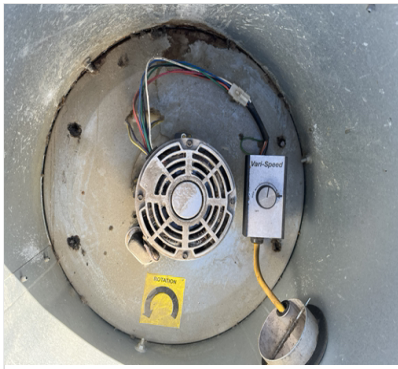
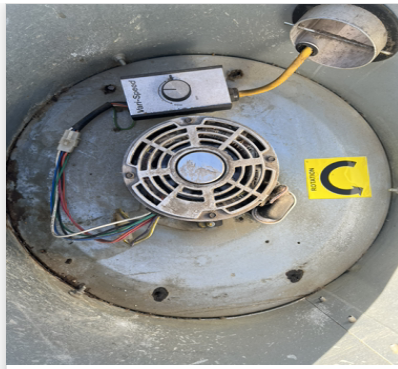
EXHAUST FAN KEF2 MOTOR HOUSING CLEANED

Wiped down
