**Report: RENEW**

**Function: Test, Adjust, & Balance**

**Date: 11/17/2022**

## 11-14 FREDDY'S - EDWARDSVILLE, IL - RENEW 2FB (5)

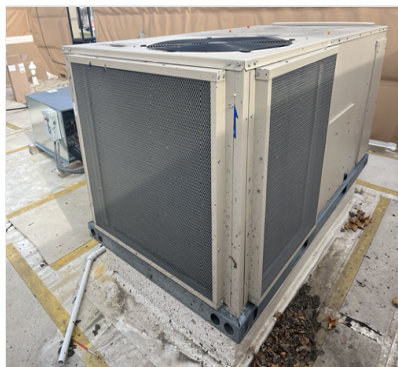
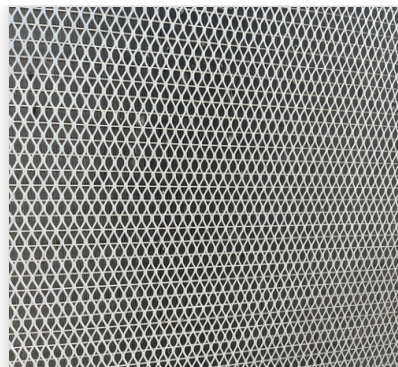
RTU 1 CONDENSOR COIL (BEFORE AND AFTER)

Not cleaned due to freezing temperatures.

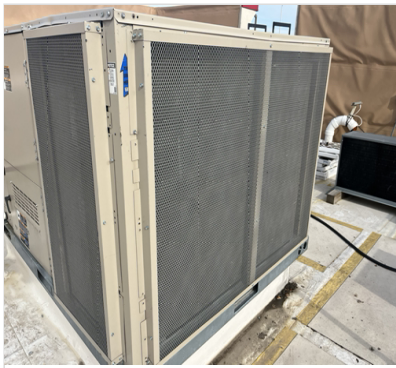
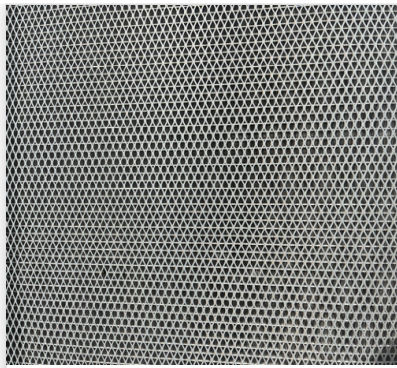
RTU 2 CONDENSOR COIL (BEFORE AND AFTER)

Not cleaned due to freezing temperatures.

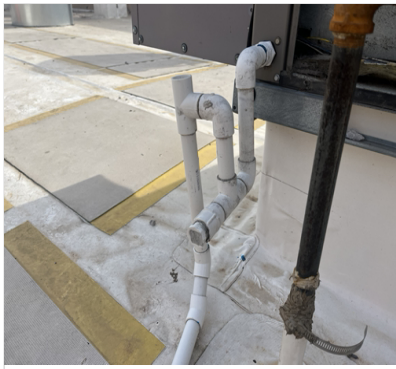
**RTU 3 CONDENSATE DRAIN**

Not cleaned due to freezing temperatures.

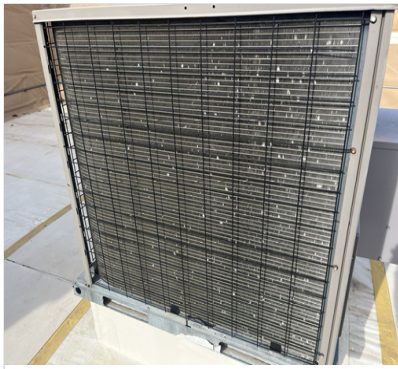
RTU 4 CONDENSOR COIL (BEFORE AND AFTER)

Not cleaned due to freezing temperatures.
