**Report: RENEW
Function: Test, Adjust, & Balance
Date: 11/17/2022**

11-14 FREDDY'S - EDWARDSVILLE, IL - RENEW 2FB (5)

Project: 11-14 FREDDY'S - EDWARDSVILLE, IL - RENEW 2FB (5)

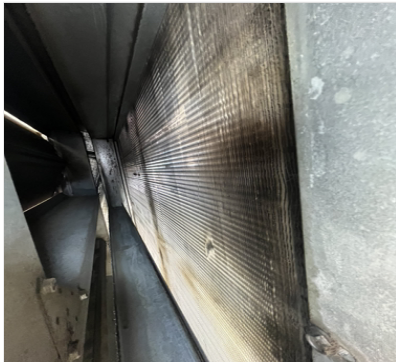
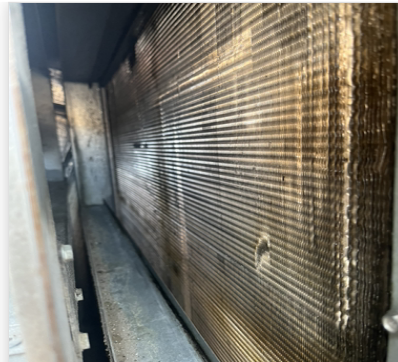
RTU 1 EVAPORATOR COIL (BEFORE AND AFTER)

Wiped down, but did not use water due to freezing temps.

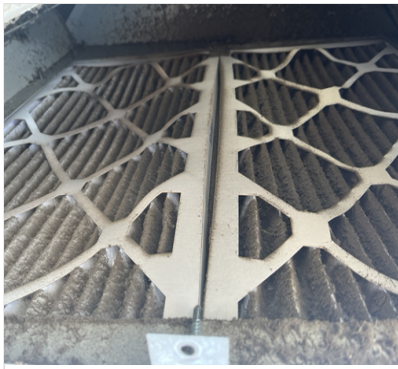
RTU 3 FINAL FILTER (BEFORE AND AFTER)

Changed

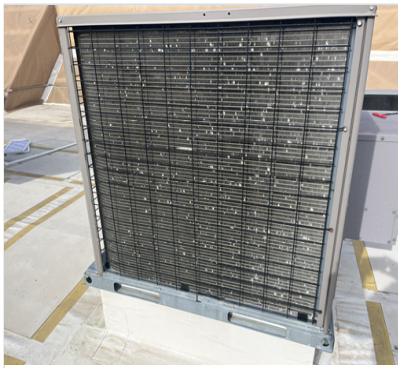
RTU 3 CONDENSOR COIL (BEFORE AND AFTER)

Did not clean due to below freezing temperatures.

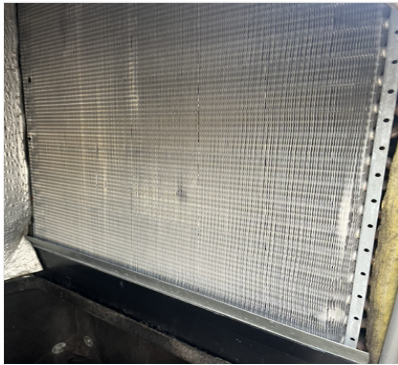
RTU 3 EVAPORATOR COIL (BEFORE AND AFTER)

Wiped down, but did not use water due to freezing temps.

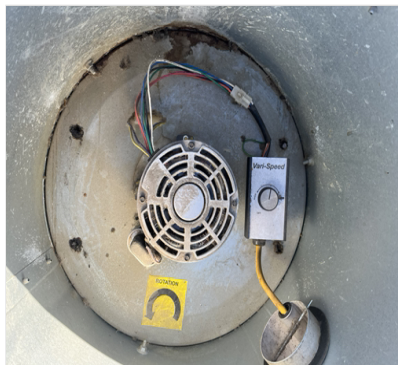
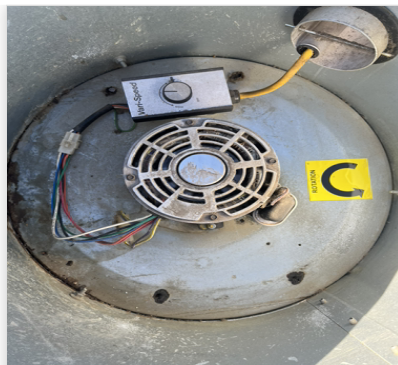
EXHAUST FAN KEF2 MOTOR HOUSING CLEANED

Wiped down
