**Report: REVIVE REPORT
Function: Test, Adjust, & Balance
Date: 03/10/2023**

**02-20-23 FREDDY'S - MCDONOUGH, GA
(REVIVE)**

1410 HWY 20 W

MCDONOUGH , GA

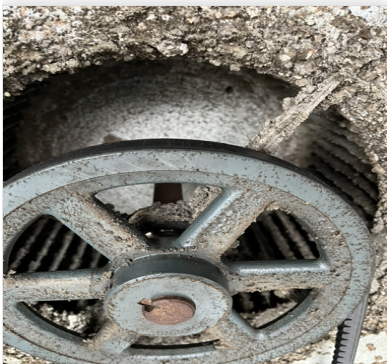
Issue Name : 02 - RTU/MUA are dirty

Description : Units are extremely dirty and need to be thoroughly cleaned. May require multiple cleanings. The condition is having a significant impact on airflow.

- **03/10/2023** National TAB - Will Turnbough
 - Typical of all units
