Report: REVIVE REPORT
Function: Test, Adjust, & Balance
Date: 03/10/2023

**02-20-23 FREDDY'S - MCDONOUGH, GA
(REVIVE)**

1410 HWY 20 W

MCDONOUGH , GA

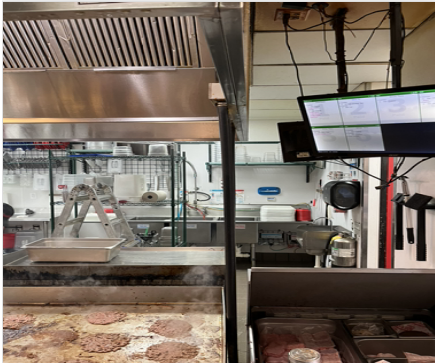
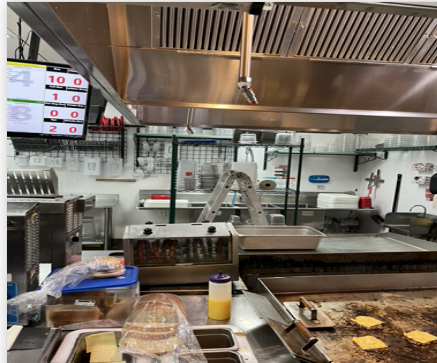
Issue Name : 01 - Grill not centered

1. The most significant issue causing smoke capture issues is the griddle not being centered under the hood. There is very little overhang over the side of the hood closest to the back door and this is where the smoke loss is occurring. The griddle cannot be moved due to adjacent table that is secured in place with large diameter conduit underneath. Next steps to resolving will require some collaboration to determine the next best step:

Description : Grill is not centered under the hood and is primary reason for the poor smoke capture. Island hood needs 12" of overhang on all sides. The only smoke loss is noted on the side without overhang.

- Not sure if feasible, but moving the table so that griddle can be moved over would be the best case scenario.
 - 2nd best option would be to install a full vertical endpanel or wall on backs of the hoods. Would require that the monitors be moved.

- Cooking on griddles only on the half closest to the front of the store should also reduce smoke loss if possible with Operations.
 - A small (12"x24") perforated diffuser between the hood and wall behind the hood may help push smoke back into the hood. An accessible damper needs to be installed at the takeoff. Still will likely be some smoke loss so this method is not preferred. In this situation the return grilles will also need to be split and distributed throughout the kitchen to reduce the return air path.

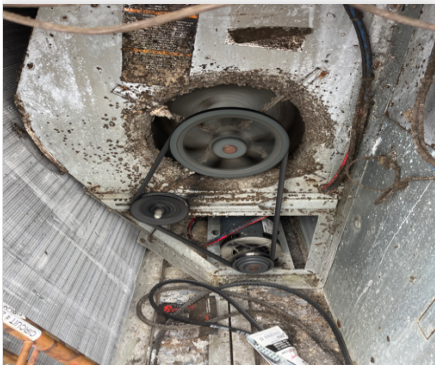
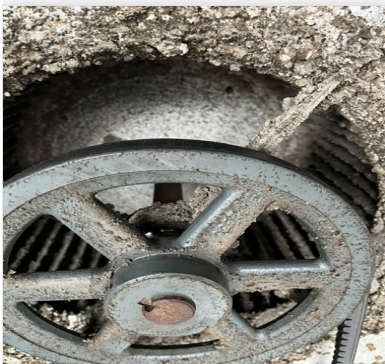
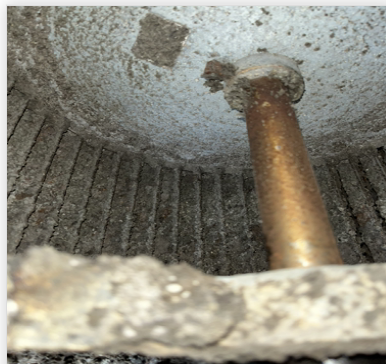
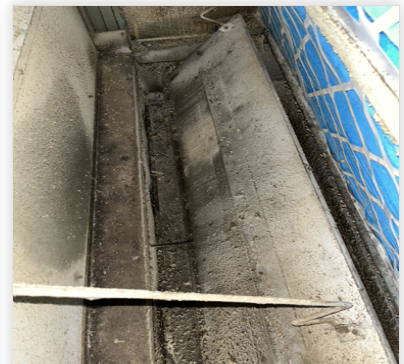
Issue Name : 02 - RTU/MUA are dirty

2. The equipment on the roof is very dirty and appears to be impacting airflow. The MUA and RTU blower compartments have significant buildup in the blower wheels. The interior of the units are also very dirty and should be cleaned. Evaporator coils need to be thoroughly cleaned. Once these units are fully cleaned it's anticipated that airflow will increase.

Description : Units are extremely dirty and need to be thoroughly cleaned. May require multiple cleanings. The condition is having a significant impact on airflow.

- **03/10/2023** National TAB - Will Turnbough
 - Typical of all units

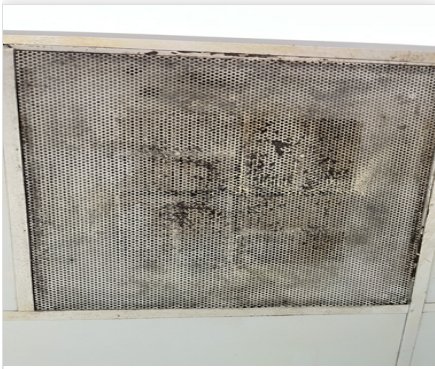
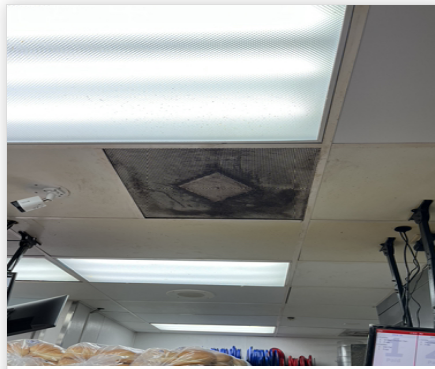
Issue Name : 04 - Diffusers throughout kitchen are dirty

3. Once the units are cleaned, recommend checking that the adjustable motor pulleys can be adjusted for balancing.
4. The kitchen RTU perforated diffusers are clogged with grease and need to be thoroughly cleaned or replaced.

Description : Recommend cleaning

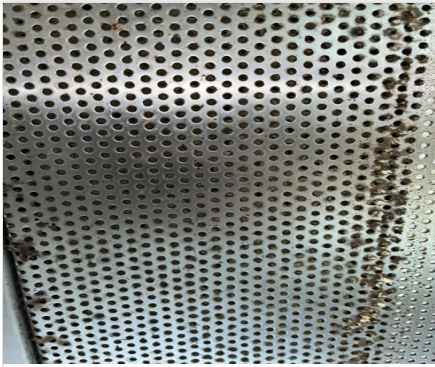
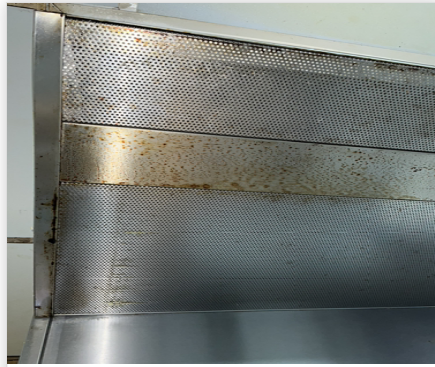
Issue Name : 05 - ACSPS is dirty

5. The AC-PSP portion of the hoods are dirty and need to be dropped down and cleaned.
6. RTU-3 evaporator coil had frost forming likely due to the very low airflow on this unit. Once unit and diffusers are cleaned, anticipated airflow will increase and that the frosting will stop.

Description : Recommend dropping the AC-ssp portion and cleaning the top and bottom of the perforated grilles.

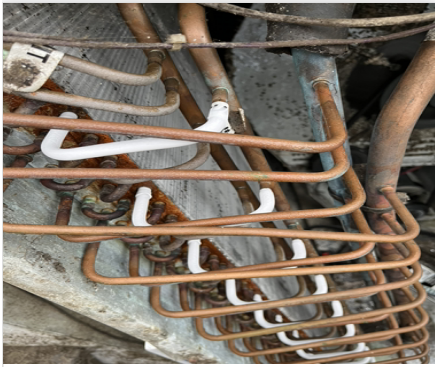
Issue Name : 06 - RTU3 coil

Description : RTU3 evaporator coil is starting to freeze. Likely due to low airflow

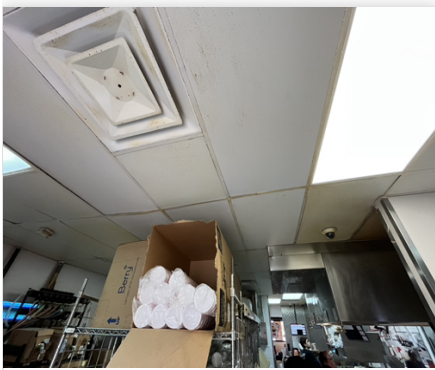
Issue Name : 07 - 4 way diffusers

7. 4-way style diffusers in the kitchen need to be changed out for perforated style diffusers. 4-way diffusers near hoods can direct drafts at the hood and cause rollout issues.

Description : Recommend changing 4 way diffusers in the kitchen to perforated style. 4 way diffusers near the hood cause drafts which result in poor hood capture

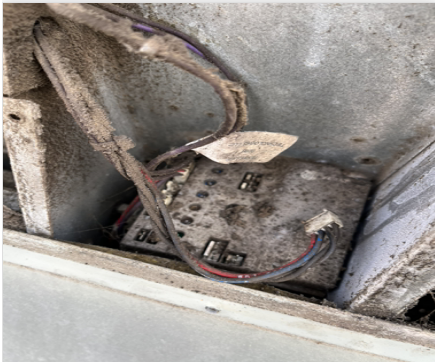
Issue Name : 08 - RTU3 Economizer

8. Economizer for RTU-3 is not functional and needs to be repaired. It was found unplugged. Plugged in and heard the actuator moving but the damper did not move.

Description : Rtu3 economizer was found unplugged. Plugged in but damper didn't move. Recommend repair

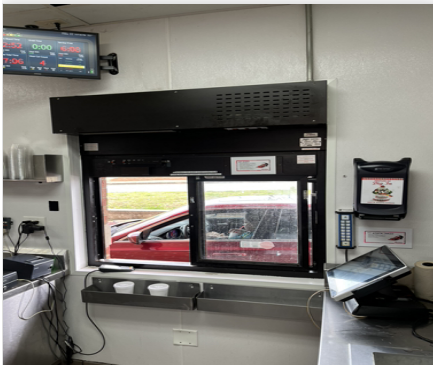
Issue Name : 09 - Drive thru door and air curtain not functional

9. Drive thru air curtain and door are not functional and need to be repaired. The door is staying open and drafts from the window are traveling through the space making the smoke capture worse at the fryer and griddle.

Description : Door and air curtain need to be repaired to prevent air drafts when door is open. The draft travels thru the space and makes smoke capture worse on fryer and griddle.

- **02/27/2023 National TAB - Will Turnbough**
 - Video of fryer capture when the drive thru door is open and air curtain not operational
 1. [Open FryerVideo.MOV](#)

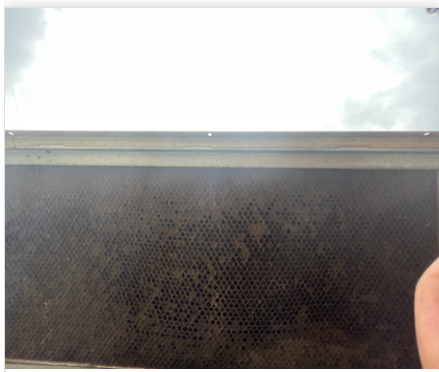
Issue Name : 10 - RTU-3 OA filter is dirty

10. RTU Outside air filter is dirty and needs to be cleaned.

Description : Recommend cleaning.

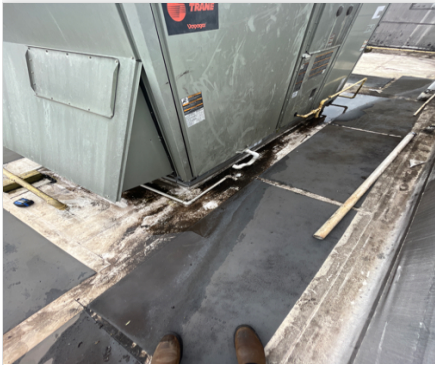
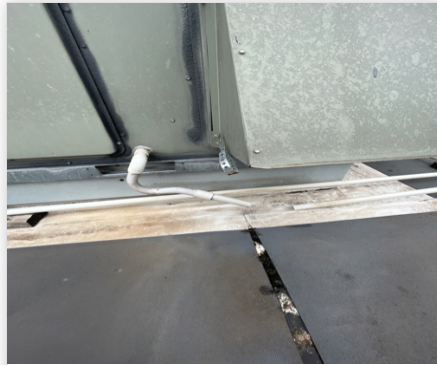
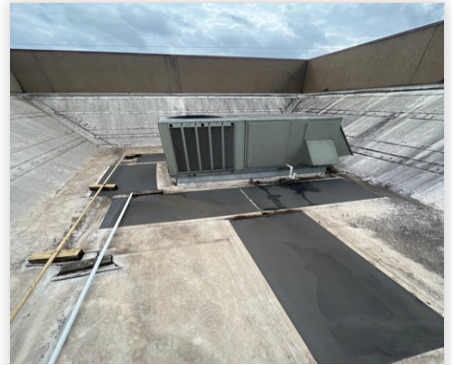
Issue Name : 11 - CONDENSATE LINES

11. Condensate drains are not connected and water is pooling up on the roof.

Description : Condensate drain lines found disconnected for all units. Recommend reconnecting. Water is pooling on the roof.
