**Report: REVIVE REPORT  
Function: Test, Adjust, & Balance  
Date: 03/10/2023**

**02-20-23 FREDDY'S - MCDONOUGH, GA  
(REVIVE)**

1410 HWY 20 W

MCDONOUGH , GA

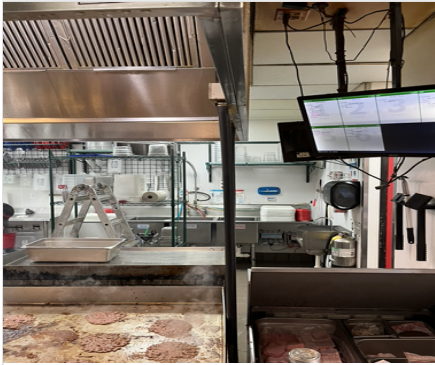
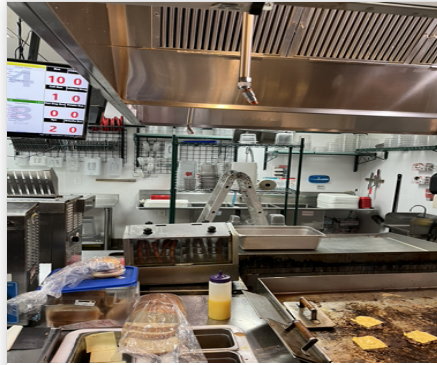
**Issue Name :** 01 - Grill not centered

**Description :** Grill is not centered under the hood and is primary reason for the poor smoke capture. Island hood needs 12" of overhang on all sides. The only smoke loss is noted on the side without overhang.

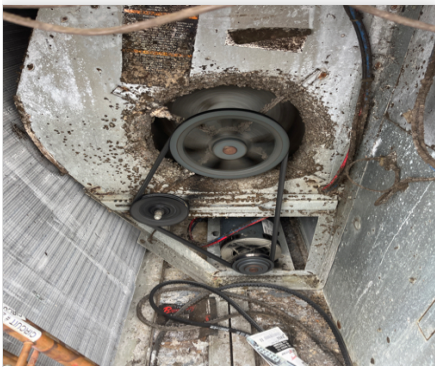
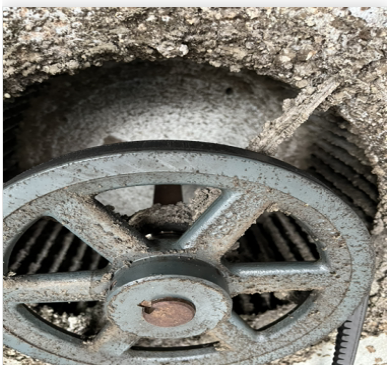
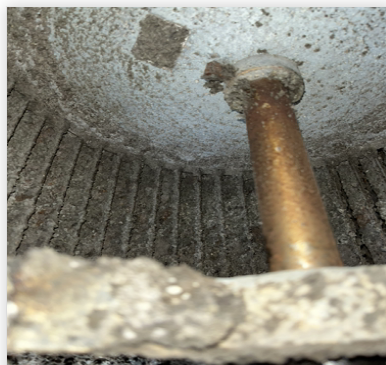
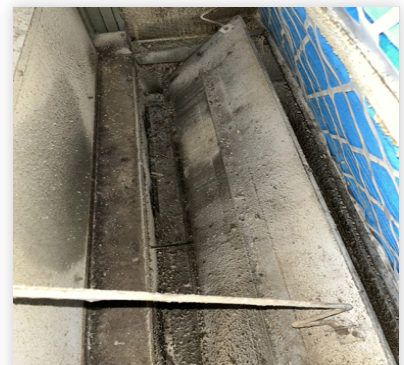
**Issue Name :** 02 - RTU FAN CABINET

**Description :** FAN CABINET DIRTY

- **03/10/2023** National TAB - Will Turnbough
  - Typical of all units

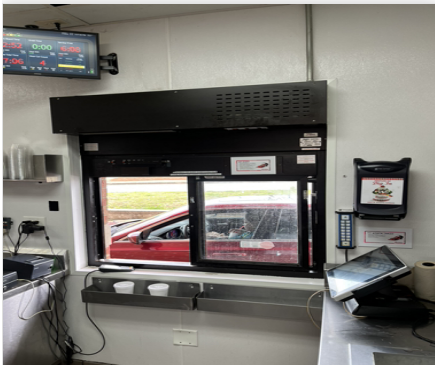
**Issue Name :** 09 - Drive thru door and air curtain not functional

**Description :** Door and air curtain need to be repaired to prevent air drafts when door is open. The draft travels thru the space and makes smoke capture worse on fryer and griddle.

- **02/27/2023 National TAB - Will Turnbough**
  - Video of fryer capture when the drive thru door is open and air curtain not operational
    1. [Open](#) FryerVideo.MOV
