Report: TAB

Function: Test, Adjust, & Balance

Date: 06/30/2025

06-30-25 CHIPOTLE #5591 HORN LAKE, MS

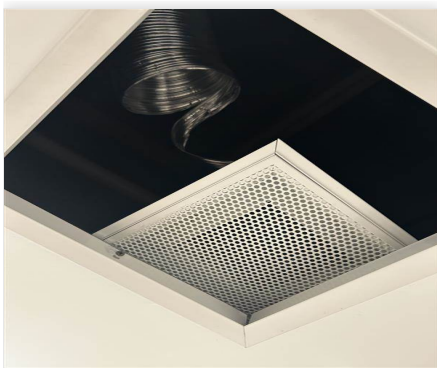
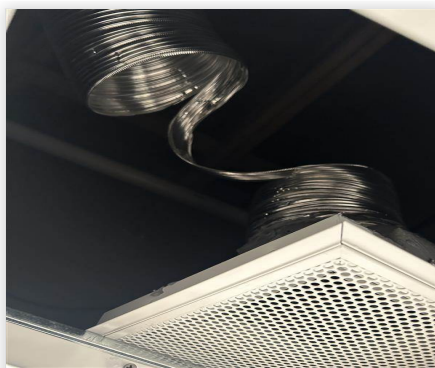
Issue Name : EF 2-2 ductwork not properly sealed
Description : Ductwork is there but is not fully connected causing low total airflow. A temporary solution has been applied to make the unit able to be balanced. Installers have been contacted to come back out.
Created By : National TAB **Assigned To :** National TAB - Dan Hertenstein
Status : Open
Priority : High **Asset Tag :**
Originated Date : 06/25/2025 - Aaron Cosby - National TAB

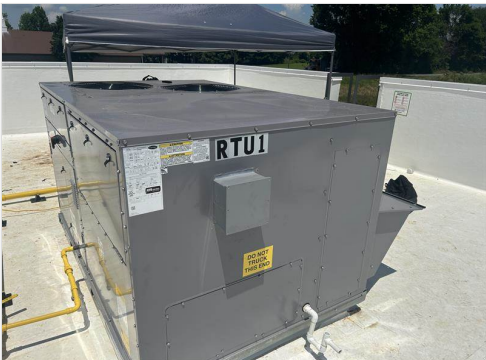
Asset: RTU1

Notes:
Pressures high. Return duct, return damper, and MA compartment checked. All good

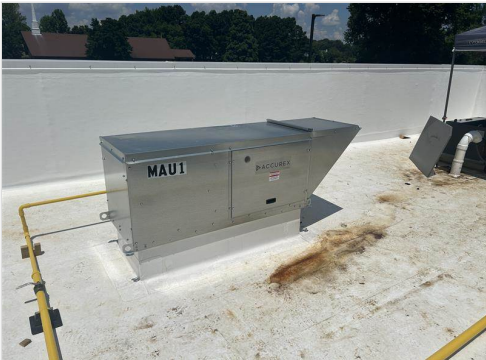
Asset: MUA1

Description : Unit was not assembled properly before delivery. Fan bracket was missing upon arrival and cannot run without immediate danger to the unit or someone. A tech will be sent out Monday 6/30 to assemble. GC's punch is Tuesday 7/1 and turnover is Tuesday 7/8

Unit inoperable at time of first visit

Gas Heat		
	Design	Actual
Heater Operates (y/n)	-	N
Flame Status (pass/fail)	-	Fail
Inlet Air Temp SetPt	-	0
Discharge Air Temp SetPt	-	0
Air Flow Switch SP Actual	-	0

Test Data		
	Design	Actual
CFM	1300	0
SF RPM	-	0
Motor RPM	-	0
SF System SetPt	-	0
RL Voltage	-	0
RL Amperage	-	0
Total ESP	-	0
Fan Discharge SP	-	0
