**Report: Punchlist**  
**Function: Test, Adjust, & Balance**  
**Date: 07/19/2023**

**PROJECT**  
**07-17-2023 CULVERS - LAKE ORION, MI**

Project: 07-17-2023 CULVERS - LAKE ORION, MI

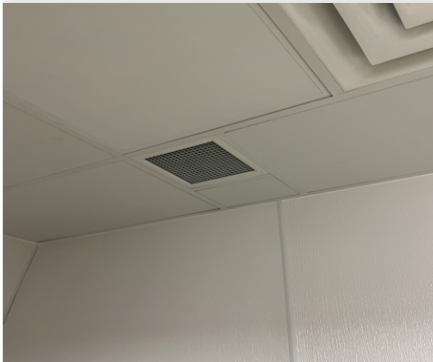
**PRV13**  
**07/19/2023**

**Issue Name :** PRV-1 no dampers  
**Description :** PRV-1 has no dampers installed for any of the 3 exhaust grilles in each bathroom. Diffuser 1 and 2 are in design. Diffuser 3 (kitchen restroom) is at the same as other 2 in terms of flow. But without damper I'm unable to reduce exhaust to kitchen restroom.  
**Created By :** National TAB                      **Assigned To :** National TAB - Dylan Crisman  
**Status :** Open  
**Originated Date :** 07/19/2023 - Dylan Crisman - National TAB

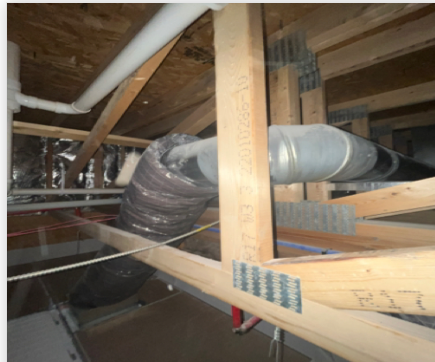
**Ductwork above restroom..**  
**07/19/2023**

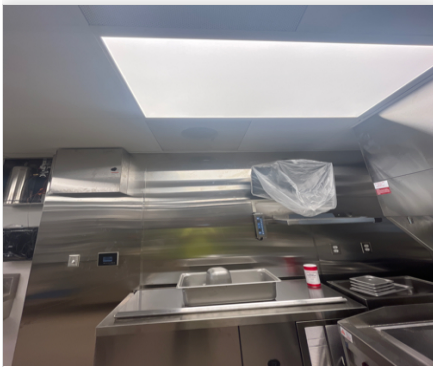
2-8  
07/19/2023

**Issue Name :** RTU-2 damper  
**Description :** Diffuser 2-8 damper shows very little change in flow when fully open or fully closed. Damper moves freely, tightened wingnut, no difference. Damper plate has no resistance when moved, don't suspect blockage.  
**Created By :** National TAB                      **Assigned To :** National TAB - Dylan Crisman  
**Status :** Open  
**Originated Date :** 07/19/2023 - Dylan Crisman - National TAB

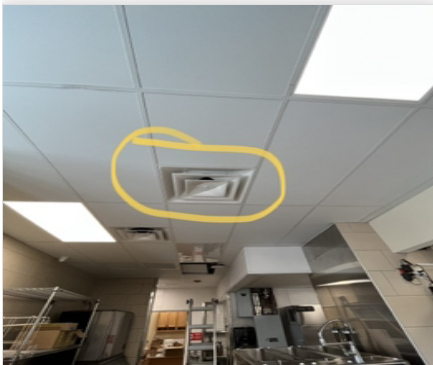
**Issue Name :** RTU-2 diffusers without dampers  
**Description :** Damper 2-1 and 2-2 unable to locate dampers. Flow is close to design but will need them installed to properly balance.  
**Created By :** National TAB                      **Assigned To :** National TAB - Dylan Crisman  
**Status :** Open  
**Originated Date :** 07/19/2023 - Dylan Crisman - National TAB

**DIFFUSER2-1circled2-2..  
07/19/2023**

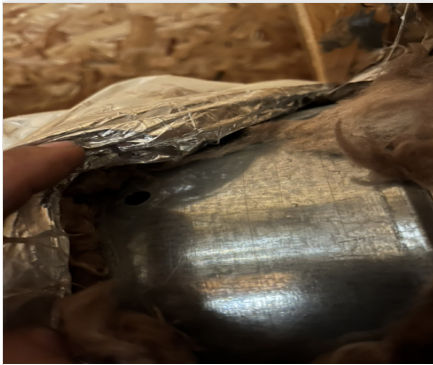
**Issue Name :** RTU-2 missing dampers  
**Description :** Dampers in kitchen missing dampers 1. 2-4 has no damper flow is reading 730/375CFM 2. 2-3 damper is broken flow is in design but will need to be installed to be properly balanced.  
**Created By :** National TAB                      **Assigned To :** National TAB - Dylan Crisman  
**Status :** Open  
**Originated Date :** 07/19/2023 - Dylan Crisman - National TAB

2-3missingdamper  
07/19/2023
