**Report: TAB Report**  
**Function: Test, Adjust, & Balance**  
**Date: 07/09/2025**  
**Completed By: National TAB**

**07-07-25 WAWA #8687 WILLIAMSBURG, VA**

4007 IRONBOUND RD

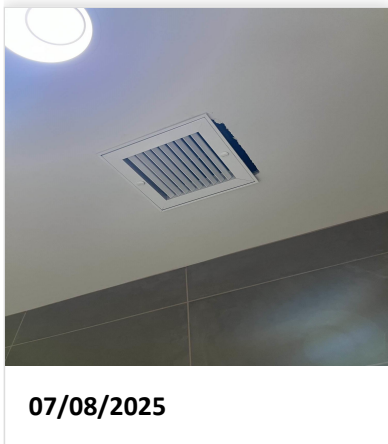
**Issue Name :** Diffuser EF1-1 is not sealed with ceiling  
**Description :** Located in the women's restroom, there is a gap in the hard ceiling right next to the diffuser. Gap needs to be filled to seal off room from above ceiling.  
**Created By :** National TAB                      **Assigned To :** National TAB - Ian Fuller  
**Status :** Open  
**Priority :** Medium                                      **Asset Tag :**  
**Originated Date :** 07/08/2025 - Ian Fuller - National TAB

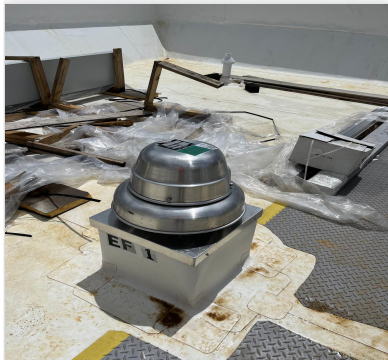
**Issue Name :** EF#1 is below design airflow  
**Description :** Currently fan is at 255 CFM when design is at 300 CFM. Fan is already at max setting. Unable to balance within design airflow. Pressure in the duct was measured to be 0.17" which is enough pressure to be within design airflow. Speed controller is responding and is set at max. Recommended for manufacturer to review.

EF#1 IS NOT ABLE TO BE BALANCED WITHIN DESIGN AIRFLOW. NO DAMPERS ON EF#2 DUCTWORK TO BALANCE INDIVIDUAL DIFFUSERS

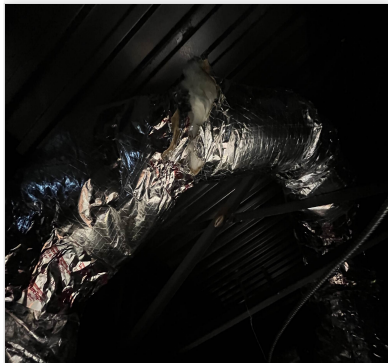
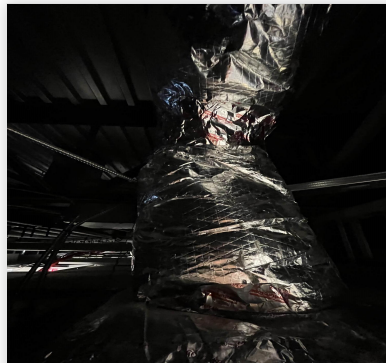
**Issue Name :** EF#2 ductwork does not have dampers installed.  
**Description :** Unable to balance individual diffusers for EF#2. No dampers are shown on the GRD.  
**Created By :** National TAB                      **Assigned To :** National TAB - Ian Fuller  
**Status :** Open  
**Priority :** Urgent                                      **Asset Tag :**  
**Originated Date :** 07/09/2025 - Ian Fuller - National TAB

Asset	Notes	Date	Written By
EGRD1	NO DAMPERS ON DUCTWORK. UNABLE TO BALANCE INDIVIDUAL DIFFUSERS.	07/09/2025	Ian Fuller

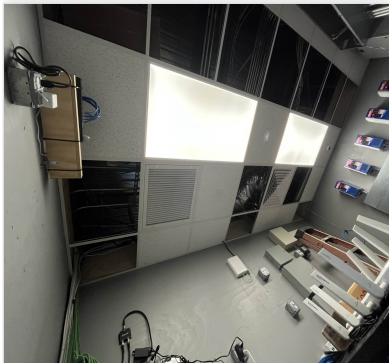
**Issue Name :** Electrical Room diffusers need to be switched  
**Description :** Currently on the diffuser 2-1 located in the electrical room has a return type grille G-1 installed on it, while the transfer grille has a supply type CD-1 diffuser installed. These diffusers need to be switched.  
**Created By :** National TAB                      **Assigned To :** National TAB - Brianna Biggs  
**Status :** Open  
**Priority :** High                                      **Asset Tag :**  
**Originated Date :** 07/08/2025 - Ian Fuller - National TAB

DIFFUSER 2-11 DOES NOT HAVE GYPSUM BOARD ELECTRICAL ROOM DIFFUSERS NEED TO BE SWITCHED. SUPPLY GRILLE IS ON RETURN DUCT.

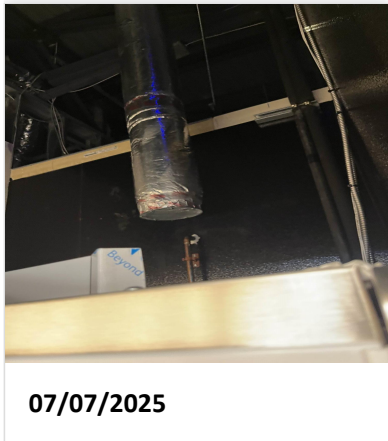
**Issue Name :** Gypsum Board not installed for diffuser 3-9  
**Description :** As shown on M1.0 detail 11 it is stated that supply duct needs to be routed through gypsum board ceiling and into cavity above freezer. Seal duct around penetration air tight and to terminate duct with open end.  
**Created By :** National TAB                      **Assigned To :** National TAB - Ian Fuller  
**Status :** Open  
**Priority :** Low                                      **Asset Tag :**  
**Originated Date :** 07/07/2025 - Ian Fuller - National TAB

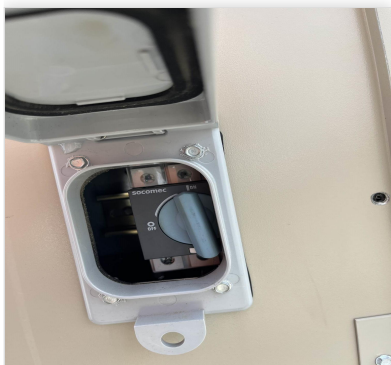
**Issue Name :** Unable to turn off RTU#1 through diconnect  
**Description :** Cover is blocking the RTU#1 disconnect. Unable to turn off unit at disconnect.  
**Created By :** National TAB                      **Assigned To :** National TAB - Ian Fuller  
**Status :** Open  
**Priority :** High                                      **Asset Tag :**  
**Originated Date :** 07/09/2025 - Ian Fuller - National TAB

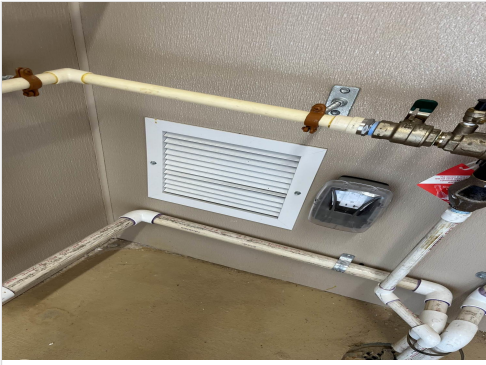
UNABLE TO REACH MOTOR, INSIDE OF WALL
