Report: TAB Report
Function: Test, Adjust, & Balance
Date: 07/09/2025
Completed By: National TAB

07-07-25 WAWA #8687 WILLIAMSBURG, VA

4007 IRONBOUND RD

Wawa
260 West Baltimore Pike
Wawa, PA 19063

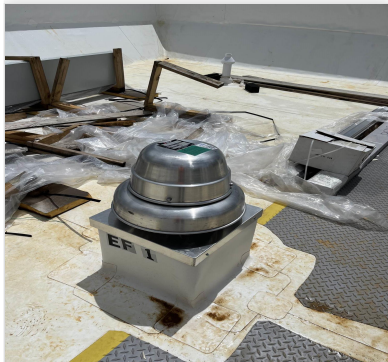
Issue Name : EF#1 is below design airflow
Description : Currently fan is at 255 CFM when design is at 300 CFM. Fan is already at max setting. Unable to balance within design airflow. Pressure in the duct was measured to be 0.17" which is enough pressure to be within design airflow. Speed controller is responding and is set at max. Recommended for manufacturer to review.

EF#1 IS NOT ABLE TO BE BALANCED WITHIN DESIGN AIRFLOW. NO DAMPERS ON EF#2 DUCTWORK TO BALANCE INDIVIDUAL DIFFUSERS

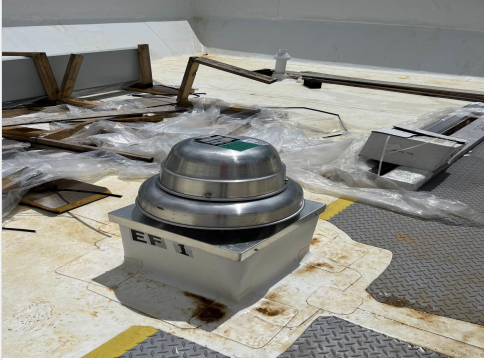
Test Data		
	Design	Actual
CFM	300	255
Fan RPM	1550	1050
Fan Rotation	-	CCW
Motor RPM	-	1050
System SetPt	-	MAX
RL Voltage	-	120
RL Amperage	-	1.0
Total ESP	.13"	0.17"
Fan Inlet SP	-	-0.17"
Fan Discharge SP	-	ATM

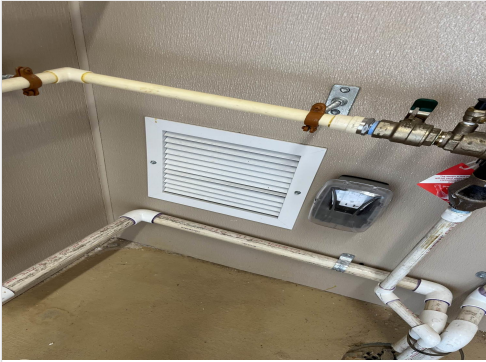
Notes:
UNABLE TO REACH MOTOR, INSIDE OF WALL
