**Report: TAB Report**  
**Function: Test, Adjust, & Balance**  
**Date: 06/10/2024**

**PROJECT**  
**08-26-24 WAWA #5443 YULEE, FL**

50 DAYDREAM AVE

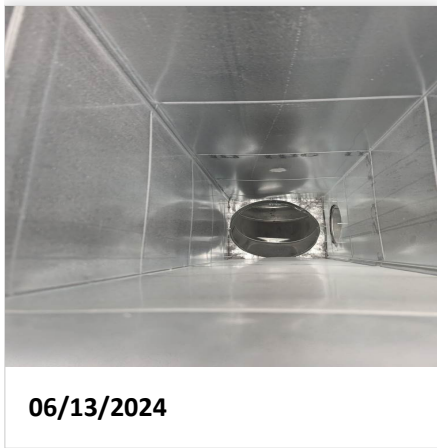
**Issue Name :** EF 1 No Backdraft Damper  
**Description :** There is no backdraft damper installed on EF-1 ductwork. Per M3.0 HVAC EXHAUST FAN SCHEDULE, EF-1 should have a backdraft damper installed.  
**Created By :** National TAB                      **Assigned To :** National TAB - Will Turnbough  
**Status :** Open  
**Priority :** Medium                                      **Asset Tag :**  
**Originated Date :** 06/13/2024 - Stephen Tassinaro - National TAB

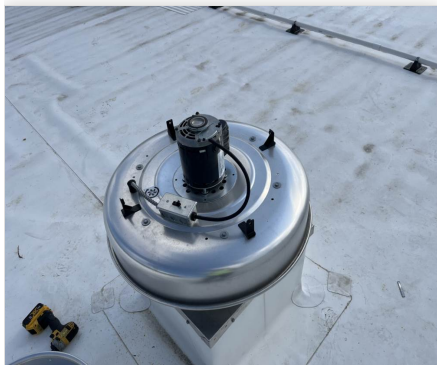
**Issue Name :** EF 1 No Speed Controller  
**Description :** There is no speed controller installed on EF-1. Current airflow is 1498CFM out of 1150CFM design (130%). Per M.30 HVAC EXHAUST FAN SCHEDULE, EF-1 should have a factory wired solid state speed controller.  
**Created By :** National TAB                      **Assigned To :** National TAB - Will Turnbough  
**Status :** Open  
**Priority :** Urgent                                      **Asset Tag :**  
**Originated Date :** 06/13/2024 - Stephen Tassinaro - National TAB

Notes:  
EXHAUST GRILLES BALANCED PROPORTIONALLY HIGH DUE TO LACK OF SPEED CONTROLLER.

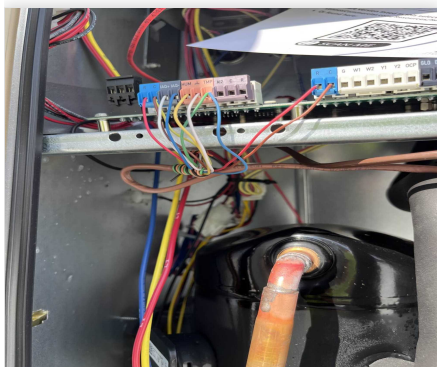
**Issue Name :** Remote Sensor Wiring  
**Description :** The remote humidity sensor wiring does not match the specification shown on the mechanical plans. 2 conductor shielded cable (Qty 2) was not used. Standard thermostat cable used for all sensors. Attached picture typical of all RTUs.  
**Created By :** National TAB                      **Assigned To :** National TAB - Will Turnbough  
**Status :** Open  
**Priority :** High                                      **Asset Tag :**  
**Originated Date :** 06/12/2024 - Stephen Tassinaro - National TAB

2 conductor shielded cable has one wire landed to Vin, one to GND, and the shield wire is not connected.	Fail
----------------------------------------------------------------------------------------------------------	------

For second shielded cable, one wire is landed to Vout and the shield wire is not connected.	Fail
---------------------------------------------------------------------------------------------	------

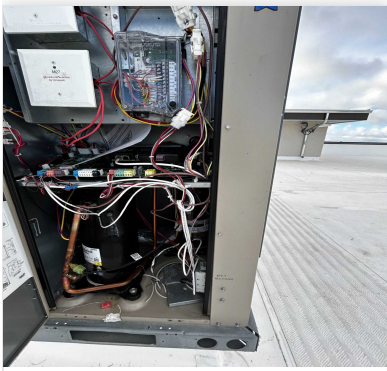
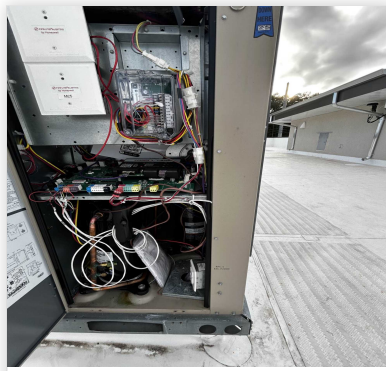
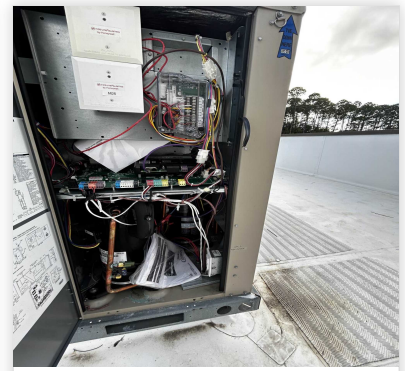
- **08/27/2024 National TAB - Kristopher Passley**
  - REMOTE HUMIDITY SENSORS WIRING NOT REPLACED

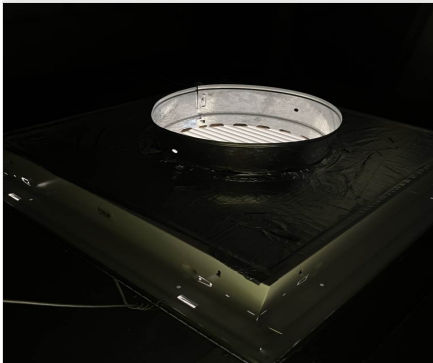
**Issue Name :** Return Grille Not Connect To Duct  
**Description :** The return grille located in the ASSOCIATES room is not connected to the duct in the ceiling. Recommend connecting.  
**Created By :** National TAB                      **Assigned To :** National TAB - Will Turnbough  
**Status :** Open  
**Priority :** Medium                                      **Asset Tag :**  
**Originated Date :** 06/13/2024 - Stephen Tassinaro - National TAB
