Report: TAB RPT
Function: Test, Adjust, & Balance
Date: 7/1/2022

05-16 CULVERS - INDIANAPOLIS, IN (SHEAR AVE)

Project Summary

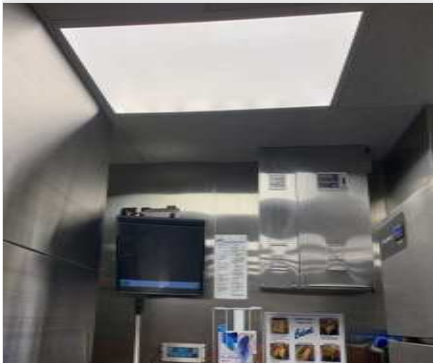
Issue Name : DIFFUSER 2-7 IS ABOVE THE CEILING AND NOT INSTALLED IN THE GRID

Description : Diffuser is above ceiling and needs to be installed in the grid. Diffuser 2-8 is installed where 2-7 would go. Ceiling grid may be too small to install a 2'x2' diffuser. May need to install a 1'x2' perforated diffuser. There is some smoke loss out right side of fryer hood as a result.

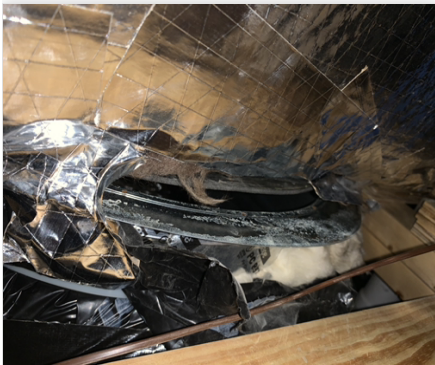
Issue Name : leakage source

Description : Located above the light near the triple sink the collar is disconnected from the main trunk for the back of the house diffusers

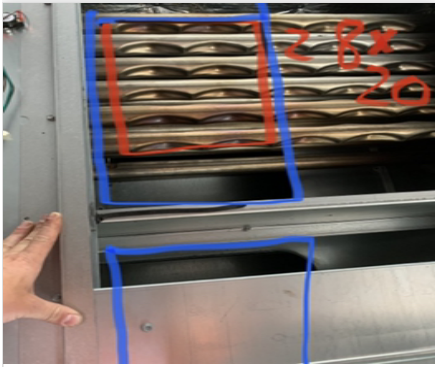
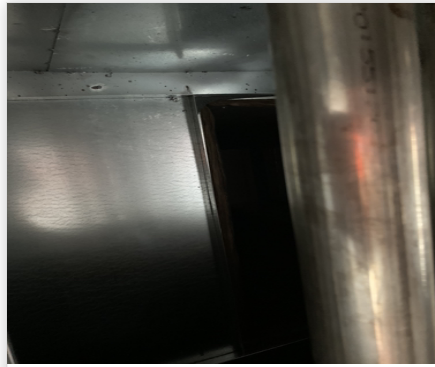
Issue Name : RTU-2 CURB ADAPTER

Description : Curb adapter does not place the supply fans centered above the main duct drop.

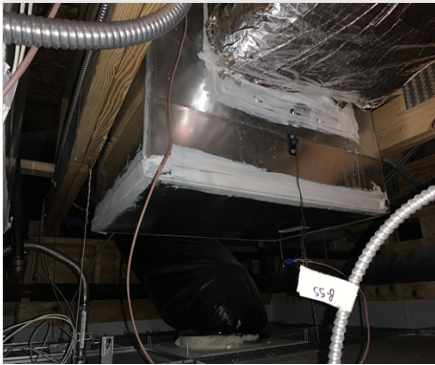
Issue Name : RTU-2 Duct drop

Description : RTU-2 drop is 20X28". Per the drawing the unit should have a 24x16 and a 28X16" drop from the unit.

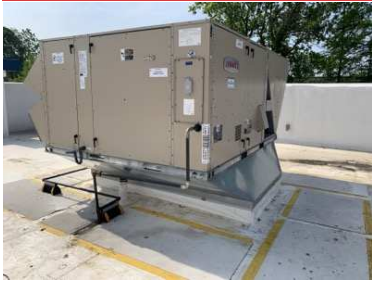
RTU-2

Note curb adaptor

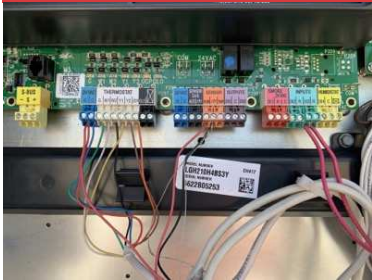
RTU-2 PRODIGY WIRING IS CORRECT

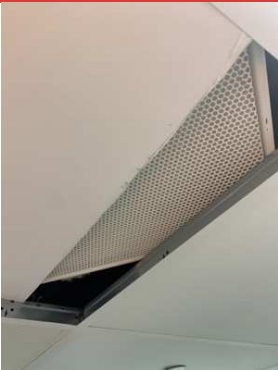
FOUND DIFFUSER 2-8 ABOVE THE CEILING

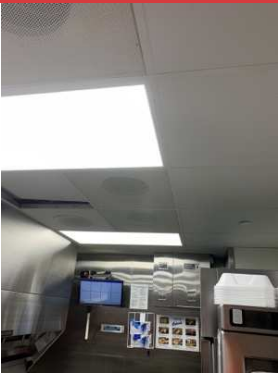
MOVED DIFFUSER 2-8 DOWN FOR TESTING TOTAL FLOW

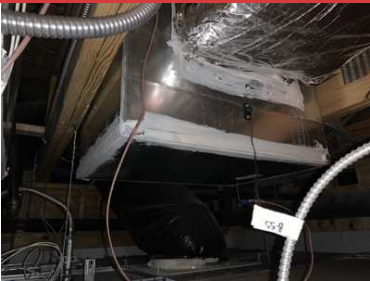
RTU-2 MAIN DROP

21X29" subtracting the Internal liner gives flow area of 20x28"

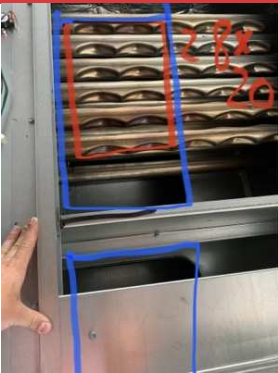
CURB ADAPTOR/ DUCT DROP ALIGNMENT

Marked in blue are the fan discharges, note the fan on the bottom is not aligned near the duct drop. For best performance red duct drop should be centered between the two fan discharges in blue.

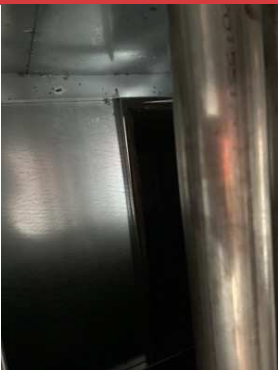
SHOWN IS DUCT DROP ALIGNED DIRECTLY UNDER FAN 2

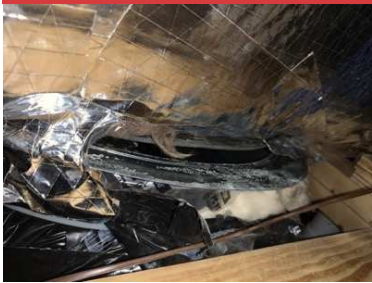
LEAKAGE SOURCE

Located above the light that is above the triple sink. Branch duct that is connected to main TRUNKLINE
