National TAB
1329 E. KEMPER ROAD
SUITE 4210
CINCINNATI, OH 45246

Report: TAB REPORT
Function: Test, Adjust, & Balance
Date: 09/22/2023

PROJECT
09-18-23 WALGREENS #3909 - ARLINGTON,
TX

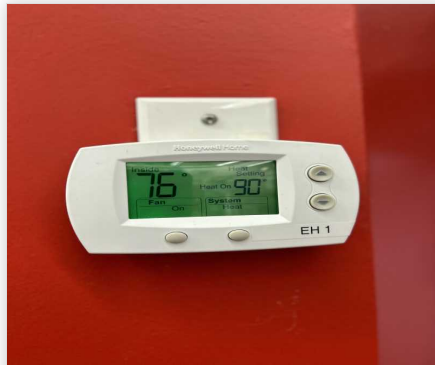
Issue Name : EH-1 Motor Fault
Description : EH-1 Motor Fault. Unit not operational upon heating/ cooling call. Motor is hot with verified power supplied.
Created By : National TAB **Assigned To :** National TAB - Will Turnbough
Status : Open
Priority : **Asset Tag :**
Originated Date : 09/23/2023 - Darius Payne - National TAB

Entrance heater non-responsive to calls for heat. Contactors close & motor buzzes without operation.

EH-1 serving main entrance non-responsive during TAB. Due to fan motor fault.

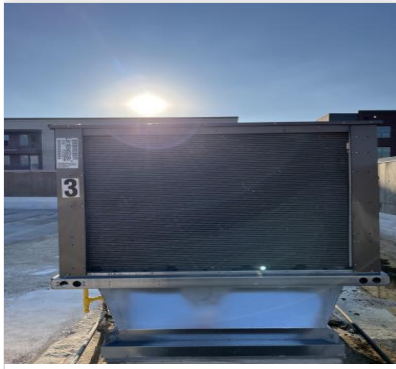
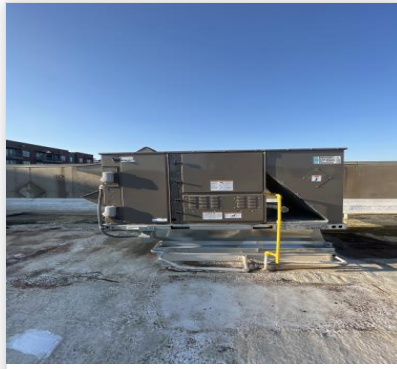
RTU3-1
09/19/2023

RTU 3 Condensate drain line to roof runoff is clogged. Creating water build up around Pharmacy.

Drain line for RTU 3 is clogged, recommended nitrogen flush.
