**Report: TAB REPORT**  
**Function: Test, Adjust, & Balance**  
**Date: 05/28/2024**

**09-18-23 WALGREENS #3909 - ARLINGTON,  
TX**

Project: 09-18-23 WALGREENS #3909 - ARLINGTON, TX

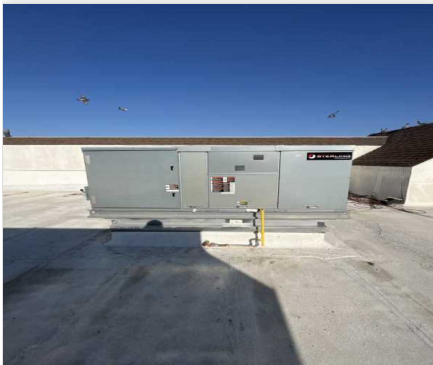
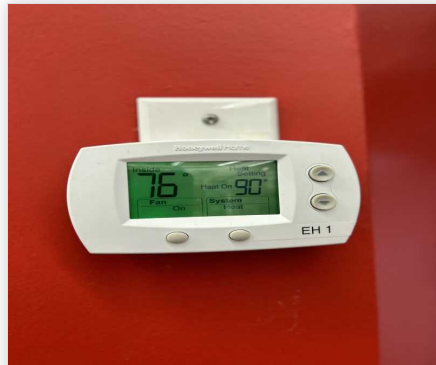
**Issue Name :** EH-1 Motor Fault  
**Description :** EH-1 Motor Fault. Unit not operational, verified no power is at disconnect on roof. Unit is not getting power.  
**Created By :** National TAB                      **Assigned To :** National TAB - Will Turnbough  
**Status :** Open  
**Priority :** Urgent                                      **Asset Tag :**  
**Originated Date :** 09/23/2023 - Darius Payne - National TAB

Entrance heater non-responsive to calls for heat. Contactors close & motor buzzes without operation.

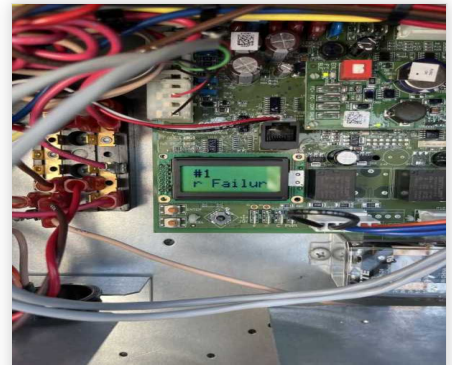
**Issue Name :** RTU 4 - IAQ Fault  
**Description :** RTU 4 - Control board displaying IAQ Fault during TAB inspection.  
**Created By :** National TAB                      **Assigned To :** National TAB - Will Turnbough  
**Status :** Open  
**Priority :**    **Asset Tag :**  
**Originated Date :** 09/23/2023 - Darius Payne - National TAB

Notes:  
 ORIGINAL DESIGN OF 8,080 CFM WAS ADJUSTED TO 6,300 CFM.  
 DIFFUSER DESIGNS WERE ADJUSTED TO ACHIEVE NEW TOTAL DESIGN CFM.  
 DESIGN CFM OBTAINED WHILE UNIT WAS OPERATING AT 48 HZ.  
 CONTROL ERROR: INDOOR AIR QUALITY SENSOR FAILURE.

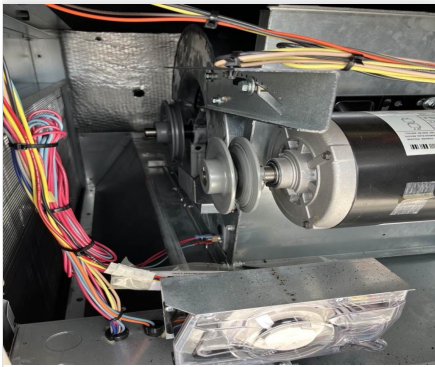
Image\_2\_  
04/26/2024

**Issue Name :** RTU-4 No belt on fan and motor  
**Description :** There is no belt present for RTU-4 connect motor to fan. No belt inside fan cabinet and no extras inside unit.  
**Created By :** National TAB                      **Assigned To :** National TAB - Will Turnbough  
**Status :** Open  
**Priority :** Urgent                                      **Asset Tag :**  
**Originated Date :** 04/26/2024 - Bayley Morvant - National TAB
