Report: TAB REPORT
Function: Test, Adjust, & Balance
Date: 09/22/2023

PROJECT
09-18-23 WALGREENS #3909 - ARLINGTON,
TX
10001 N MACARTHUR BLVD
ARLINGTON, TX 75063

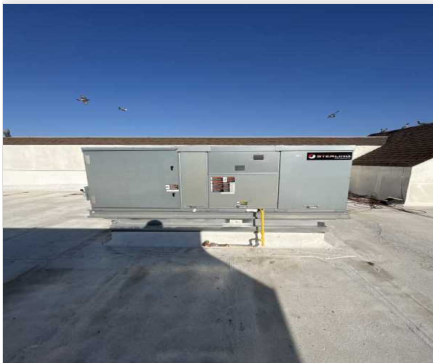
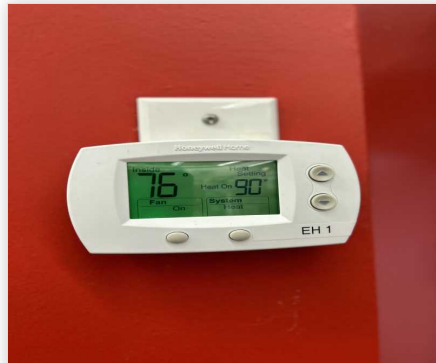
Issue Name : EH-1 Motor Fault
Description : EH-1 Motor Fault. Unit not operational upon heating/ cooling call. Motor is hot with verified power supplied.
Created By : National TAB **Assigned To :** National TAB - Will Turnbough
Status : Open
Priority : **Asset Tag :**
Originated Date : 09/23/2023 - Darius Payne - National TAB

Entrance heater non-responsive to calls for heat. Contactors close & motor buzzes without operation.

EH-1 serving main entrance non-responsive during TAB. Due to fan motor fault.

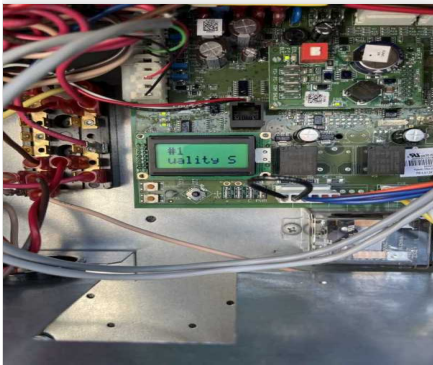
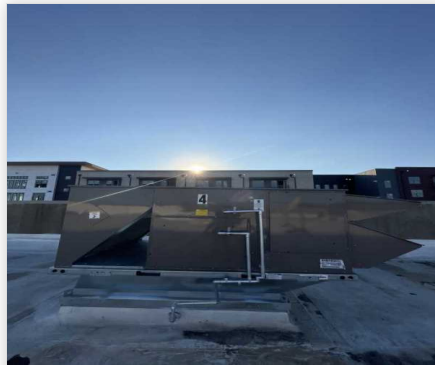
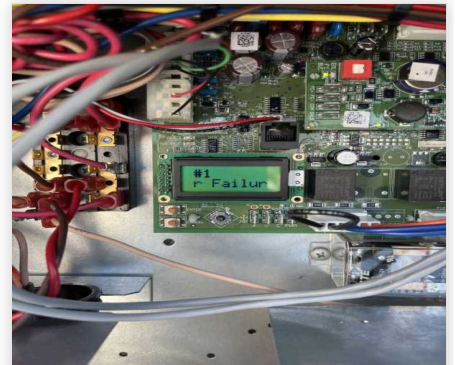
Issue Name : RTU 4 - IAQ Fault
Description : RTU 4 - Control board displaying IAQ Fault during TAB inspection.
Created By : National TAB **Assigned To :** National TAB - Will Turnbough
Status : Open
Priority : **Asset Tag :**
Originated Date : 09/23/2023 - Darius Payne - National TAB

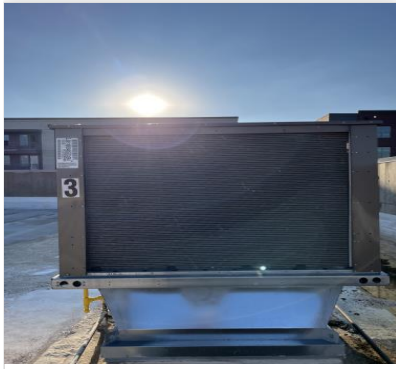
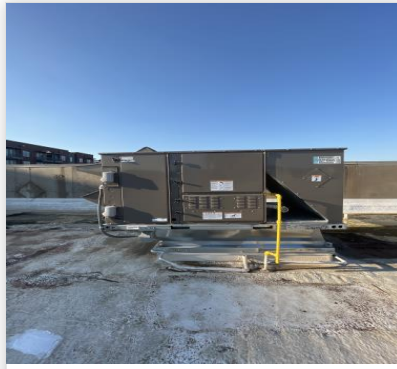
RTU-3

RTU 3 Condensate drain line to roof runoff is clogged. Creating water build up around Pharmacy.

Drain line for RTU 3 is clogged, recommended nitrogen flush.
