Report: TAB REPORT
Function: Test, Adjust, & Balance
Date: 05/28/2024

**09-18-23 WALGREENS #3909 - ARLINGTON,
TX**

Project: 09-18-23 WALGREENS #3909 - ARLINGTON, TX

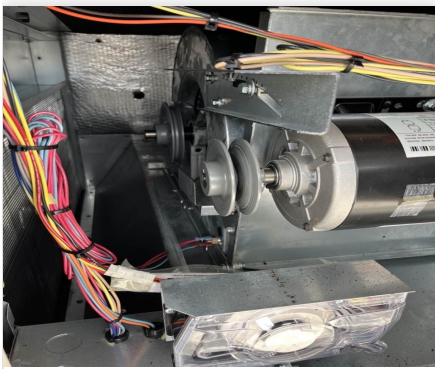
Image_2_
04/26/2024

Issue Name : RTU-4 No belt on fan and motor
Description : There is no belt present for RTU-4 connect motor to fan. No belt inside fan cabinet and no extras inside unit.
Created By : National TAB **Assigned To :** National TAB - Will Turnbough
Status : Open
Priority : Urgent **Asset Tag :**
Originated Date : 04/26/2024 - Bayley Morvant - National TAB
