Report: TAB Report
Function: Test, Adjust, & Balance
Date: 05/13/2025
Completed By: National TAB

PROJECT
05-12-25 CHILI'S CLEARWATER FL

25987 US Hwy 19 N

Clearwater, FL 33763

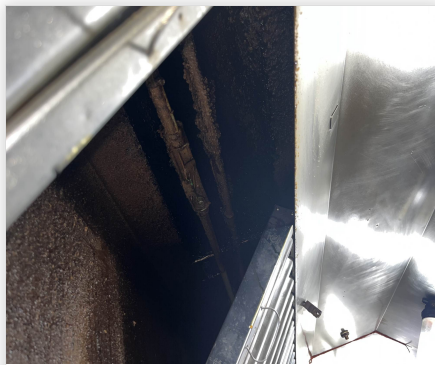
Issue Name : Grease Duct Dirty
Description : The grease ducts are dirty on Hood 1. This is not causing performance issues, but is a fire hazard.
Created By : National TAB **Assigned To :** National TAB - Dan Hertenstein
Status : Open
Priority : High **Asset Tag :**
Originated Date : 05/15/2025 - Stephen Tassinaro - National TAB

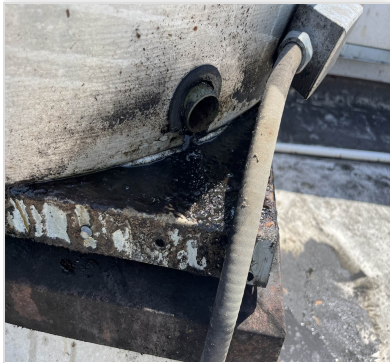
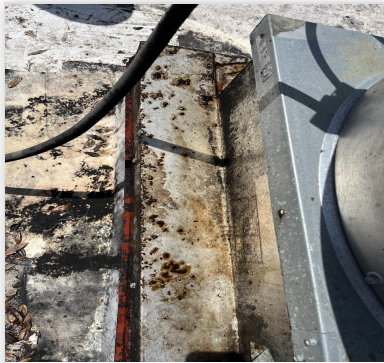
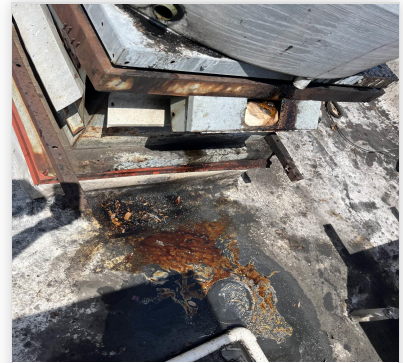
- **05/16/2025 National TAB - Stephen Tassinaro**
 - There is also grease dripping out of the fans onto the rooftop.

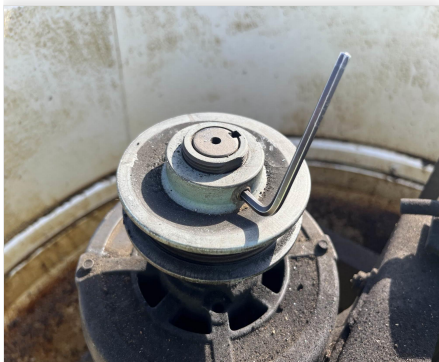
Issue Name : KEF-2 Pulley Seized
Description : KEF-2, serving the right side of the main cookline hood, has a seized motor pulley that cannot be adjusted. It is recommended to replace the motor pulley with a 1VP34X7/8 and replace the fan pulley with a AK44X1-1/8. The existing belt size should be acceptable as there is significant tensioner adjustment available on this fan.
Created By : National TAB **Assigned To :** National TAB - Dan Hertenstein
Status : Open
Priority : Urgent **Asset Tag :**
Originated Date : 05/15/2025 - Stephen Tassinaro - National TAB

Design net airflow is positive, current net airflow & building pressure is negative. This is because of a broken outside air damper on RTU-5 and seized pulleys on KEF-2 & KEF-3. With these items resolved it is expected the space will swing to a positive pressure.

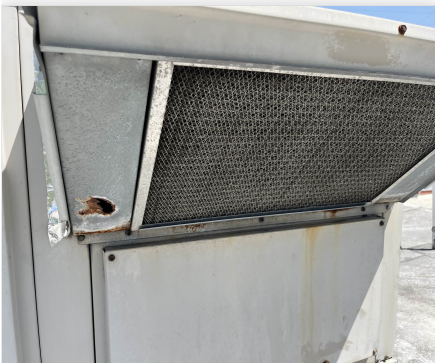
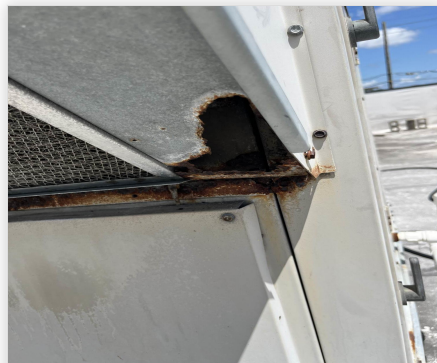
Issue Name : RTU-2 & RTU-3 Minor Rust Damage
Description : There is some minor rust damage on the outside air hoods of RTU-2 & RTU-3. It is recommended to patch these rust holes to prevent foreign materials, bugs, or other small animals from entering the unit.
Created By : National TAB **Assigned To :** National TAB - Dan Hertenstein
Status : Open
Priority : Low **Asset Tag :**
Originated Date : 05/16/2025 - Stephen Tassinaro - National TAB

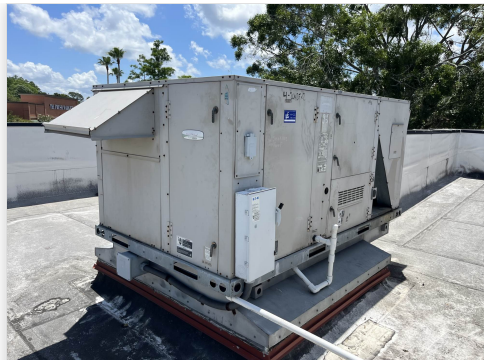
Asset: RTU5

[1] Distance between blades. Damper is not functional.

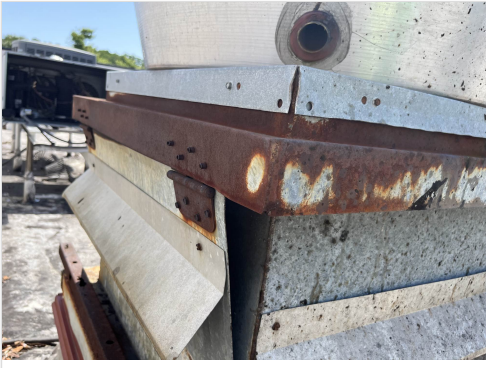
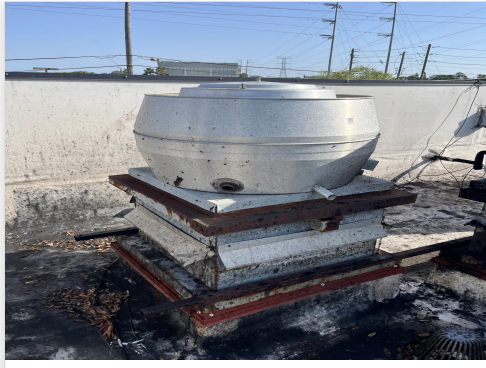
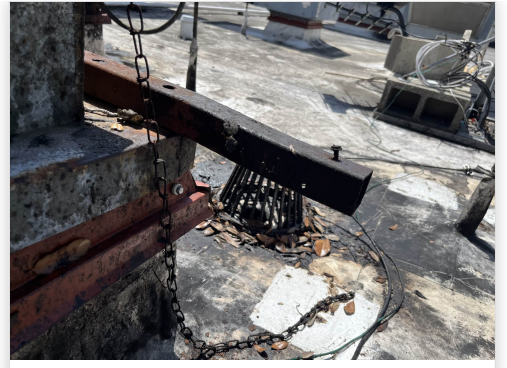
Asset: EF3

[1] ALL WIRING INSIDE CONDUIT. LIGHT SWITCH STYLE DISCONNECT NEEDS TO BE DISASSEMBLED FOR AMPERAGE DRAW READING. //

[2] UNABLE TO TILT FAN WHILE RUNNING. FAN HOUSING TOO FLEXIBLE AND BLADES STARTED TO RUB.
