**Report: TAB Report**  
**Function: Test, Adjust, & Balance**  
**Date: 05/13/2025**  
**Completed By: National TAB**

**PROJECT**  
**05-12-25 CHILI'S CLEARWATER FL**

Brinker  
3000 Olympus Blvd  
Coppell, TX 75019

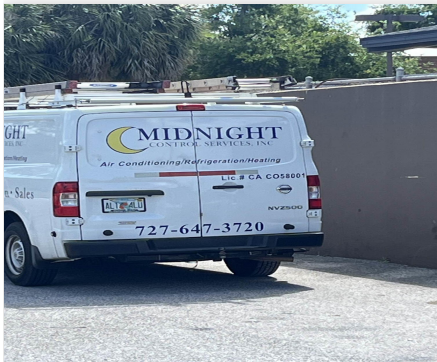
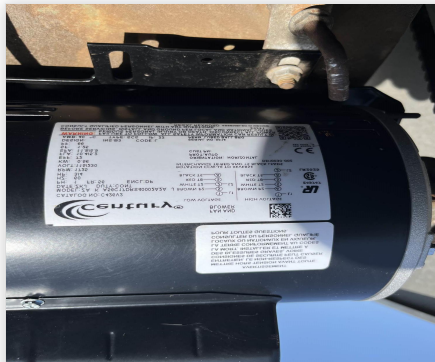
**Issue Name :** 0. Extra Info  
**Description :** On 5/14/2025 the MC (MID NIGHT CONTROL SERVICES) was on site. They cleaned all evaporator and condenser coils, replaced all final filters, and checked belt tensions. They also repaired MAU-3 by installing a new motor. All NTi tests were completed after this work was completed.  
**Created By :** National TAB                      **Assigned To :** National TAB - Dan Hertenstein  
**Status :** Open  
**Priority :** InfoOnly                                      **Asset Tag :**  
**Originated Date :** 05/15/2025 - Stephen Tassinaro - National TAB

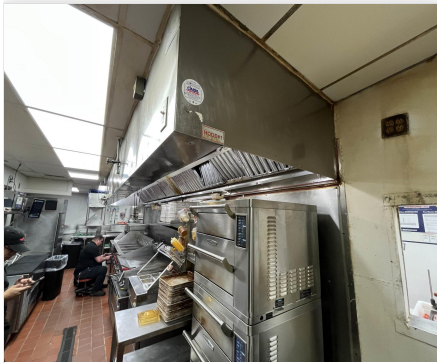
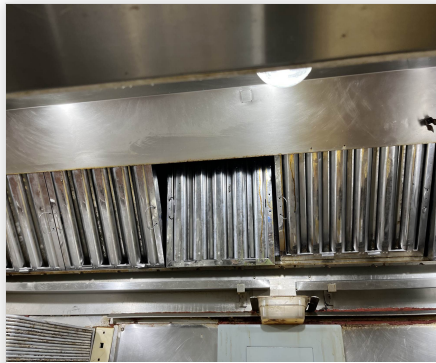
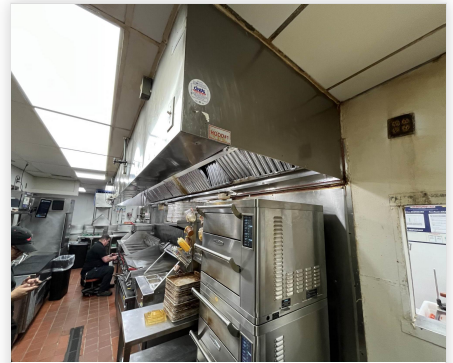
**Issue Name :** 1. Hood Filters Not Locked Into Hoods  
**Description :** The hood filters are not locked in place in the hoods, this is causing both safety issues and functional issues. If KEF-1 or KEF-2 turns off at any point, the filters can fall out of the hoods and into the cooking equipment/cooks. From a functional standpoint the filters do not seal well and the grease/air can bypass the filters.  
**Created By :** National TAB                      **Assigned To :** National TAB - Dan Hertenstein  
**Status :** Open  
**Priority :** Urgent                                      **Asset Tag :**  
**Originated Date :** 05/15/2025 - Stephen Tassinaro - National TAB

Hood 1 right - filters are not staying in place and are being pulled into the grease trap. Hood 3 there is a 3" gap in the filters.

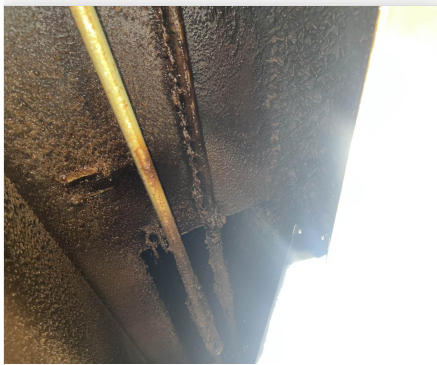
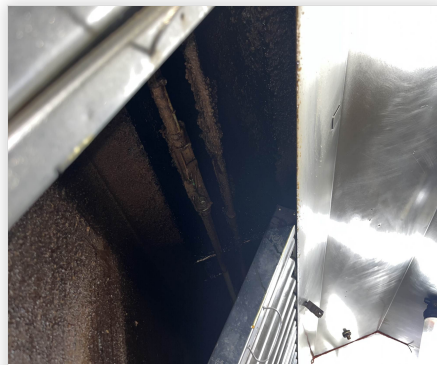
**Issue Name :** Grease Duct Dirty  
**Description :** The grease ducts are dirty on Hood 1. This is not causing performance issues, but is a fire hazard.  
**Created By :** National TAB      **Assigned To :** National TAB - Dan Hertenstein  
**Status :** Open  
**Priority :** High      **Asset Tag :**  
**Originated Date :** 05/15/2025 - Stephen Tassinaro - National TAB

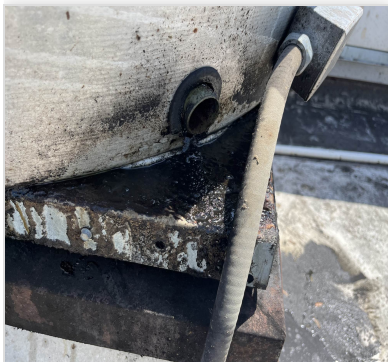
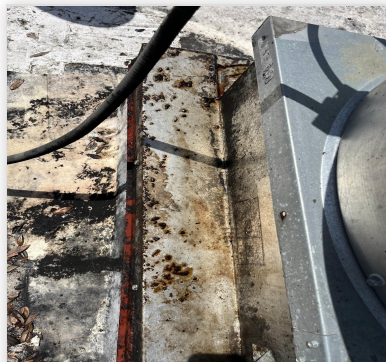
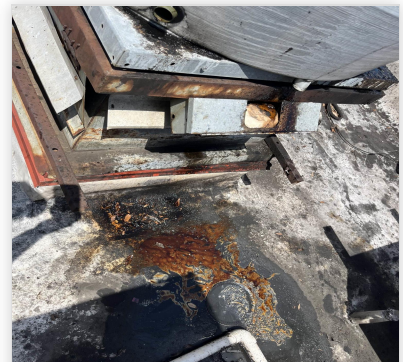
- **05/16/2025 National TAB - Stephen Tassinaro**
  - There is also grease dripping out of the fans onto the rooftop.

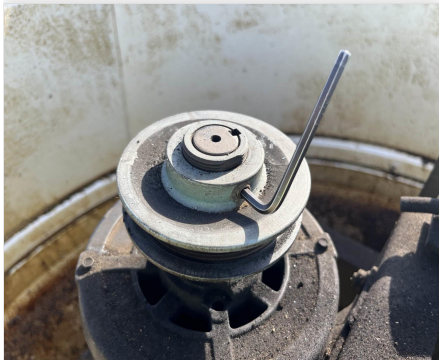
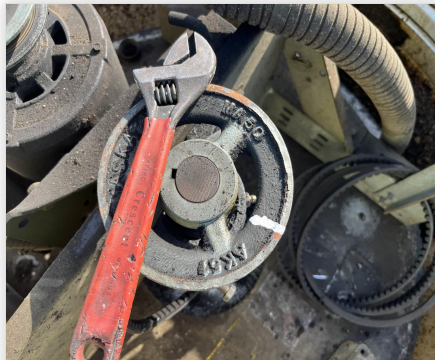
**Issue Name :** KEF-2 Pulley Seized  
**Description :** KEF-2, serving the right side of the main cookline hood, has a seized motor pulley that cannot be adjusted. It is recommended to replace the motor pulley with a 1VP34X7/8 and replace the fan pulley with a AK44X1-1/8. The existing belt size should be acceptable as there is significant tensioner adjustment available on this fan.  
**Created By :** National TAB      **Assigned To :** National TAB - Dan Hertenstein  
**Status :** Open  
**Priority :** Urgent      **Asset Tag :**  
**Originated Date :** 05/15/2025 - Stephen Tassinaro - National TAB

Design net airflow is positive, current net airflow & building pressure is negative. This is because of a broken outside air damper on RTU-5 and seized pulleys on KEF-2 & KEF-3. With these items resolved it is expected the space will swing to a positive pressure.

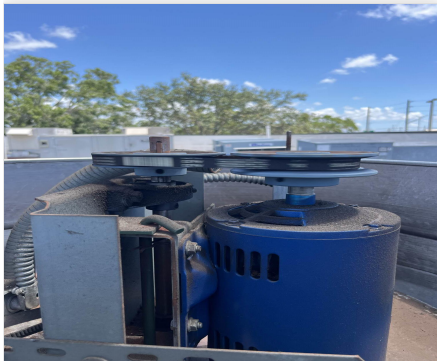
**Issue Name :** KEF-3 Pulley Sized  
**Description :** EF-3, serving Hood 2, has a seized motor pulley that cannot be adjusted. Recommend changing motor pulley to a 1VP34X7/8. The existing belt should be acceptable as there is significant tensioner adjustment available on this fan.  
**Created By :** National TAB                      **Assigned To :** National TAB - Dan Hertenstein  
**Status :** Open  
**Priority :** Urgent                                      **Asset Tag :**  
**Originated Date :** 05/15/2025 - Stephen Tassinaro - National TAB

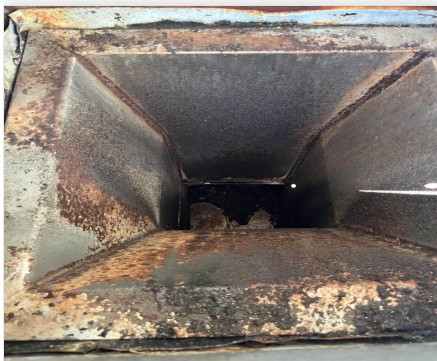
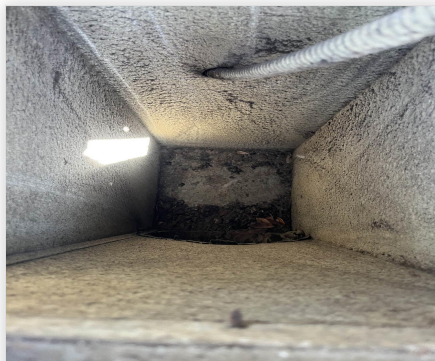
**Issue Name :** No Backdraft Dampers  
**Description :** There are no backdraft dampers installed on any of the fans in the space. It is recommended to install them on any non-grease fan. In this case the dishwasher fan and restroom exhaust fan.  
**Created By :** National TAB                      **Assigned To :** National TAB - Dan Hertenstein  
**Status :** Open  
**Priority :** Medium                                      **Asset Tag :**  
**Originated Date :** 05/16/2025 - Stephen Tassinaro - National TAB

Restroom EF and Dish EF do not have backdraft dampers

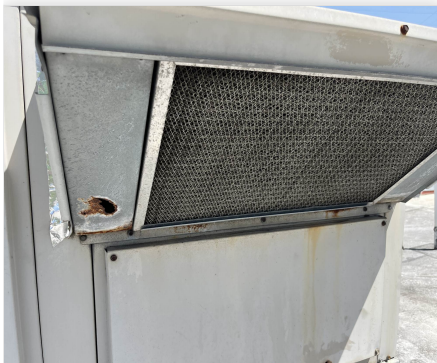
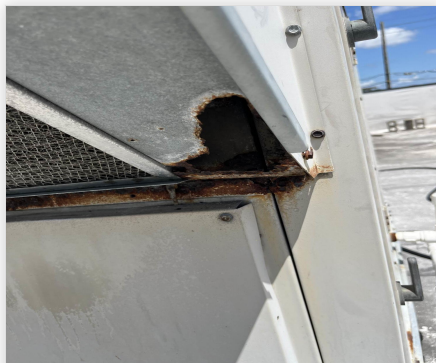
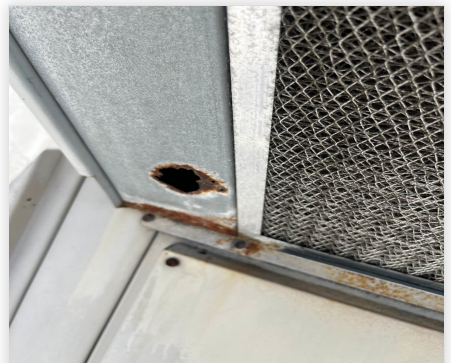
**Issue Name :** RTU-2 & RTU-3 Minor Rust Damage  
**Description :** There is some minor rust damage on the outside air hoods of RTU-2 & RTU-3. It is recommended to patch these rust holes to prevent foreign materials, bugs, or other small animals from entering the unit.  
**Created By :** National TAB                      **Assigned To :** National TAB - Dan Hertenstein  
**Status :** Open  
**Priority :** Low                                      **Asset Tag :**  
**Originated Date :** 05/16/2025 - Stephen Tassinaro - National TAB

Some rust on RTUs 3 and 4. Near Outside air intakes.

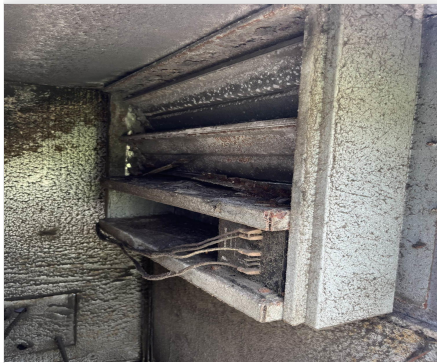
**Issue Name :** RTU-5 OA Damper  
**Description :** The outside air damper in RTU-5 is broken and seized in its current position. Replacement recommend so that outside airflow can be increased. This will assist in pressurizing the space.  
**Created By :** National TAB                      **Assigned To :** National TAB - Dan Hertenstein  
**Status :** Open  
**Priority :** Urgent                                      **Asset Tag :**  
**Originated Date :** 05/15/2025 - Stephen Tassinaro - National TAB

RTU 1 - Yes / RTU 2 - Manual slider / RTU 3 - Manual slider / RTU 4 - Manual slider / RTU 5 - Motorized damper broken & seized

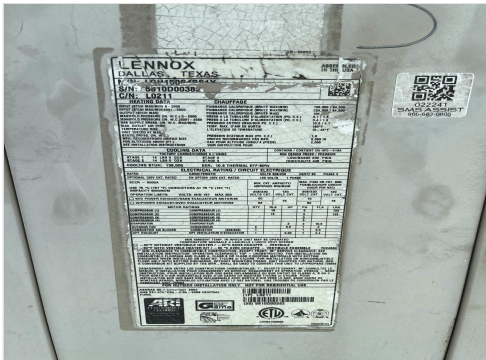
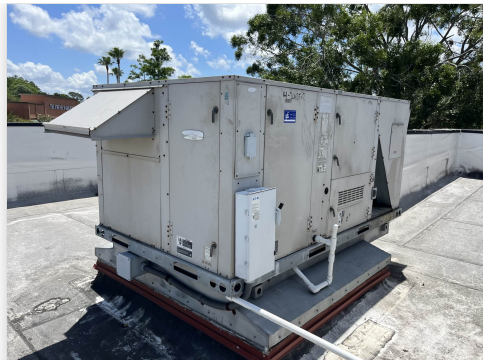
Asset: RTU5

[1] Distance between blades. Damper is not functional.

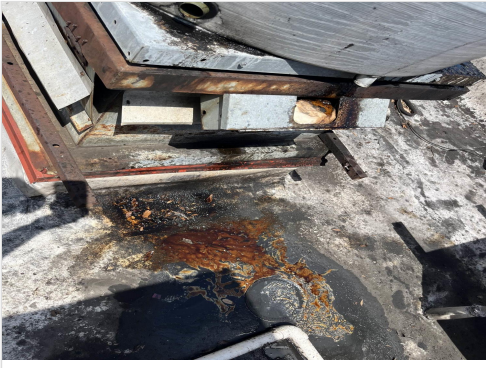
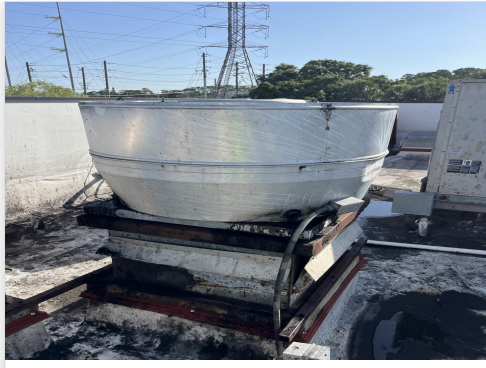
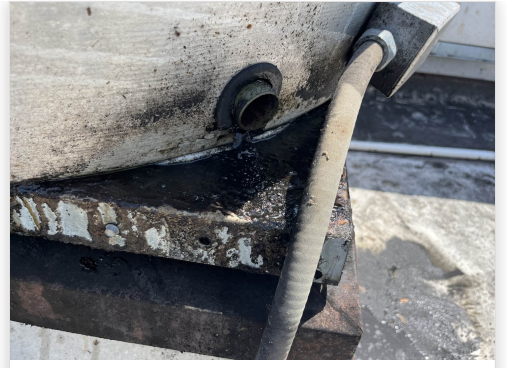
Asset: EF2

[1] ALL WIRING INSIDE CONDUIT. LIGHT SWITCH STYLE DISCONNECT NEEDS TO BE DISASSEMBLED FOR AMPERAGE DRAW READING. //

[2] UNABLE TO TILT FAN WHILE RUNNING. FAN HOUSING TOO FLEXIBLE AND BLADES STARTED TO RUB.

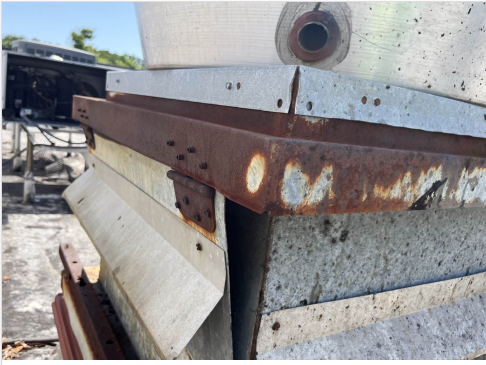
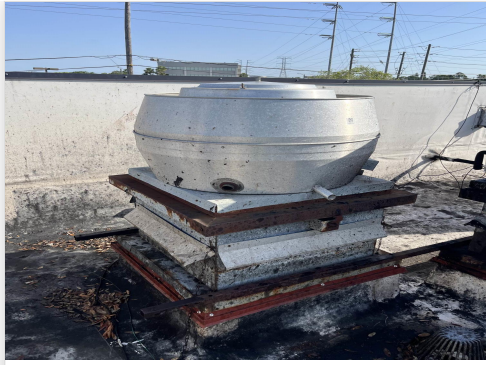
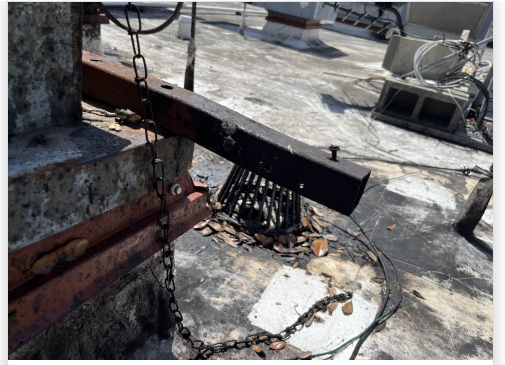
Asset: EF3

[1] ALL WIRING INSIDE CONDUIT. LIGHT SWITCH STYLE DISCONNECT NEEDS TO BE DISASSEMBLED FOR AMPERAGE DRAW READING. //

[2] UNABLE TO TILT FAN WHILE RUNNING. FAN HOUSING TOO FLEXIBLE AND BLADES STARTED TO RUB.
