Report: TAB Report
Function: Test, Adjust, & Balance
Date: 05/13/2025
Completed By: National TAB

PROJECT
05-12-25 CHILI'S CLEARWATER FL

25987 US Hwy 19 N

Clearwater, FL 33763

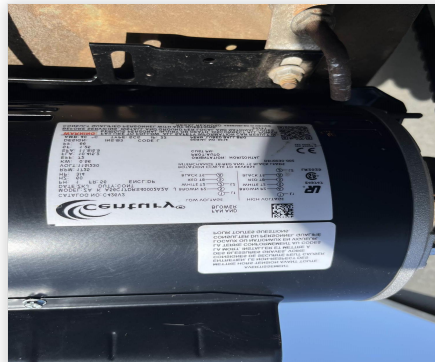
Issue Name : Issues resolved on site
Description : On 5/14/2025 the MC (MID NIGHT CONTROL SERVICES) was on site. They cleaned all evaporator and condenser coils, replaced all final filters, and checked belt tensions. They also repaired MAU-3 by installing a new motor. All NTi tests were completed after this work was completed.
Created By : National TAB **Assigned To :** National TAB - Dan Hertenstein
Status : Open
Priority : InfoOnly **Asset Tag :**
Originated Date : 05/15/2025 - Stephen Tassinaro - National TAB

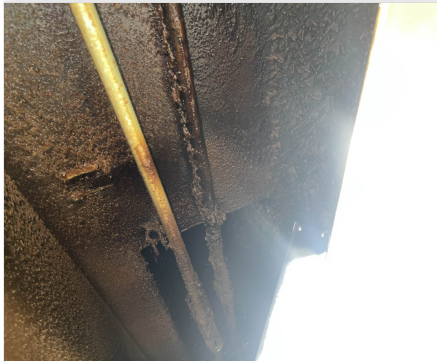
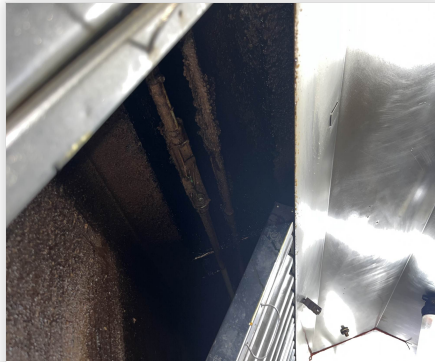
Issue Name : Grease Duct Dirty
Description : The grease ducts are dirty on Hood 1. This is not causing performance issues, but is a fire hazard.
Created By : National TAB **Assigned To :** National TAB - Dan Hertenstein
Status : Open
Priority : High **Asset Tag :**
Originated Date : 05/15/2025 - Stephen Tassinaro - National TAB

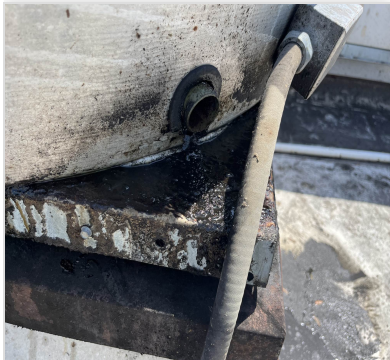
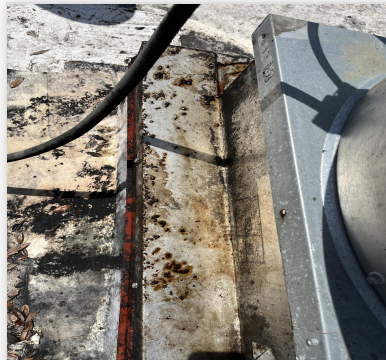
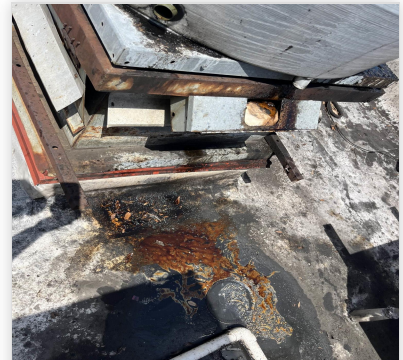
- **05/16/2025 National TAB - Stephen Tassinaro**
 - There is also grease dripping out of the fans onto the rooftop.

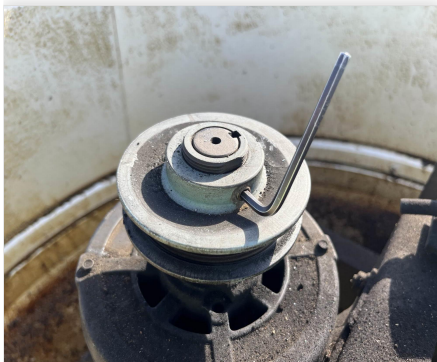
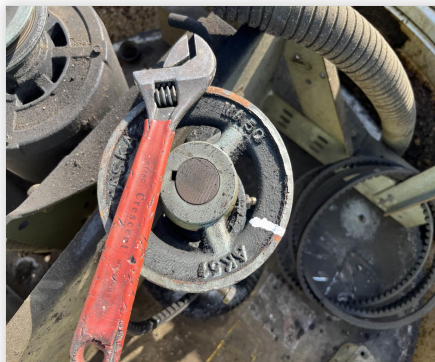
Issue Name : KEF-2 Pulley Seized
Description : KEF-2, serving the right side of the main cookline hood, has a seized motor pulley that cannot be adjusted. It is recommended to replace the motor pulley with a 1VP34X7/8 and replace the fan pulley with a AK44X1-1/8. The existing belt size should be acceptable as there is significant tensioner adjustment available on this fan.
Created By : National TAB **Assigned To :** National TAB - Dan Hertenstein
Status : Open
Priority : Urgent **Asset Tag :**
Originated Date : 05/15/2025 - Stephen Tassinaro - National TAB

Design net airflow is positive, current net airflow & building pressure is negative. This is because of a broken outside air damper on RTU-5 and seized pulleys on KEF-2 & KEF-3. With these items resolved it is expected the space will swing to a positive pressure.

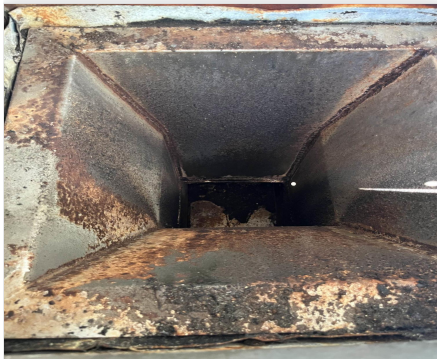
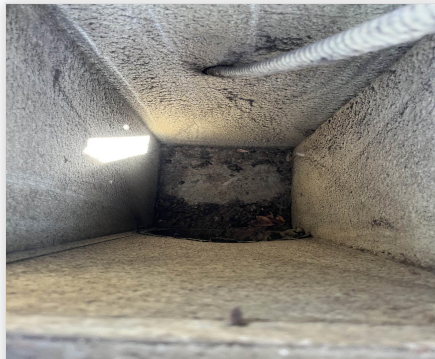
Issue Name : No Backdraft Dampers
Description : There are no backdraft dampers installed on any of the fans in the space. It is recommended to install them on any non-grease fan. In this case the dishwasher fan and restroom exhaust fan.
Created By : National TAB **Assigned To :** National TAB - Dan Hertenstein
Status : Open
Priority : Medium **Asset Tag :**
Originated Date : 05/16/2025 - Stephen Tassinaro - National TAB

Restroom EF and Dish EF do not have backdraft dampers

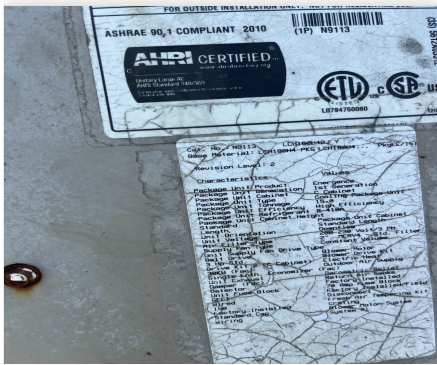
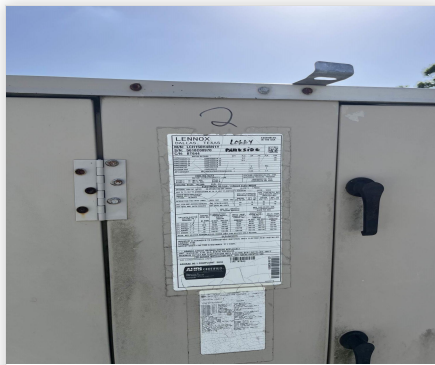
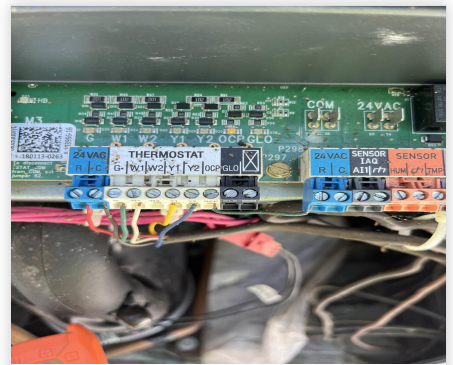
Issue Name : Non-Humiditrol RTUs
Description : The currently installed RTUs do not appear to have the Humiditrol option. Humidity sensors are consequently not installed at this location.
Created By : National TAB **Assigned To :** National TAB - Dan Hertenstein
Status : Open
Priority : InfoOnly **Asset Tag :**
Originated Date : 06/25/2025 - Stephen Tassarano - National TAB

None of the RTUs have dehumidification functions.

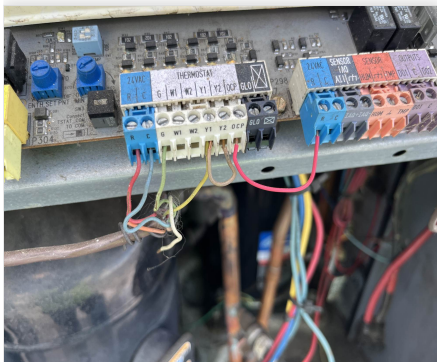
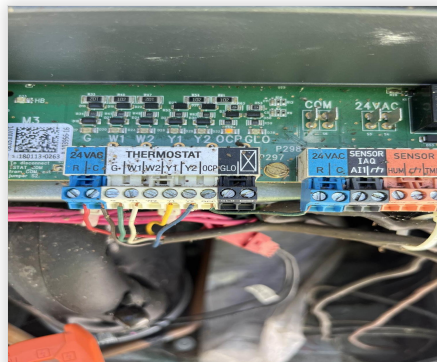
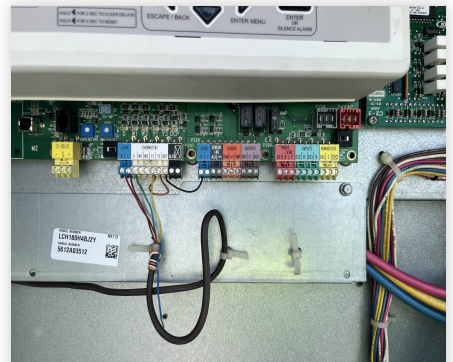
Issue Name : OCC Terminal Jumpers Installed
Description : The OCC terminals in the RTUs have jumper wires installed. This prevents the units with motorized outside air dampers from closing these outside air dampers when the space is unoccupied. It is worth mentioning that many of the RTUs at this location use manual outside air dampers that are not capable of closing on their own.

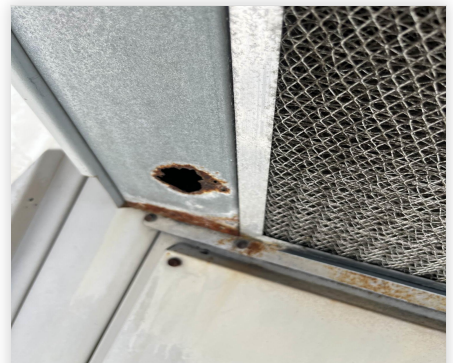
Issue Name : RTU-2 & RTU-3 Minor Rust Damage
Description : There is some minor rust damage on the outside air hoods of RTU-2 & RTU-3. It is recommended to patch these rust holes to prevent foreign materials, bugs, or other small animals from entering the unit.
Created By : National TAB **Assigned To :** National TAB - Dan Hertenstein
Status : Open
Priority : Low **Asset Tag :**
Originated Date : 05/16/2025 - Stephen Tassinaro - National TAB

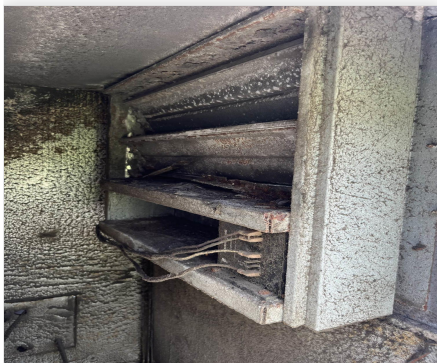
Issue Name : RTU-5 OA Damper
Description : The outside air damper in RTU-5 is broken and seized in its current position. Replacement recommend so that outside airflow can be increased. This will assist in pressurizing the space.
Created By : National TAB **Assigned To :** National TAB - Dan Hertenstein
Status : Open
Priority : Urgent **Asset Tag :**
Originated Date : 05/15/2025 - Stephen Tassinaro - National TAB

RTU 1 - Yes / RTU 2 - Manual slider / RTU 3 - Manual slider / RTU 4 - Manual slider / RTU 5 - Motorized damper broken & seized

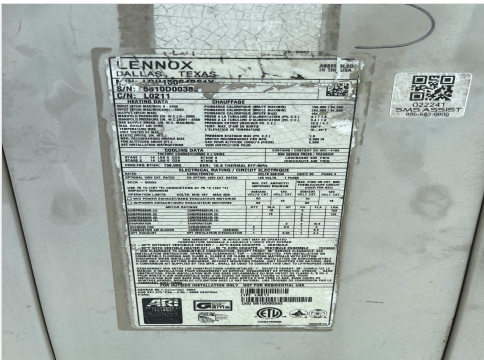
Asset: RTU5

Test Data		
	Design	Actual
SF RPM	-	NOT ACCESSIBLE
OA CFM	1250	582
RL Voltage	-	214/213/213
RL Amperage	-	9.2/9.5/8.8
SF Rotation	-	CCW
RA Damper Position	-	FULL OPEN
RA Damper Type	-	NONE
OA Damper Position	-	1.75" [1]
OA Damper Type	-	OBD
OA Enthalpy Setpt	-	N/A

[1] Distance between blades. Damper is not functional.
