Report: TAB Submittal
Function: Test, Adjust, & Balance
Date: 05/13/2025
Completed By: National TAB

PROJECT
05-12-25 CHILI'S CLEARWATER FL

Project: 05-12-25 CHILI'S CLEARWATER FL

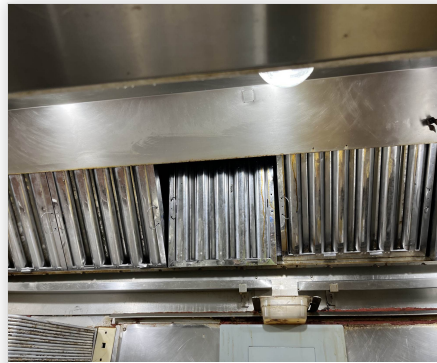
Issue Name : 1. Hood Filters Not Locked Into Hoods
Description : The hood filters are not locked in place in the hoods, this is causing both safety issues and functional issues. If KEF-1 or KEF-2 turns off at any point, the filters can fall out of the hoods and into the cooking equipment/cooks. From a functional standpoint the filters do not seal well and the grease/air can bypass the filters.

Hood 1 right - filters are not staying in place and are being pulled into the grease trap. Hood 3 there is a 3" gap in the filters.

Some denting on the supply air grilles, hood filters missing handles.

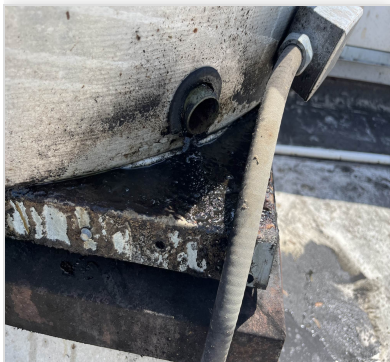
- **05/16/2025 National TAB - Stephen Tassinaro**
 - There is also grease dripping out of the fans onto the rooftop.

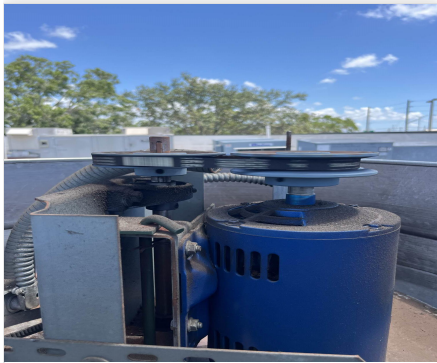
Issue Name : KEF-3 Pulley Sized
Description : EF-3, serving Hood 2, has a seized motor pulley that cannot be adjusted. Recommend changing motor pulley to a 1VP34X7/8. The existing belt should be acceptable as there is significant tensioner adjustment available on this fan.
Created By : National TAB **Assigned To :** National TAB - Dan Hertenstein
Status : Open
Priority : Urgent **Asset Tag :**
Originated Date : 05/15/2025 - Stephen Tassinaro - National TAB

Design net airflow is positive, current net airflow & building pressure is negative. This is because of a broken outside air damper on RTU-5 and seized pulleys on KEF-2 & KEF-3. With these items resolved it is expected the space will swing to a positive pressure.

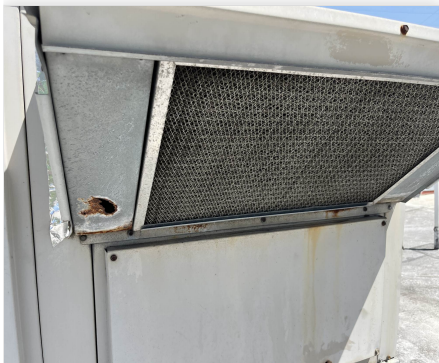
Issue Name : RTU-2 & RTU-3 Minor Rust Damage
Description : There is some minor rust damage on the outside air hoods of RTU-2 & RTU-3. It is recommended to patch these rust holes to prevent foreign materials, bugs, or other small animals from entering the unit.
Created By : National TAB **Assigned To :** National TAB - Dan Hertenstein
Status : Open
Priority : Low **Asset Tag :**
Originated Date : 05/16/2025 - Stephen Tassinaro - National TAB

Some rust on RTUs 3 and 4. Near Outside air intakes.

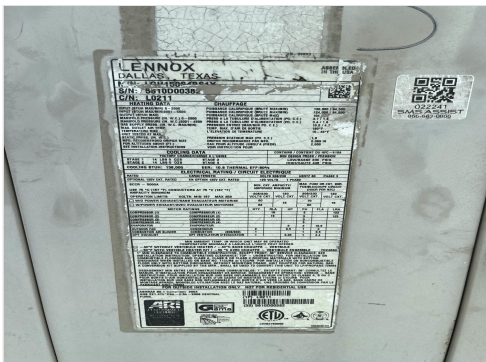
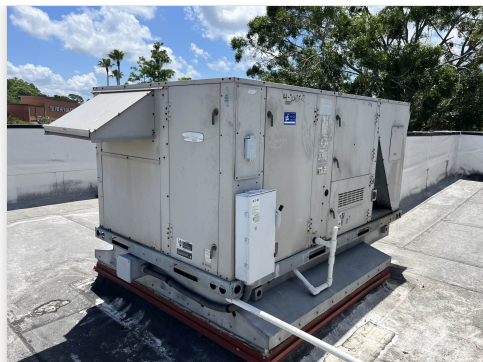
Asset: RTU5

[1] Distance between blades. Damper is not functional.

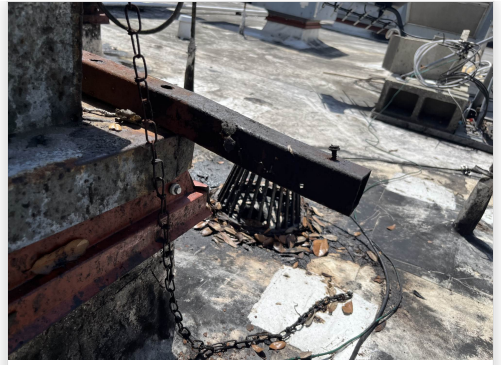
Asset: EF3

[1] ALL WIRING INSIDE CONDUIT. LIGHT SWITCH STYLE DISCONNECT NEEDS TO BE DISASSEMBLED FOR AMPERAGE DRAW READING. //

[2] UNABLE TO TILT FAN WHILE RUNNING. FAN HOUSING TOO FLEXIBLE AND BLADES STARTED TO RUB.
