Report: Test and Balance  
Date: 9/23/2020

**CHICK-FIL-A #01815 PHENIX CITY FSU (PHENIX CITY,  
AL)**

# National TAB

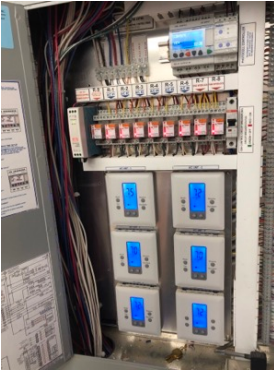
**CABLE ROUTING COMPARTMENT IS NOT YET INSTALLED**

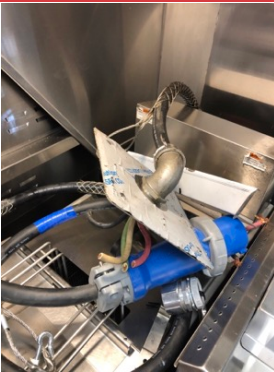
**HOOD 4 PIN AND SLEEVE OUTLET IS NOT YET WIRED**

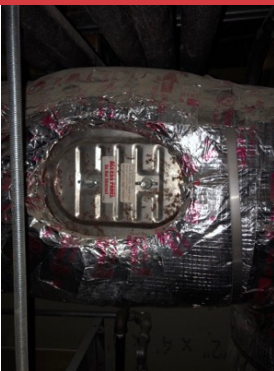
**ACCESS DOORS ARE NOT EXACTLY WHAT IS SHOWN ON PLANS**

Different access doors need to be replaced with access doors on plans if CFA does not approve of different access doors. See sheet M-3.1 detail 9.

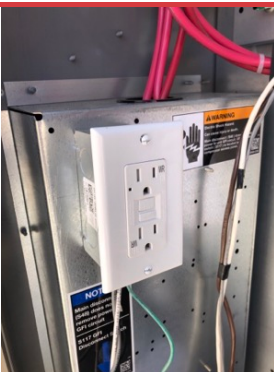
**GFI OUTLETS HAVE NO POWER**

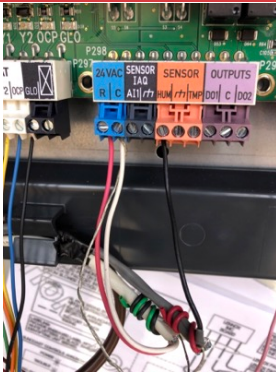
REVIEW + RECTIFY	Humidistat wiring is not landed at the RTU as shown in the mechanical drawings. GND wire and shielded wires are landed at C, but should be landed at drain terminal. See M-4.1 detail 3 for correct wiring diagram.
INFO ONLY	No backdraft damper is installed in the duct for EF3, the restroom exhaust fan. This fan is also not secured to the curb. The fan is existing and installation of the backdraft damper is not in the scope of work. Listing as an issue since it is a deviation from typical CFA spec.
INFO ONLY	Some existing diffusers do not have hard elbow. Typical CFA design is for all diffusers to have a rigid 90 degree fitting installed per SAG/RAG/Grille Take-off Drawing Sheet M-3.1. Existing ductwork in dining room area is outside of the scope of construction. Listed as it is a deviation from typical CFA spec.
REVIEW + RECTIFY	Diffusers in Mechanical area and kitchen are not placed exactly where shown on plans. Recommend installing per plan on M101.MOD

**WIRES AND SHIELD WIRES ARE NOT LANDED TO DRAIN TERMINAL**

-Wire from terminal GND in the panel as well as both shield wires are landed at the drain terminal?	NO, LANDED TO C INSTEAD.
-Wire is landed to HUM?	YES
-Wire for humidstats is landed at 24VAC R terminal on the "Sensor" strip?	YES
-Wire landed to DI-1 smoke detector?	YES
<b>OTHER</b>	
-Laminated copy of the control wiring is included in each RTU electrical cabinet as per the Controls M Sheet	YES
-Has mechanical contractor provided a second set of filters for owner (should be stored in space somewhere)	NO
-Annunciators are the specified Suncoast Keyless type?	YES
-All annunciators are labeled?	YES EXCEPT FOR AC2, WHICH IS MISSING ITS LABEL.

See M-4.1 Detail 3 for correct wiring diagram.

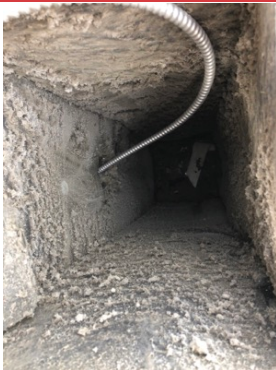
**NO BACKDRAFT DAMPER IN RR EXHAUST FAN**

Fan is also not secured to curb.

The fan is existing and installation of the back draft damper is not in the scope of work. Listing as an issue since it is a deviation from typical CFA spec.

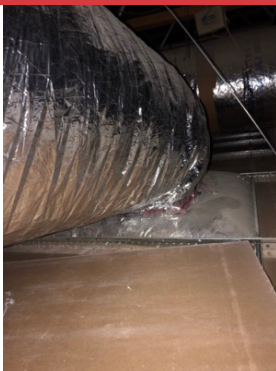
**SOME EXISTING DIFFUSERS DO NOT HAVE HARD ELBOW**

Existing ductwork in dining room area is outside of the scope of construction. Listed as it is a deviation from typical CFA spec.

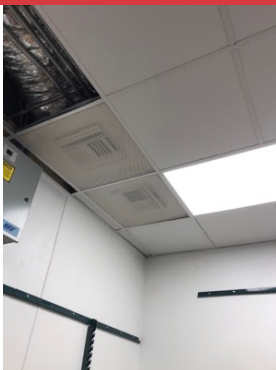
**DIFFUSERS IN MECHANICAL AREA AND KITCHEN ARE NOT PLACED EXACTLY WHERE SHOWN ON PLANS.**

Recommend installing per plan on M101.MOD

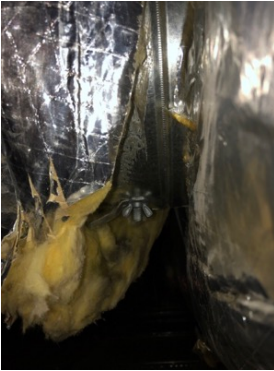
INFO ONLY	Existing ductwork has dampers on bottom of duct with no ribbon. Typical CFA design is for all damper handles to be installed on left or right side of duct and marked with fluorescent ribbon, per Start Collar Drawing Sheet M-3.1. Insulation completely covers dampers on existing ductwork. Existing ductwork in dining room area is outside of the scope of construction. Listed as it is a deviation from typical CFA spec.
INFO ONLY	There is no hard pipe after start collar on some existing ductwork. Typical CFA design is for all diffuser take-offs to have at the minimum 1' of hard duct installed per Start Collar Drawing Sheet M-3.1. Existing ductwork in dining room area is outside of the scope of construction. Listed as it is a deviation from typical CFA spec.
INFO ONLY	Existing ductwork uses more than 4' of flex in places. Typical CFA design is for a maximum of 48" of flex duct for each diffuser run per SAG/RAG/Grill Take-off Drawing Sheet M-3.1. Existing ductwork in dining room area is outside of the scope of construction. Listed as it is a deviation from typical CFA spec.

**EXISTING DUCTWORK HAS DAMPERS ON BOTTOM OF DUCT WITH NO RIBBON**

Insulation completely covers dampers on existing ductwork.

Existing ductwork in dining room area is outside of the scope of construction. Listed as it is a deviation from typical CFA spec.

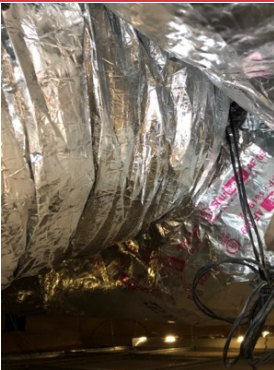
**THERE IS NO HARD PIPE AFTER START COLLAR ON SOME EXISTING DICTWORK**

Existing ductwork in dining room area is outside of the scope of construction. Listed as it is a deviation from typical CFA spec.

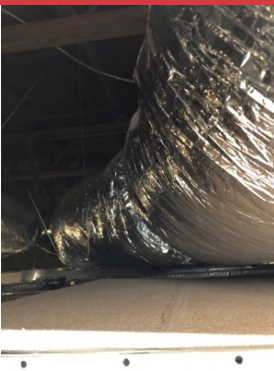
**EXISTING DUCTWORK USES MORE THAN 4' OF FLEX IN PLACES**

Existing ductwork in dining room area is outside of the scope of construction. Listed as it is a deviation from typical CFA spec.

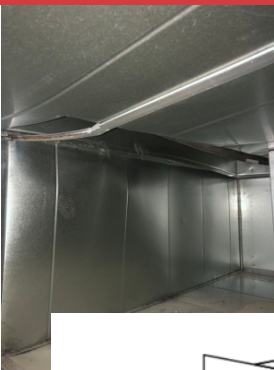
CRITICAL	AC1 return drop has a hard 90 installed that is not shown in drawings. Supply airflow is 89% AC1 and this deviation appears to be a source of restriction. See M-3.1 detail 6 for how duct should be installed. Appears the duct was installed this way due to lack of space above the ceiling. IF the duct cannot be installed per design, recommend consulting the engineer of record to determine next steps.
REVIEW + RECTIFY	More than 4' of flex on AHU1 diffusers. Plans specify a maximum of 48" of flex duct for each diffuser run per SAG/RAG/Grill Take-off Drawing. See sheet M3.1 detail 6.
REVIEW + RECTIFY	AHU1 has dampers on bottom on horizontal duct. Plans call for all damper handles to be installed on left or right side of duct and marked with fluorescent ribbon, per Start Collar Drawing. Vertically installed dampers can restrict airflow. See sheet M3.1 detail 6.
REVIEW + RECTIFY	AC2 annunciator is not labeled. Other labels do not meet specification. Install labels per Smoke Detector and Annunciator Wiring Diagram Sheet M-4.1

**AC1 RETURN DROP IS A HARD 90 WITHOUT GRADUAL ANGLE**

Airflow is low on AC1 and return drop is a hard 90. See M-3.1 detail 6. There does not appear to be room in the ceiling for proper transition.

See detail 6 on sheet M3.1. This is the largest deviation to specification that was noted.

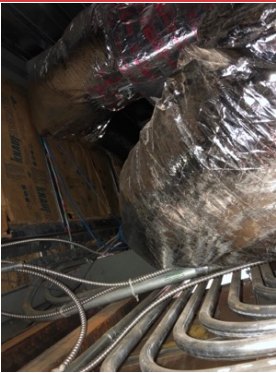
### **MORE THAN 4' OF FLEX ON AHU1 DIFFUSERS**

See sheet M3.1 detail 6.

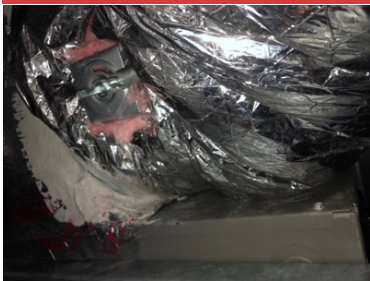
### **EXPANSION HAS DAMPERS ON BOTTOM ON HORIZONTAL DUCT**

See sheet M3.1 detail 6.

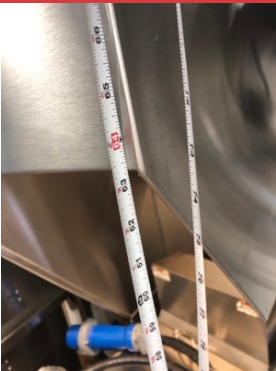
### **HOOD 3 IS HUNG AT 63.5"**

See M-6.1, detail 2, which specs 76" from floor. However, Halton hood sheets specify 64" from floor. There are two conflicting dimensions on the plans.

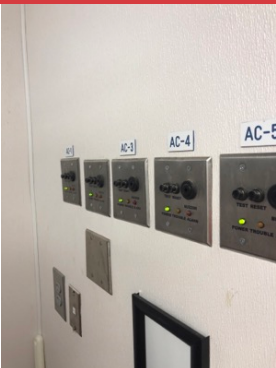
### **AC2 ANNUNCIATOR IS NOT LABELLED**
