Report: TAB REPORT
Function: Test, Adjust, & Balance
Date: 09/29/2023

PROJECT
09-25-23 CULVERS BLUE SPRINGS, MO
REVIVE

1307 MO-7

MPH Dinning

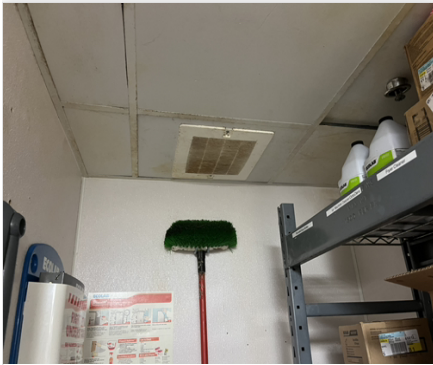
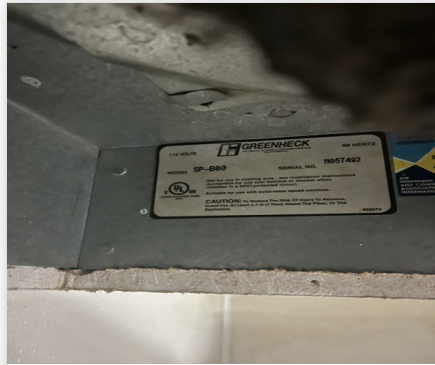
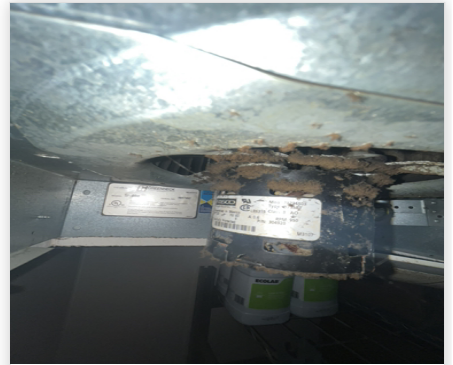
Issue Name : EF1 mop fan does not run
Description : EF1 for the mop sink was found not running. Typically there is a switch for the unit but there was no switch to be found. Recommend replacing the fan.
Created By : National TAB **Assigned To :** National TAB - Jacob Davidson
Status : Open
Originated Date : 09/29/2023 - Jacob Davidson - National TAB

Notes:
FAN DOES NOT HAVE A SWITCH AND DOES NOT RUN.

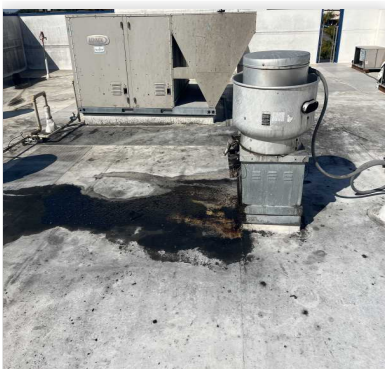
IMG_5055
09/29/2023

Issue Name : Grease spill on roof
Description : PRV1 grease spout was found out of the grease trap on the roof. Tech has corrected but there is significant grease leakage on the roof as a result. Recommend having it cleaned for safety.
Created By : National TAB **Assigned To :** National TAB - Jacob Davidson
Status : Open
Originated Date : 09/29/2023 - Jacob Davidson - National TAB

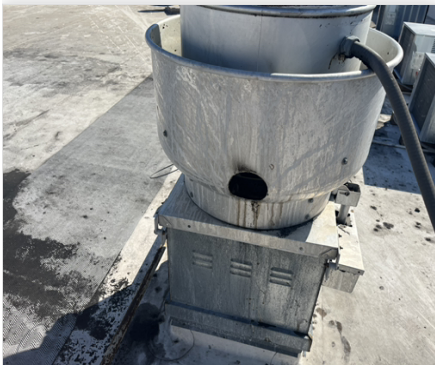
PRV1
09/29/2023

Issue Name : PRV1/PRV2 grease plug missing
Description : Grease plug is missing from both hood exhaust fans which can allow grease to fall onto the roof. Recommend replacing the grease plugs.
Created By : National TAB **Assigned To :** National TAB - Jacob Davidson
Status : Open
Originated Date : 09/29/2023 - Jacob Davidson - National TAB

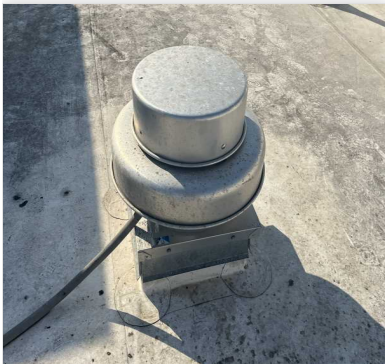
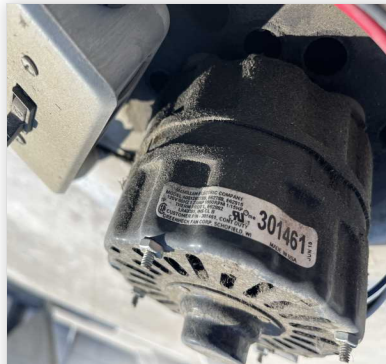
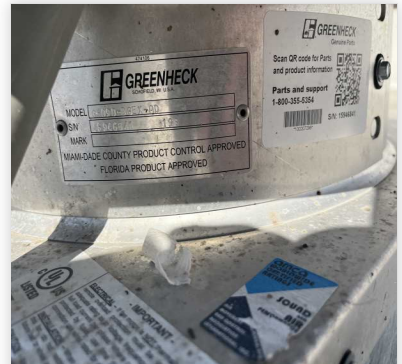
Issue Name : PRV3 restroom exhaust does not run
Description : PRV3 for restroom exhaust was found not running with the disconnect on. Recommend replacing the fan motor.
Created By : National TAB **Assigned To :** National TAB - Jacob Davidson
Status : Open
Originated Date : 09/29/2023 - Jacob Davidson - National TAB

Notes:
FAN DOES NOT RUN.

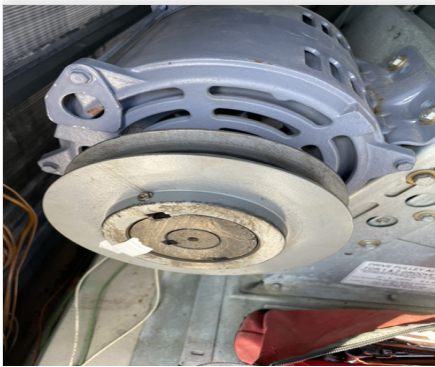
Pulley
09/29/2023

Issue Name : RTU2 motor pulley seized
Description : Motor pulley is seized and tech is unable to move the pulley in order to increase unit speed. Recommend having MC loosen the pulley to be freely adjusted.
Created By : National TAB **Assigned To :** National TAB - Jacob Davidson
Status : Open
Originated Date : 09/29/2023 - Jacob Davidson - National TAB

Notes:
MOTOR PULLEY IS SEIZED UP. TECH IS UNABLE TO INCREASE SPEED ON THE UNIT.

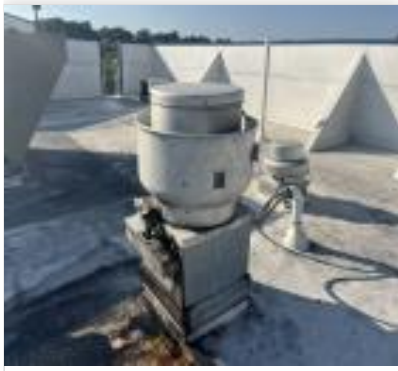
PRV1
09/29/2023

PRV1 CANNOT BE LEANED BACK DUE TO GRINDING NOISE

FAN MAKES LOUD GRINDING NOISE WHEN LIFTING FOR PRESSURES. TECH WAS UNABLE TO GET PRESSURES AS A RESULT.

Issue Name : PRV1 loud rattle when trying to lift fan
Description : When trying to lift up the fan to get pressure, the fan made a very loud rattling and grinding noise. Recommend having the fan adjusted so that it can be lifted up.
Created By : National TAB **Assigned To :** National TAB - Jacob Davidson
Status : Open
Originated Date : 09/29/2023 - Jacob Davidson - National TAB

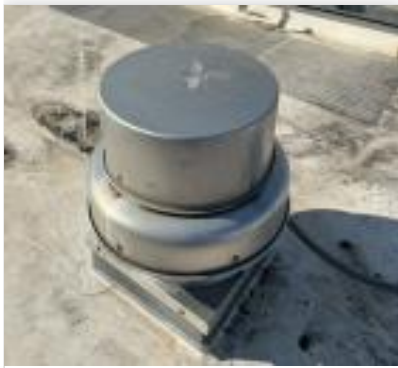
PRV4
09/29/2023

Notes:
FAN IS RUNNING. TECH IS UNABLE TO READ FAN AIRFLOW DUE TO CEILING OBSTRUCTION.

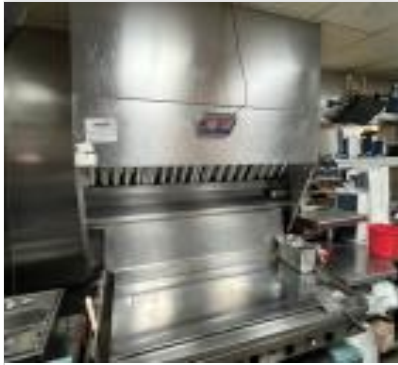
HD1
09/29/2023

Notes:
HOOD LABEL CANNOT BE READ. UNABLE TO DETERMINE MODEL OR SERIAL NUMBER.

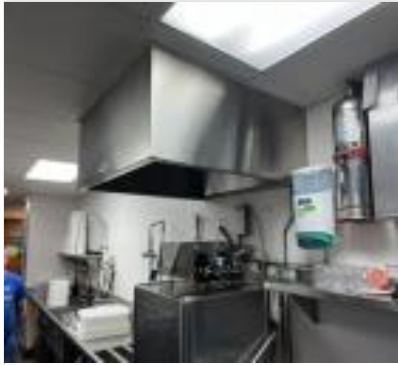
HD3
09/29/2023

Notes:
TECH IS UNABLE TO READ DUE TO CEILING OBSTRUCTION.
