Report: TAB REPORT  
Function: Test, Adjust, & Balance  
Date: 05/07/2024

## 05-06-24 SWEETGREEN WASHINGTON, DC (GEORGETOWN) REVIVE

1044 WISCONSIN AVE NW

Sweetgreen

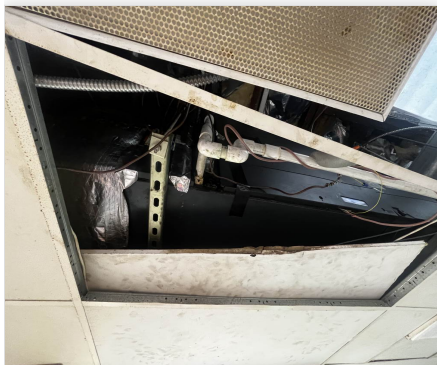
**Issue Name :** AHU-1(above BOH): Water leaking from unit  
**Description :** There was some water leaking from the unit around the condensate trap. Recommend having condensate gaps sealed.  
**Created By :** National TAB                      **Assigned To :** National TAB - David Annan  
**Status :** Open  
**Priority :** High                                      **Asset Tag :**  
**Originated Date :** 05/07/2024 - David Annan - National TAB

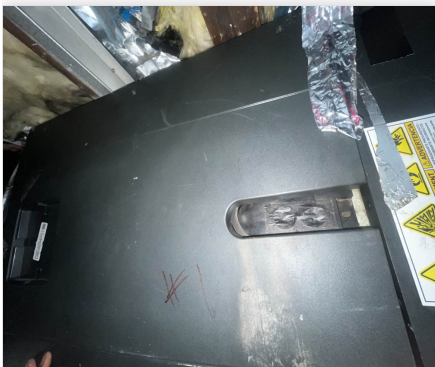
**Issue Name :** AHU-1: Air leakage around the coil compartment  
**Description :** There is air leakage around the coil compartment that is dumping a good amount of airflow above the ceiling. Recommend having all compartment panels properly sealed.  
**Created By :** National TAB                      **Assigned To :** National TAB - David Annan  
**Status :** Open  
**Priority :** Urgent                                      **Asset Tag :**  
**Originated Date :** 05/06/2024 - David Annan - National TAB

Coil compartment was not completely sealed. Air was leaking into the ceiling. Condensate leaks on ceiling tile.

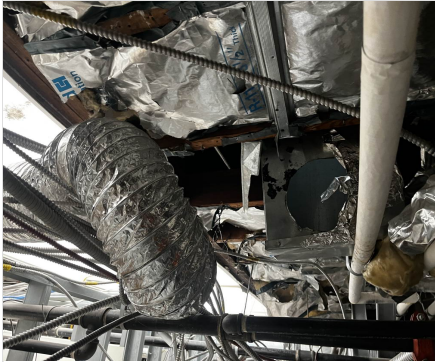
**Issue Name :** AHU-1:OA is not connected to intake  
**Description :** The OA DUCT for AHU-1 is not connected to the intake.Recommend having the duct reconnected.  
**Created By :** National TAB                      **Assigned To :** National TAB - David Annan  
**Status :** Open  
**Priority :** **Urgent**                                      **Asset Tag :**  
**Originated Date :** 05/07/2024 - David Annan - National TAB

Unable to measure due to OA duct not being fully connected to the fresh air intake.

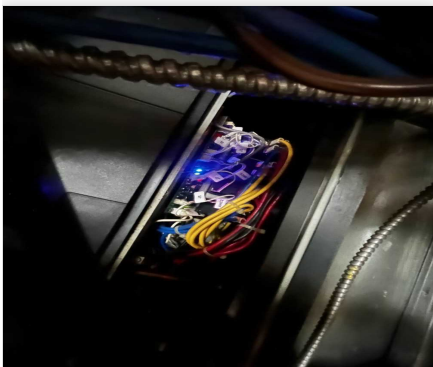
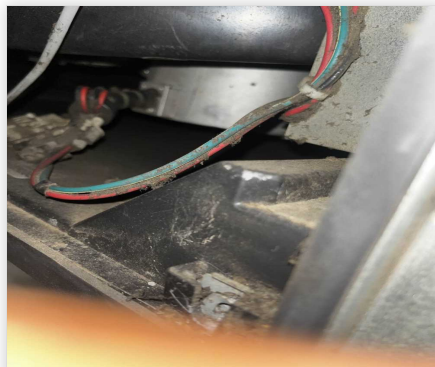
**Issue Name :** AHU-2(Above the restrooms): Was not in operation  
**Description :** AHU-2 which serves the second floor dining and office was found to not be in operation despite receiving high voltage power. Recommend having unit serviced.  
**Created By :** National TAB                      **Assigned To :** National TAB - David Annan  
**Status :** Open  
**Priority :** Urgent                                      **Asset Tag :**  
**Originated Date :** 05/07/2024 - David Annan - National TAB

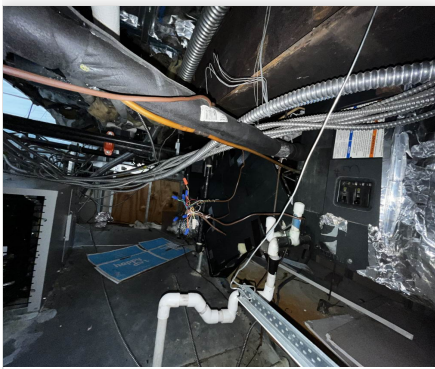
**Issue Name :** AHU-3(above the cooler): Coil compartment panel is not secured  
**Description :** The coil compartment panel is not secured properly. Resulting into majority of the airflow leaking above the cooler. Recommend having coil compartment properly secured.  
**Created By :** National TAB                      **Assigned To :** National TAB - David Annan  
**Status :** Open  
**Priority :** Urgent                                      **Asset Tag :**  
**Originated Date :** 05/07/2024 - David Annan - National TAB

Coil compartment was completely off. Was unable to reach and fully try secure the panel to prevent airflow.

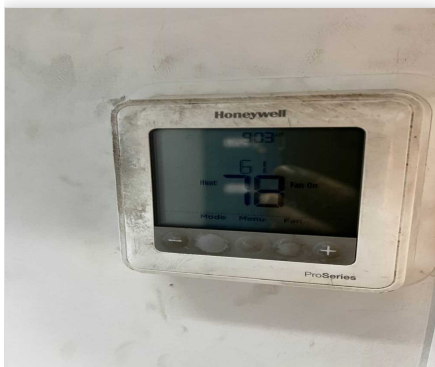
**Issue Name :** Office thermostat button is not functional  
**Description :** The office thermostat, which controls AHU-2, heating and cooling button was not working and thermostat was stuck on heating mode. Recommend having stat replaced.  
**Created By :** National TAB                      **Assigned To :** National TAB - David Annan  
**Status :** Open  
**Priority :** Urgent                                      **Asset Tag :**  
**Originated Date :** 05/07/2024 - David Annan - National TAB

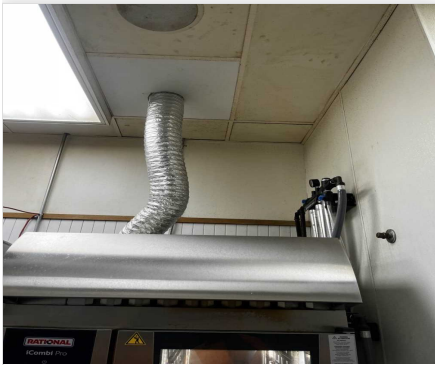
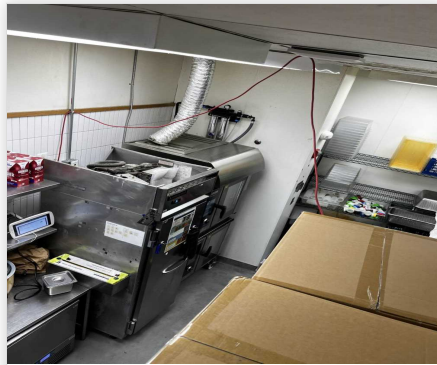
**Issue Name :** Oven: Exhaust Flex connection is not laying on oven  
**Description :** The exhaust flex connection is laying on top of the oven and is not connected to anything.  
**Created By :** National TAB **Assigned To :** National TAB - David Annan  
**Status :** Open  
**Priority :** Urgent **Asset Tag :**  
**Originated Date :** 05/07/2024 - David Annan - National TAB
