PlanGrid Task Report - Jul 22, 2025

L05434_Westerville (OH) FSU

680 Polaris Parkway, Westerville, Ohio

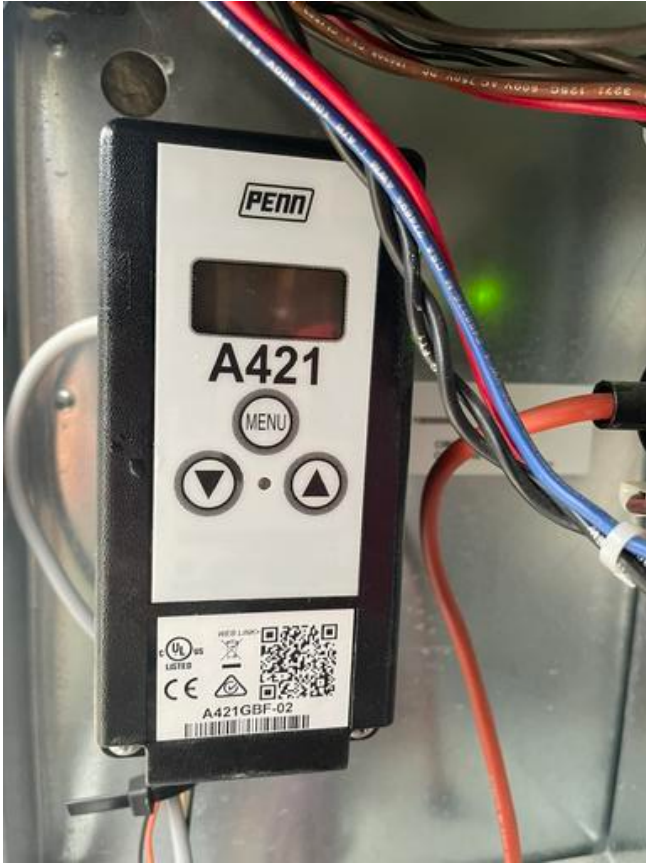
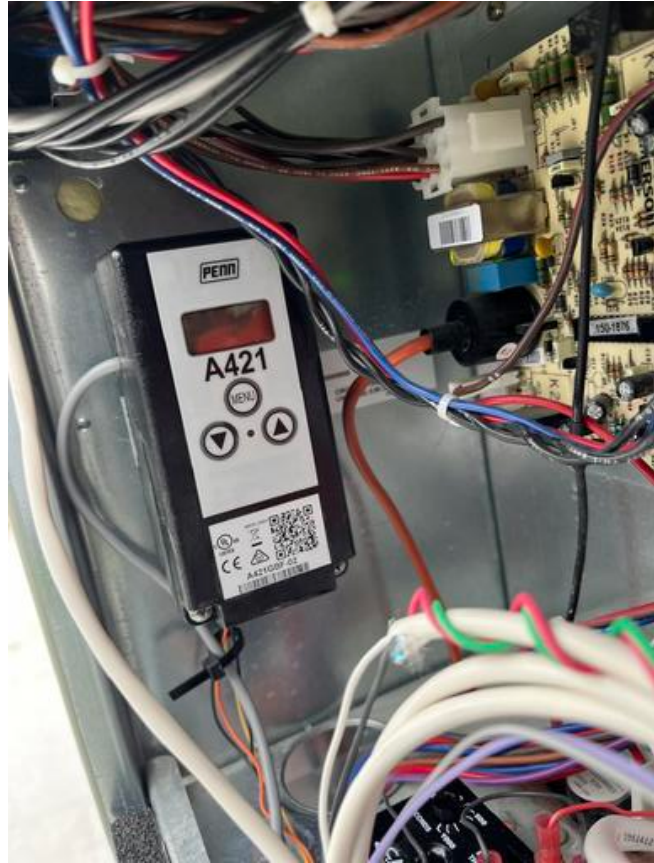
#163 [UNIT 504] [NEW] Equipment Fresh Air Tempering.

Fresh air tempering Penn controller is not powered on AC#4. Off should be set to 67 degrees, On should be set to 62 degrees, with SF turned to 0 for when the Penn controller gets power.

Return trip 05/06/25, fresh air tempering kit remains un-powered.

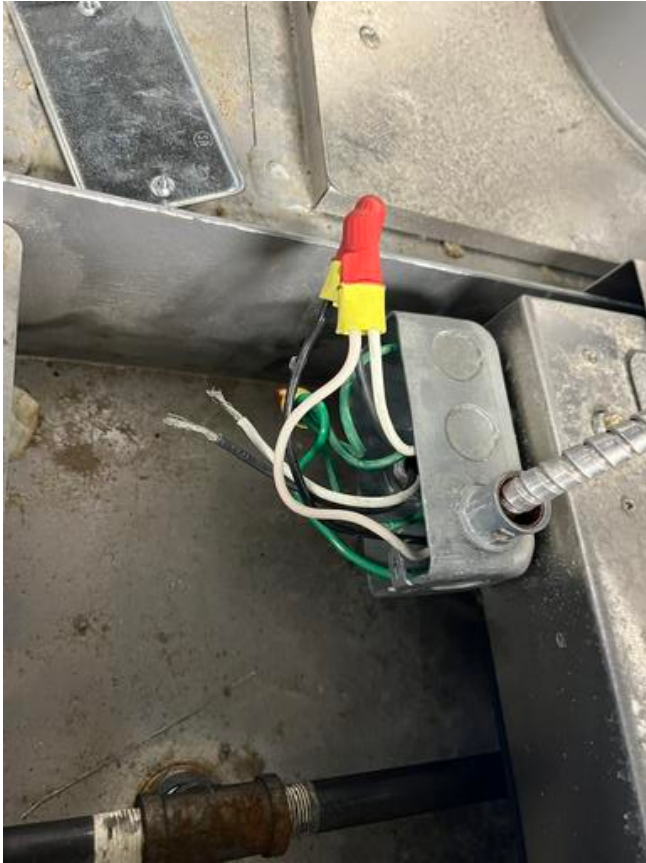
#161 [HOOD 004] [NEW] CRITICAL - CaptureJet speed controller.

CaptureJet or Side

CaptureJet speed controller

not wired.

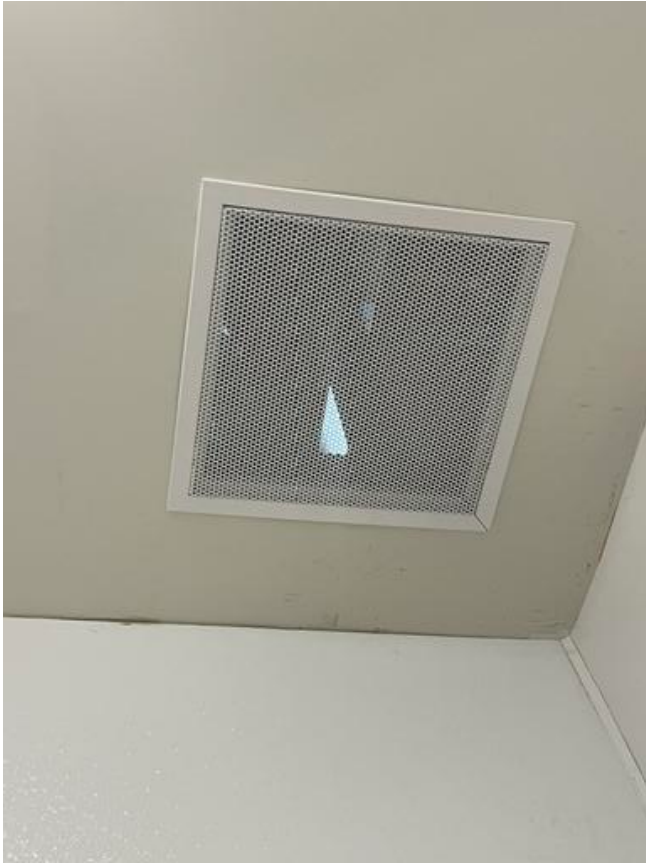
#160 [DUCT 021] [NEW] CRITICAL – Diffuser total deficiency.

RA not installed per specification. Return diffuser with no duct attached is installed in flex space. Not shown on GRD, recommended to remove diffuser and to fill space to the ceiling.

Task re-opened. No resolution documented.

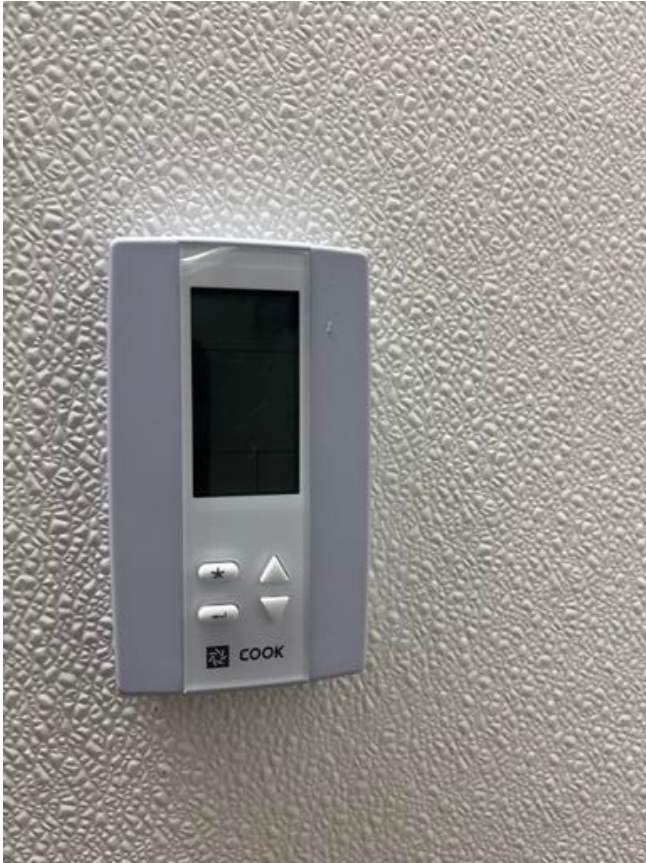
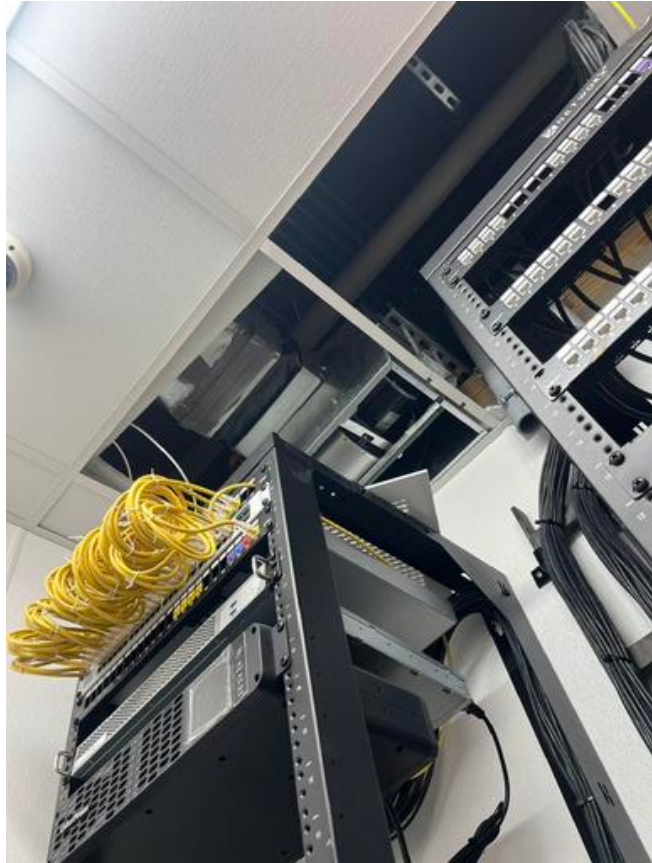
#157 [CNTL 503] [NEW] DTT Stat not operational.

DTT thermostat / fan is not powered, operational, or does not turn on / off according to set point at time of TAB inspection.

Task re-opened. No documentation of repair uploaded.

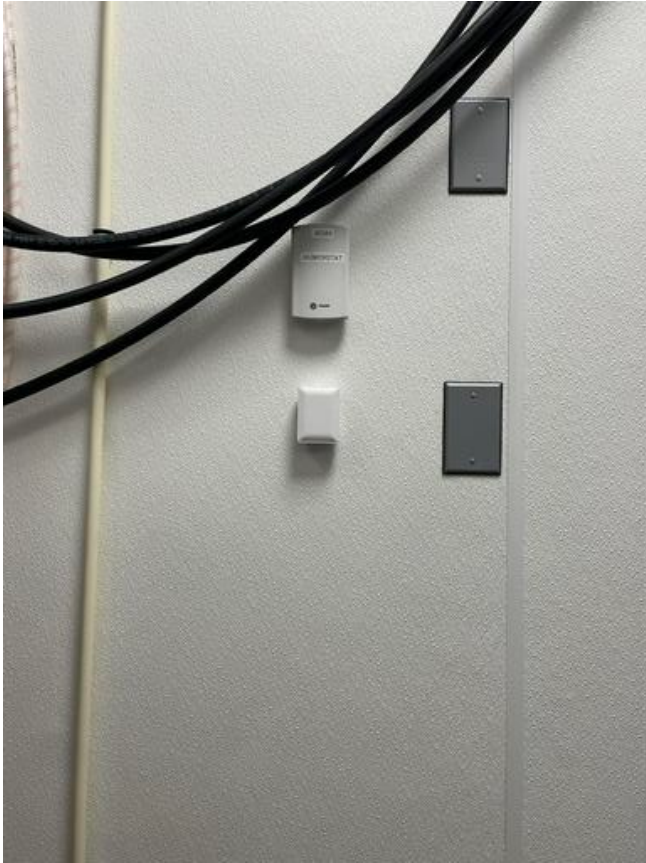
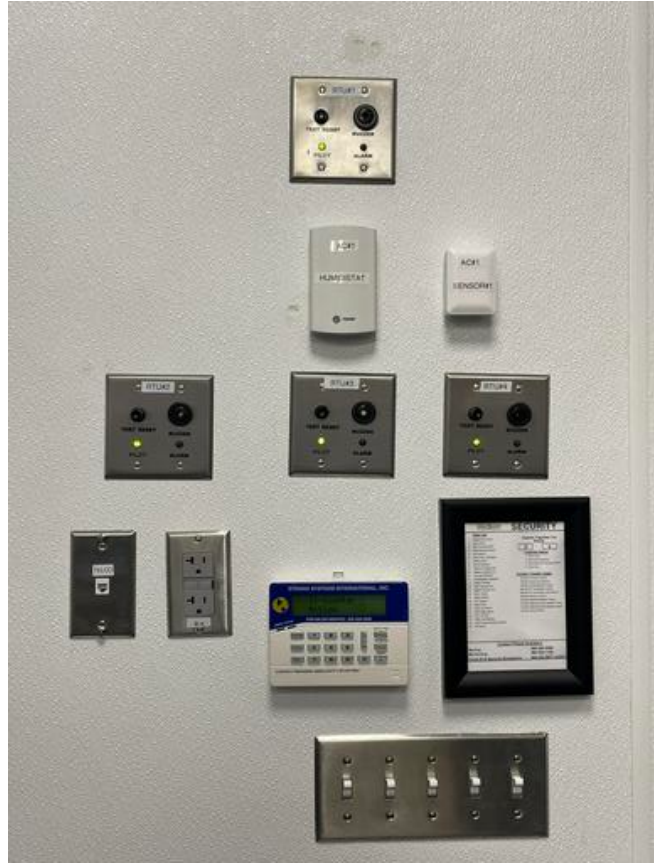
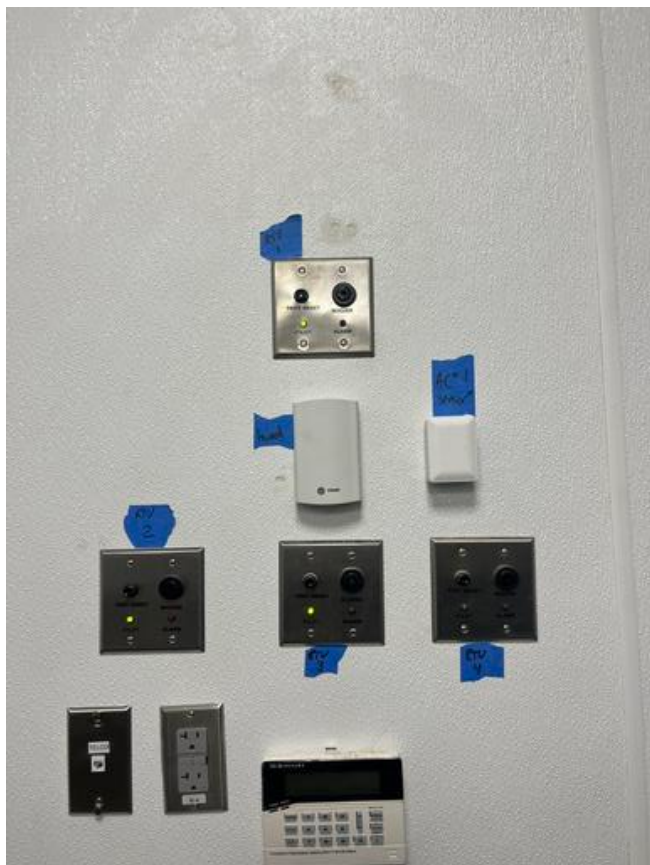
#156 [CNTL 508] [NEW] Controls labeling.

Label all sensors, humidistats, thermostats, and smoke annunciators.

All annunciators, humidistat's and temp sensors labeled excluding temp sensor for AC-4.

Sensors are labeled but not per specification. Install labels as described in mechanical plans.

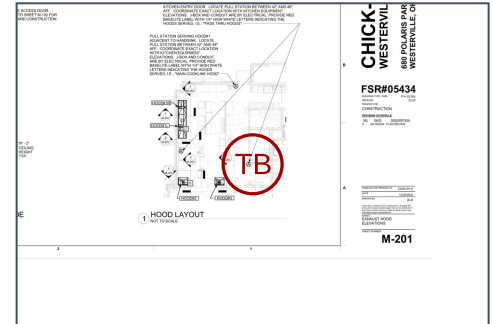
M-201

Label all ansul pull stations for which hoods they serve.

Pull station for hood 1 is labeled. Pull station for hood's 2 and 3 is not present where indicated on drawing and cannot be found anywhere in kitchen.

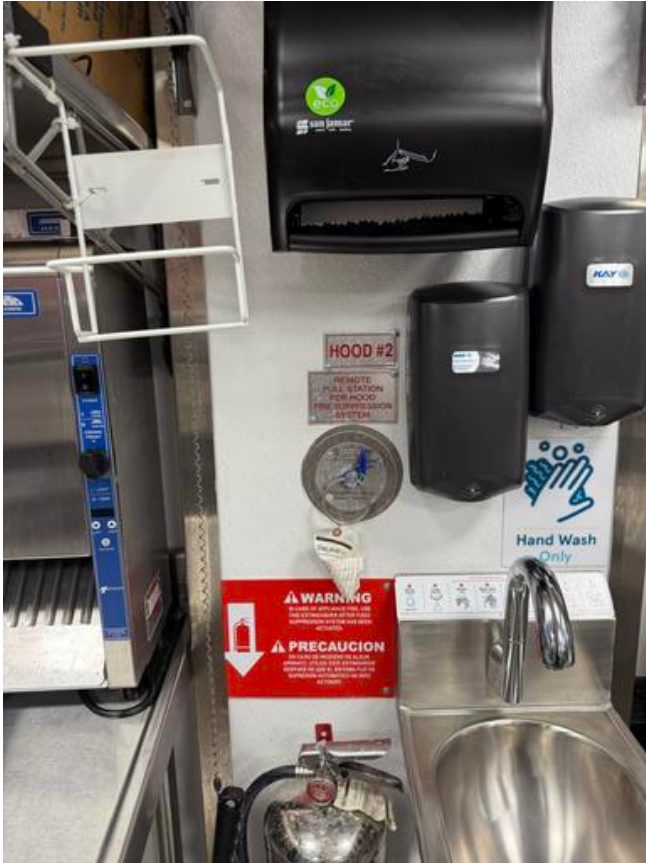
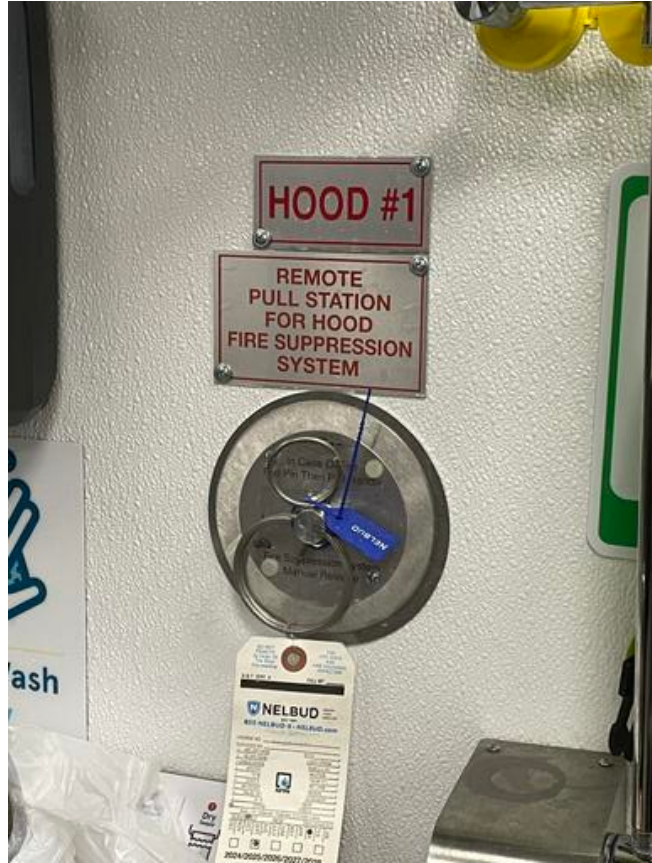
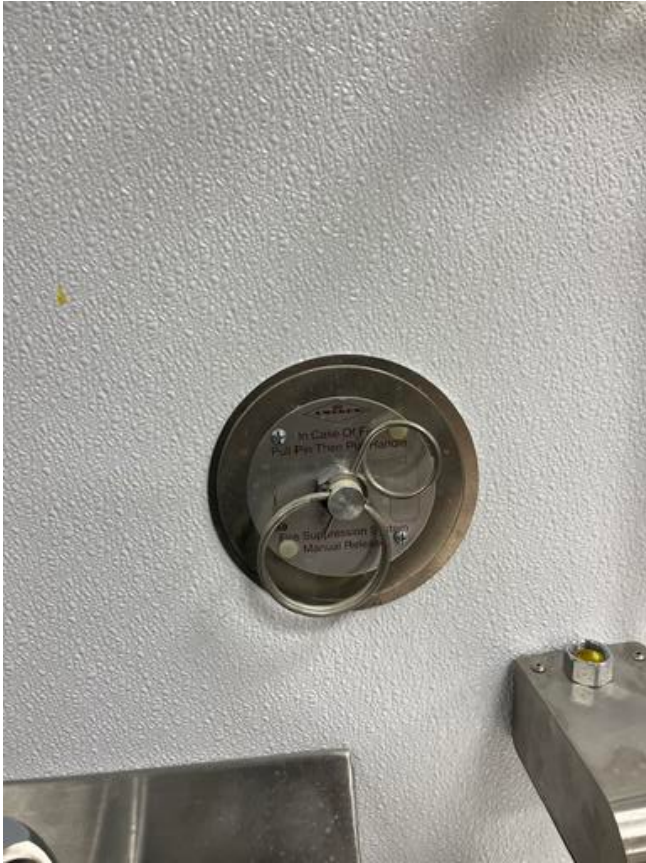
#155 [CNTL 509] [NEW] Ansul pull labeling.

Drawings indicate 2 pull stations. Both are labeled.

There are three pull stations, see attached.

No documentation of a 3rd pull station. Task remains open.

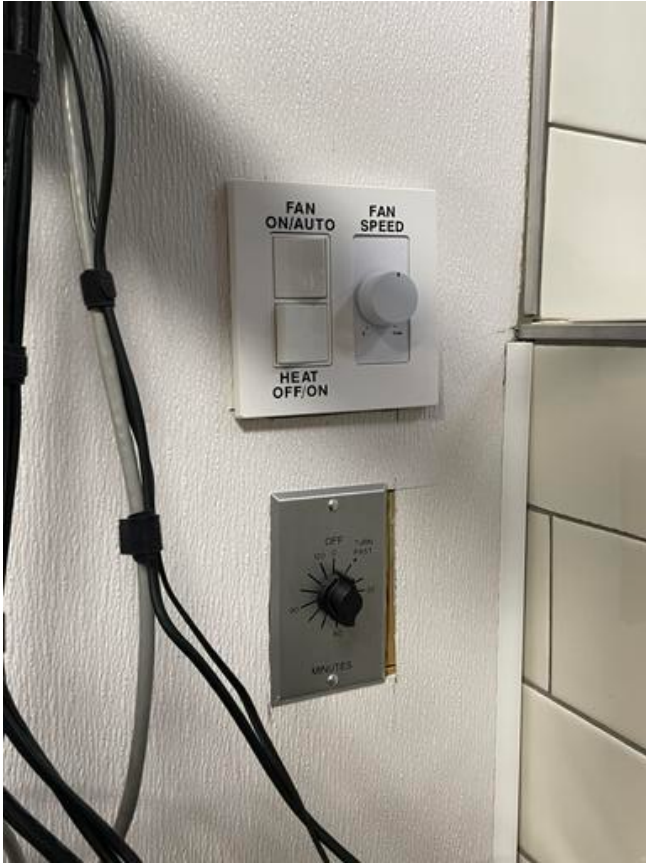
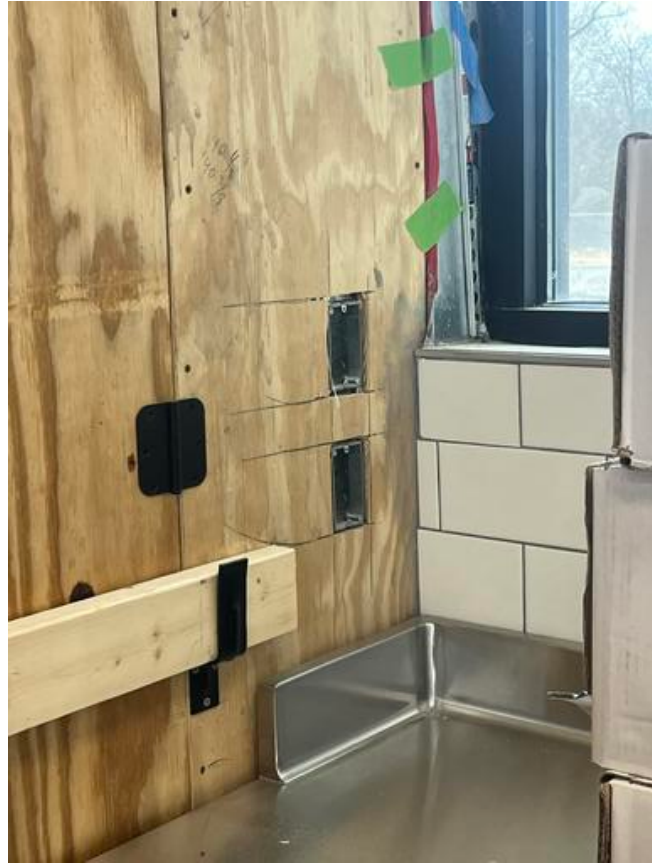
#150 [CURT 503] [NEW] Air curtain door switches.

Air curtain magnetic door switches are not installed correctly or not properly controlling mode activation in Auto at time of TAB inspection.

Switches are installed, however fan does not operate when in "auto" and drive thru door is open. Switch currently set to "on" and not "auto".

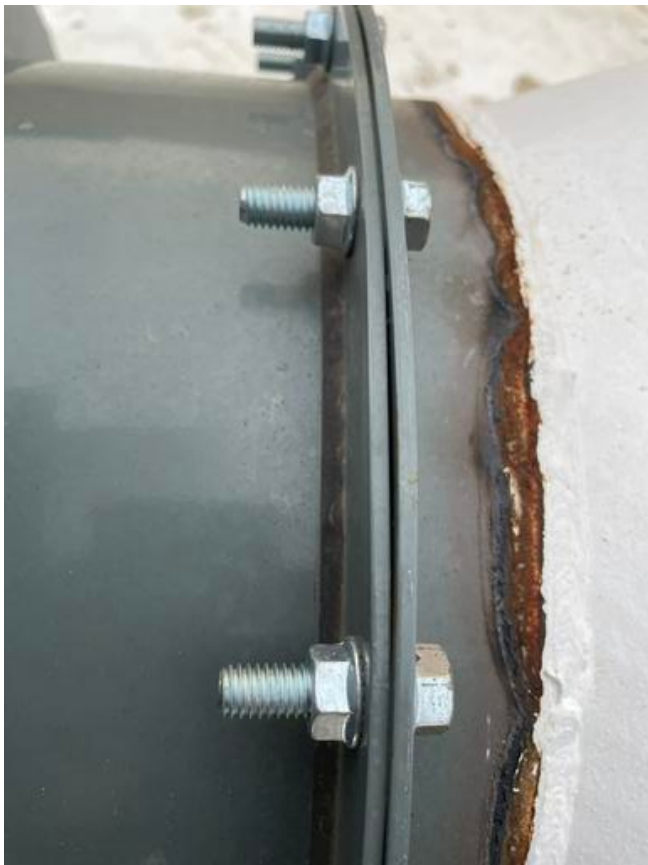
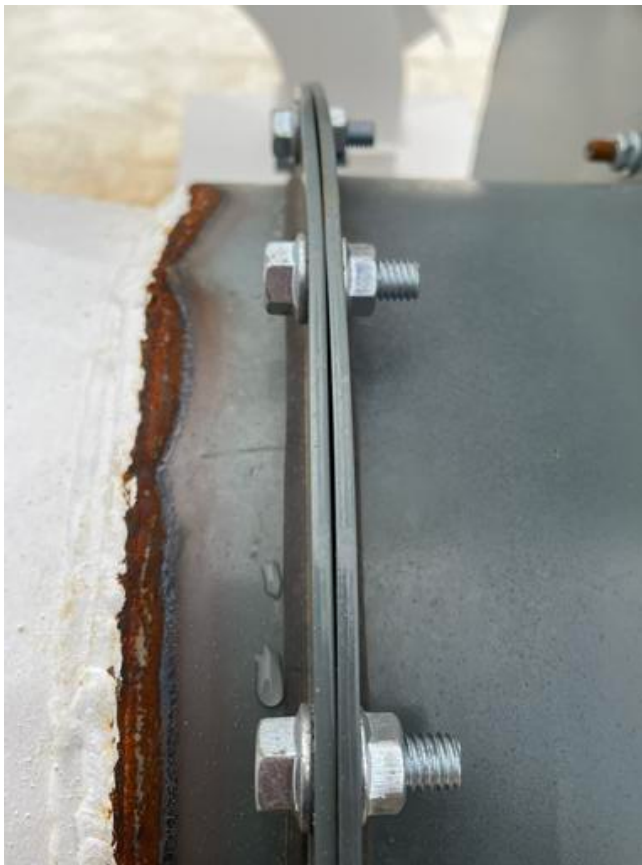
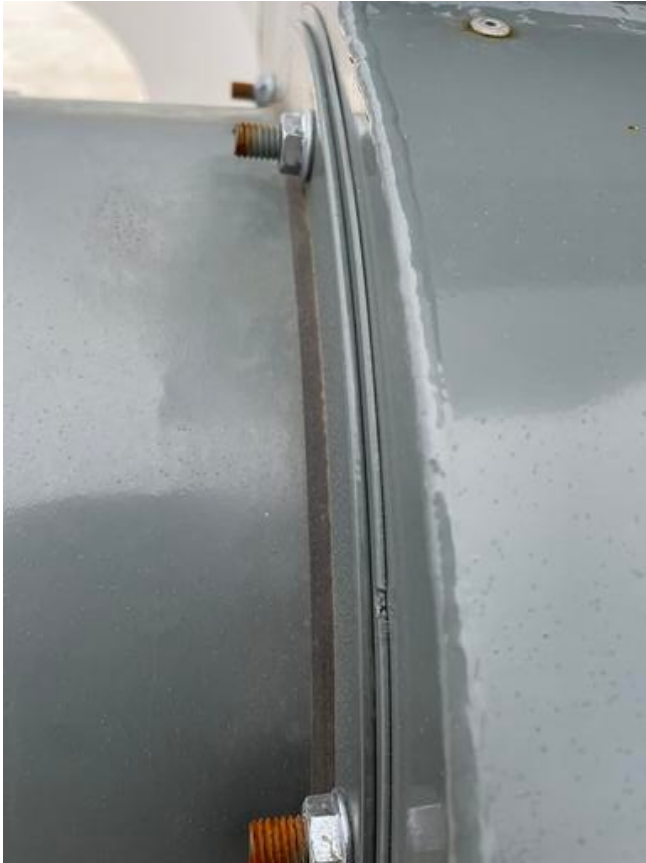
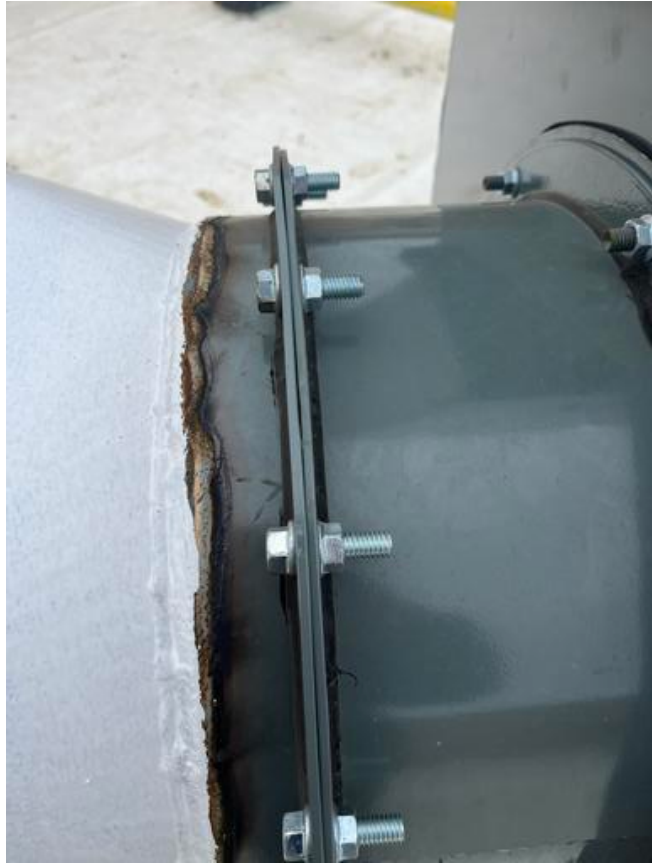
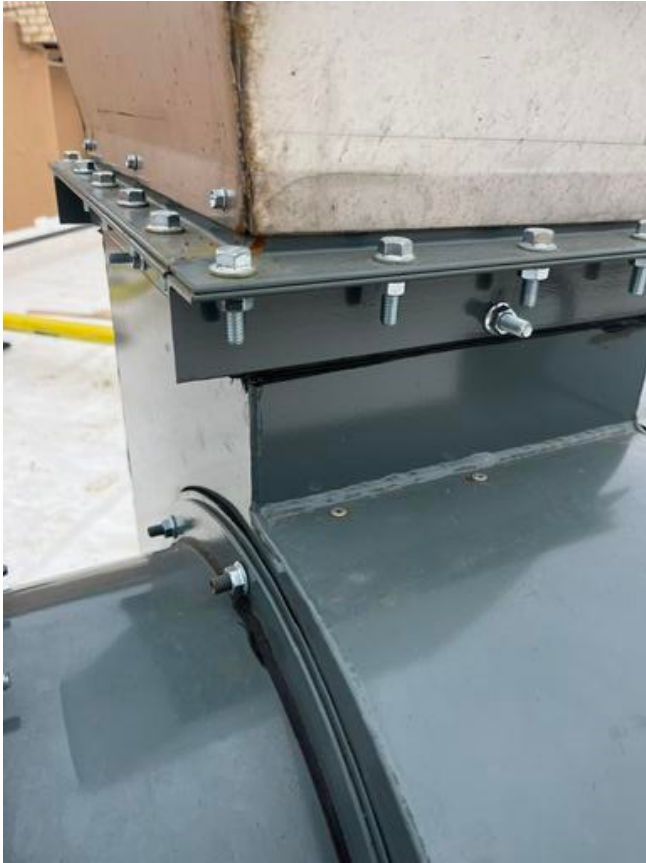
#148 [EXHA 505] [NEW] Exhaust fan 1500F gasketing.

Exhaust fan is missing
1500°F rated field provided/
installed gasketing at intake
and/or discharge companion
flange connections.

Return trip 05/06/25, exhaust fans are still missing 1500°F rated field provided/installed gasketing at intake and/or discharge companion flange connections.

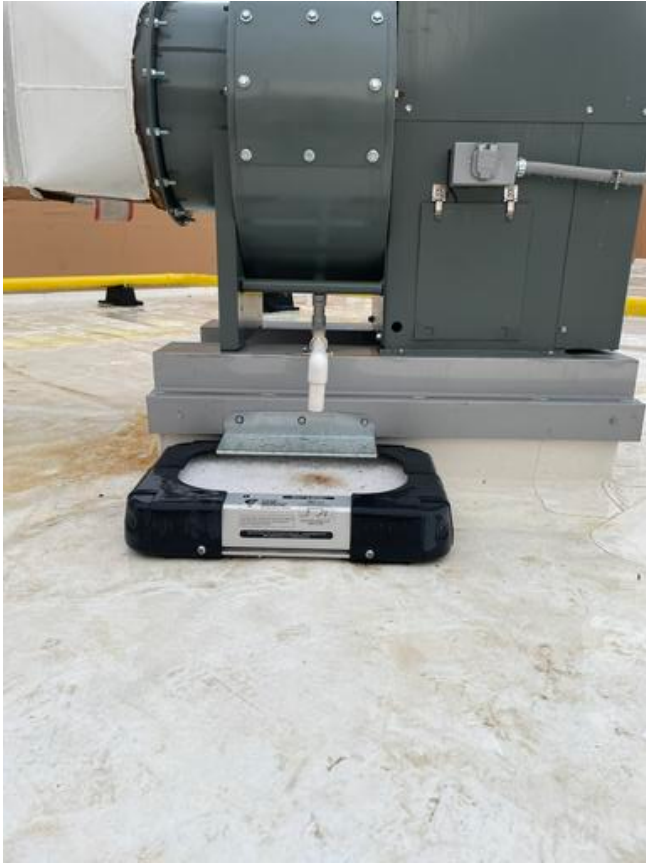
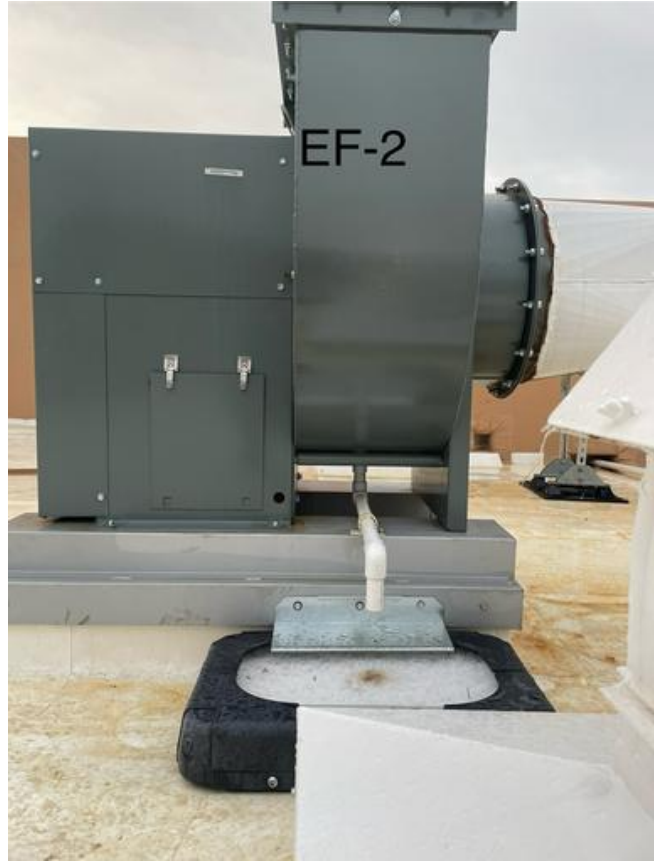
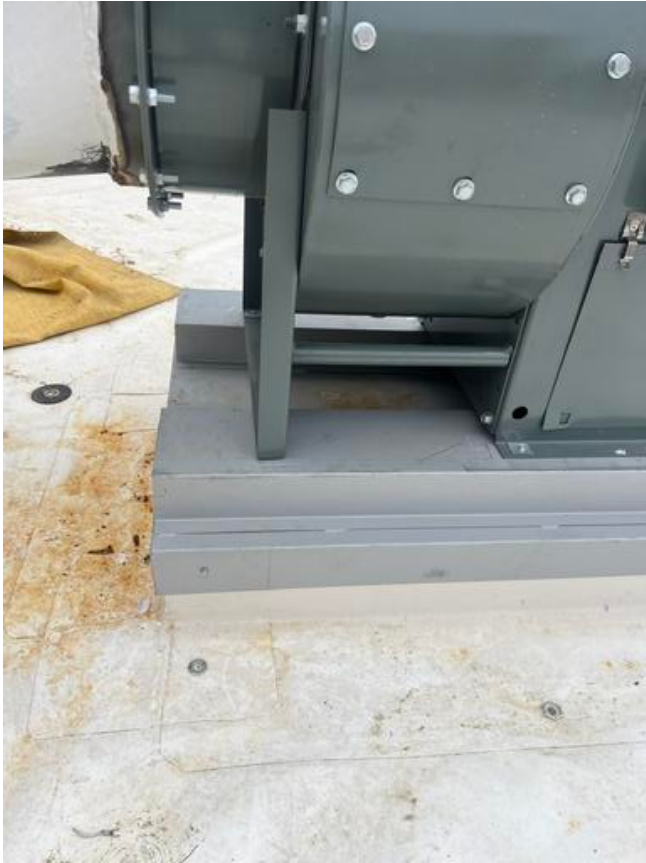
#147 [EXHA 507] [NEW] Exhaust fan drain line.

Exhaust fan drain is not installed, pitched, or routed to center of drip guard per detail.

Both fans have drains installed however, drain for EF-2 is pitched up up-slope. Recommend relocating drain and G2 drip guard to other side.

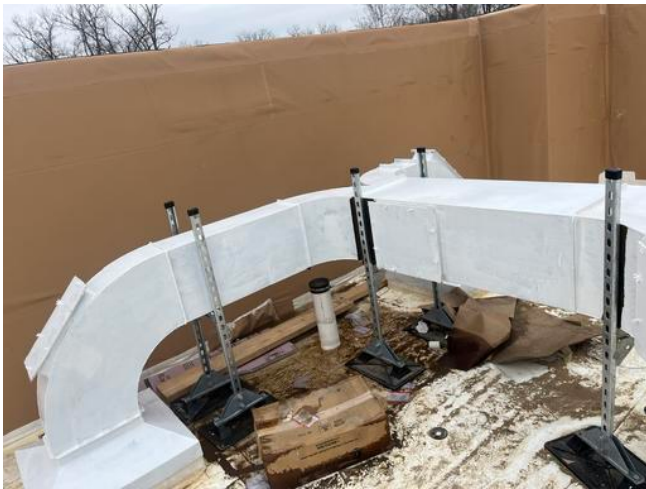
#145 [EXHA 511] [NEW] Grease exhaust duct curb cap.

Grease duct curb cap is to be screwed at all corners along with a full perimeter weld between curb cap and duct.

Task re-opened. No documentation of repair uploaded.

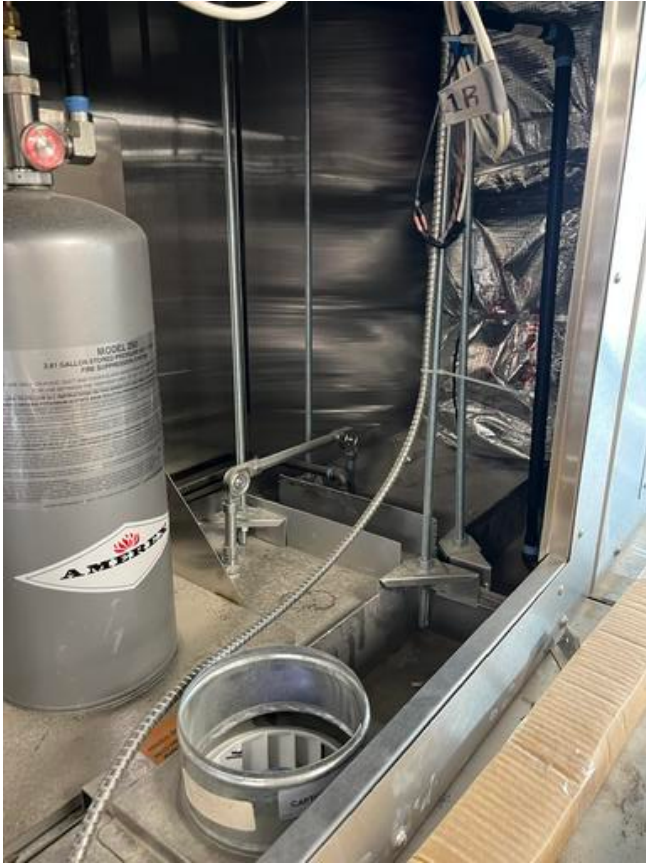
#144 [HOOD 507] [NEW] CaptureJet piping.

CaptureJet duct is to be hard piped and sealed at seams up to intake grilles. Intake grilles are to remain unobstructed and removable by Operator for cleaning.

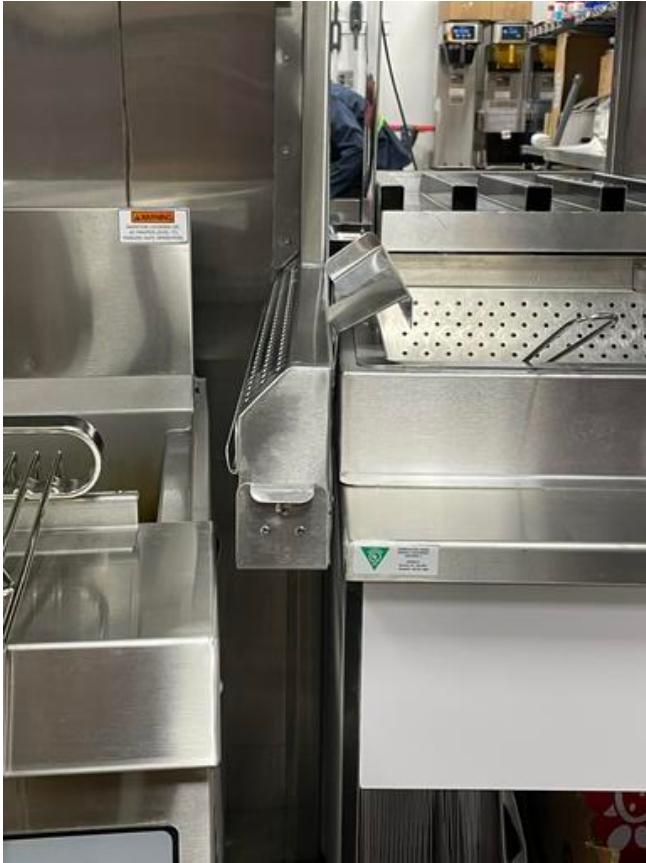
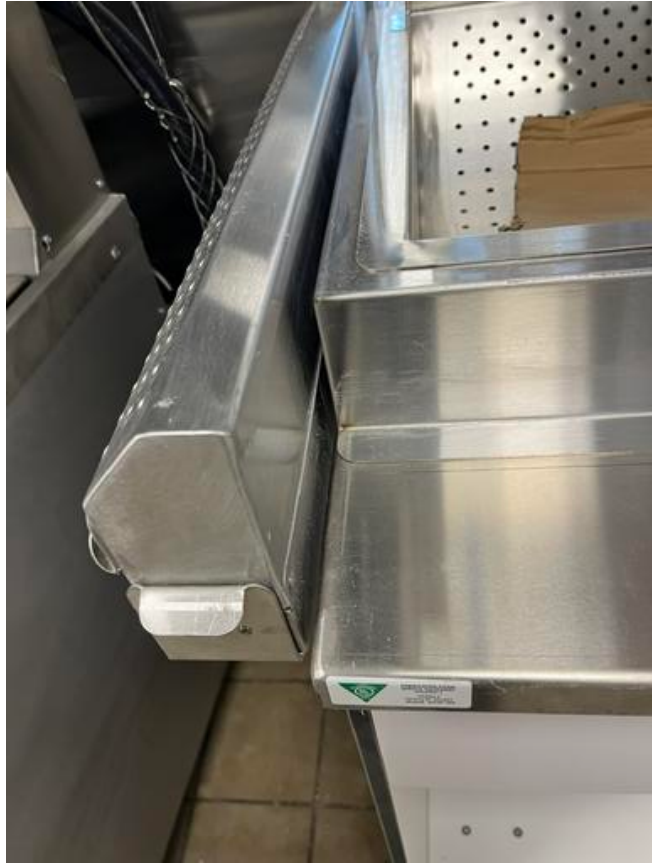
#143 [HOOD 508] [NEW] Sidejet arm angle bracket.

The Halton supplied angle bracket that connects the integral sidejet arm to the counter is missing or not installed correctly. Secure bracket to arm and bracket to counter underneath removeable fry dump via stainless steel rivets.

Angle bracket connecting side jet arm to counter not installed on hood 2

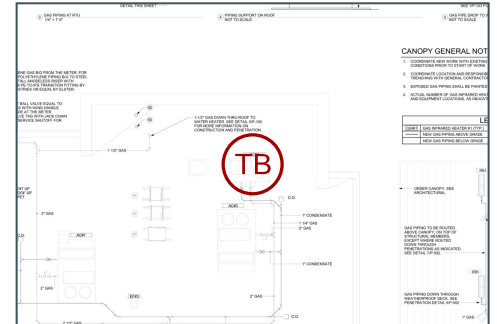
P-105

Equipment condensate piping pitch is not sloped correctly downward away from the unit. No stands installed for condensate piping.

Condensate drain supported with stands and pitched correctly. However, condensate drain should exit from AC-4 on side nearest AC-3 instead of from back of unit.

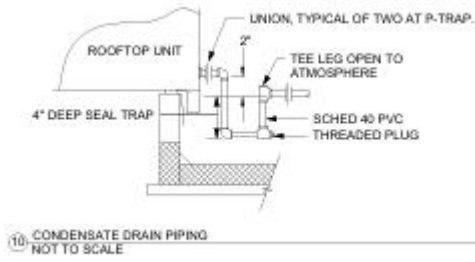
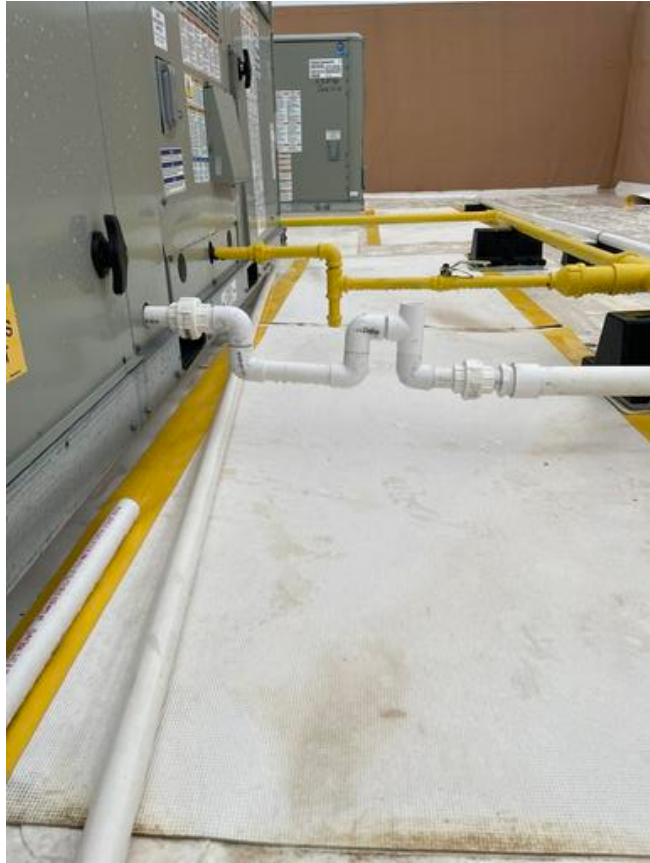
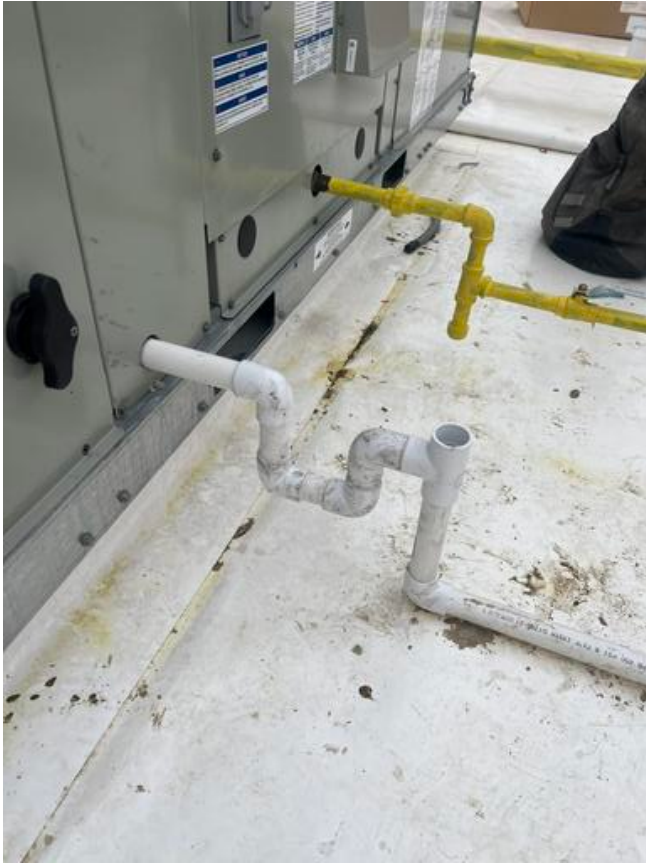
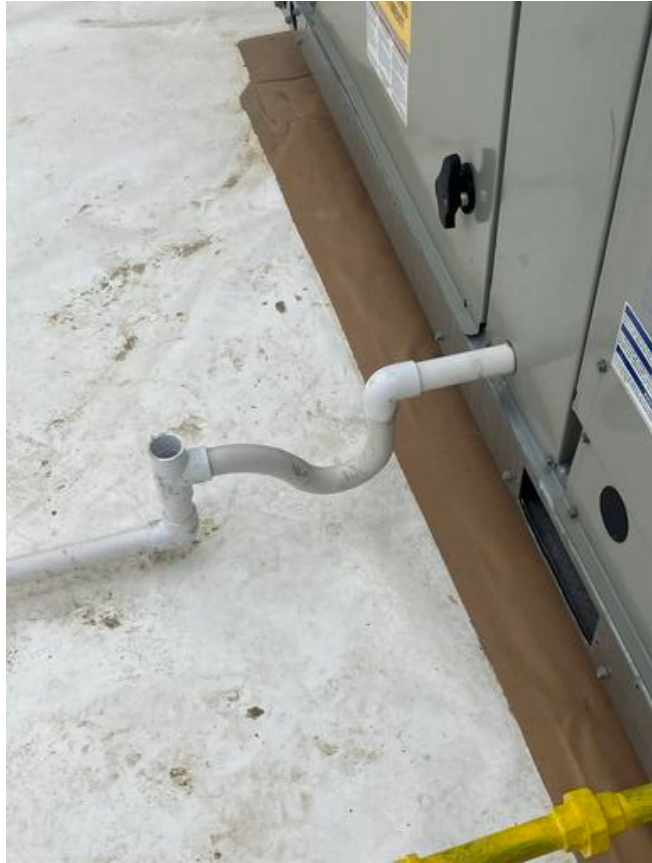
#140 [UNIT 517] [NEW] Condensate piping construction.

Equipment condensate piping or p-trap is not constructed per normal CFA specifications.

P-trap meets specifications.

Correction, P-trap is not per CFA specifications. Task re-opened.

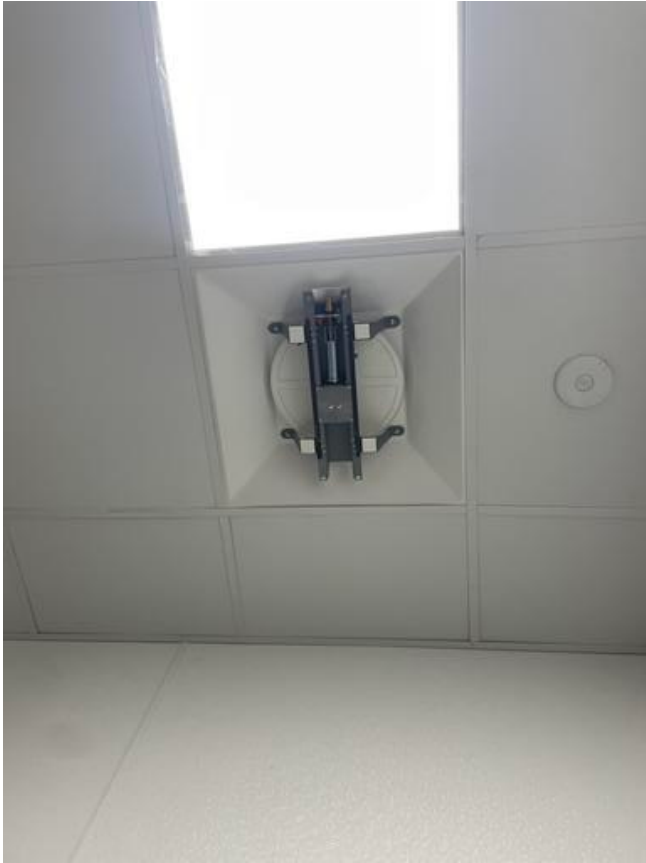
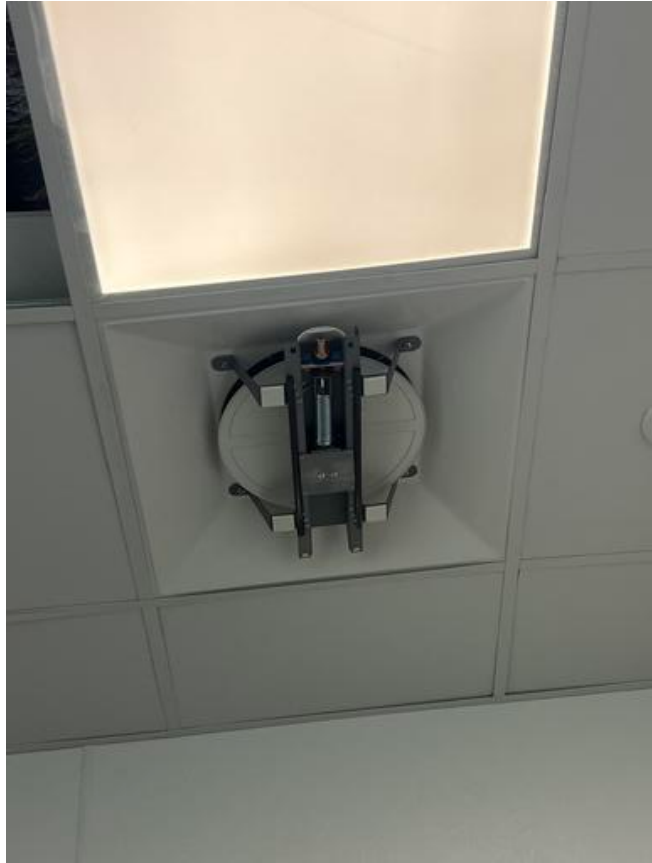
#139 [DUCT 500] [NEW] Air pattern deflections.

Air pattern deflections are missing on Diffuser 4-4 in office.

Air pattern deflections remain missing on Diffuser 4-4 in office.

The bottom plate that covers the controls is missing. It looks like a large white square deflector.

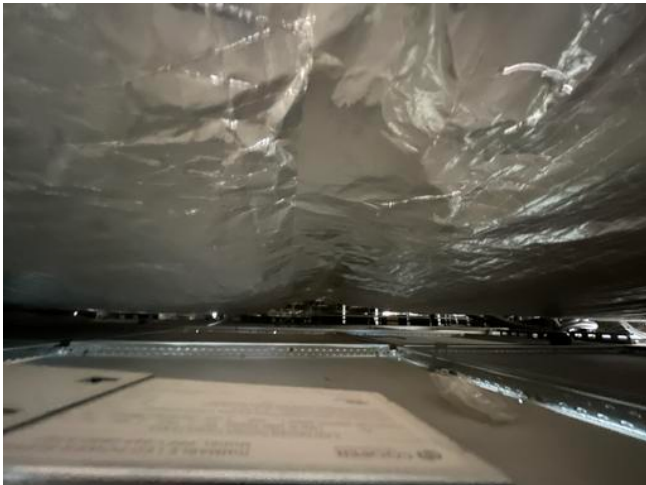
#138 [DUCT 501] [NEW] Insulation stick pins.

External insulation on bottom of ducts 24" or wider is to be supported by stick pins 18" on center. Cut pins and apply tape or mastic over stick pin washers.
