Report: TAB Report
Function: Test, Adjust, & Balance
Date: 10/27/2023

10-23-23 WALGREENS #11134 - SMYRNA, DE

Walgreens

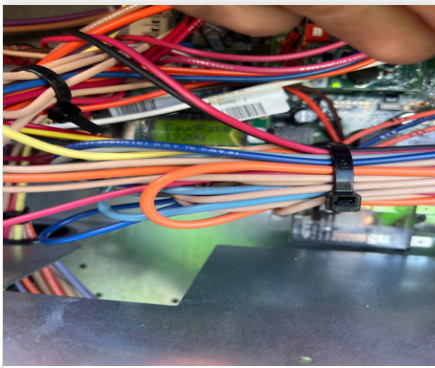
Baudrate
10/25/2023

Issue Name : CONTROLLER: Baud rate setting
Description : Baudrate setting not set to auto. All units set to 19200
Created By : National TAB **Assigned To :** National TAB - Tyler Youells
Status : Open
Priority : **Asset Tag :**
Originated Date : 10/25/2023 - Tyler Youells - National TAB

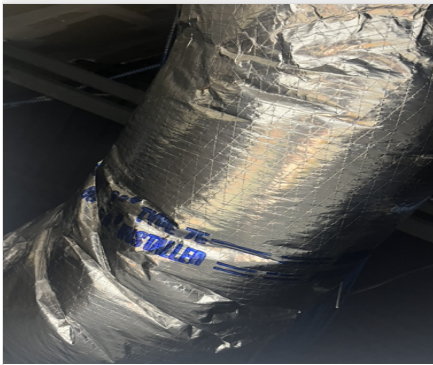
**Missingdamper62
01/02/2024**

Issue Name : DIFFUSER 6-2 NO DAMPER
Description : Diffuser 6-2 does not have a damper installed. Unable to proportionally balance diffusers
Created By : National TAB **Assigned To :** National TAB - Tyler Youells
Status : Open
Priority : **Asset Tag :**
Originated Date : 01/02/2024 - Tyler Youells - National TAB

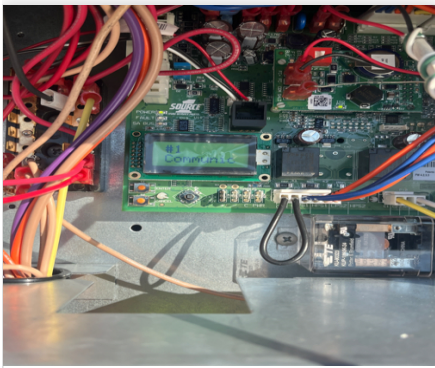
Communicationerror.jp..
10/25/2023

Issue Name : RTU's 2, 4, 5: COMMUNICATION ERROR
Description : Rtu-2, 4, &5 have a stage 4 communication error alarm.
Created By : National TAB **Assigned To :** National TAB - Tyler Youells
Status : Open
Priority : **Asset Tag :**
Originated Date : 10/25/2023 - Tyler Youells - National TAB
