**Report: TAB Report**  
**Function: Test, Adjust, & Balance**  
**Date: 01/03/2024**

## 10-23-23 WALGREENS #11134 - SMYRNA, DE

Walgreens

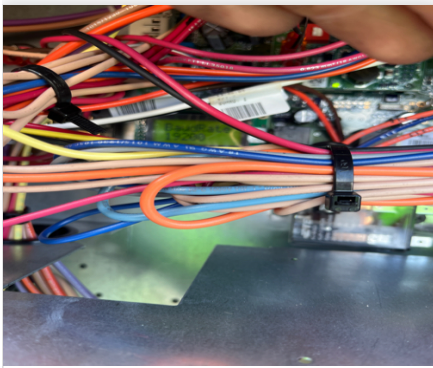
**Baudrate**  
**10/25/2023**

**Issue Name :** CONTROLLER: Baud rate setting  
**Description :** Baudrate setting not set to auto. All units set to 19200  
**Created By :** National TAB                      **Assigned To :** National TAB - Tyler Youells  
**Status :** Open  
**Priority :**    **Asset Tag :**  
**Originated Date :** 10/25/2023 - Tyler Youells - National TAB

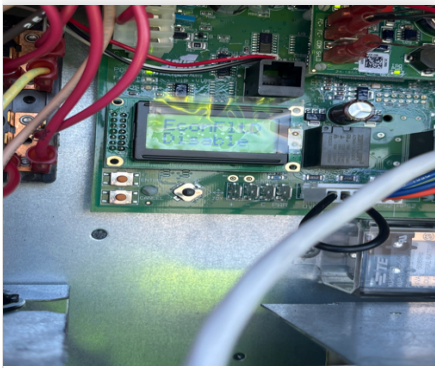
**Econfitdetect  
10/25/2023**

**Issue Name :** CONTROLS: EconFitDetectEn  
**Description :** Econ fit detect En is set to disabled when it should be enabled.  
**Created By :** National TAB                      **Assigned To :** National TAB - Tyler Youells  
**Status :** Open  
**Priority :**    **Asset Tag :**  
**Originated Date :** 10/25/2023 - Tyler Youells - National TAB

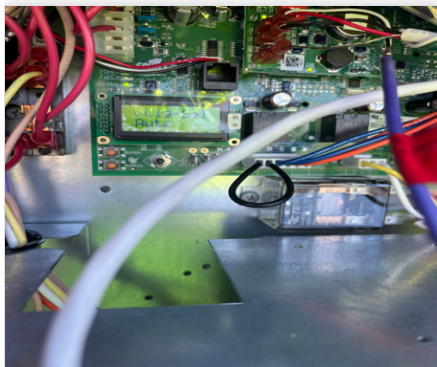
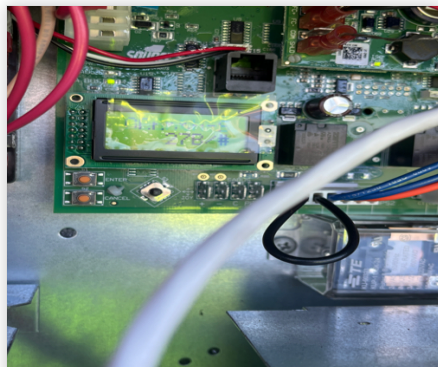
**Issue Name :** CONTROLS: Enthalpy reference  
**Description :** Under Econ free cooling selection it is set to auto for all units when it should be set to single enthalpy. All enthalpy engage setpoints are 27B/# when they should be 24B/#  
**Created By :** National TAB                      **Assigned To :** National TAB - Tyler Youells  
**Status :** Open  
**Priority :**    **Asset Tag :**  
**Originated Date :** 10/25/2023 - Tyler Youells - National TAB

**Selection auto**  
**10/25/2023**

**Enthalpy engage setpoint..**  
**10/25/2023**

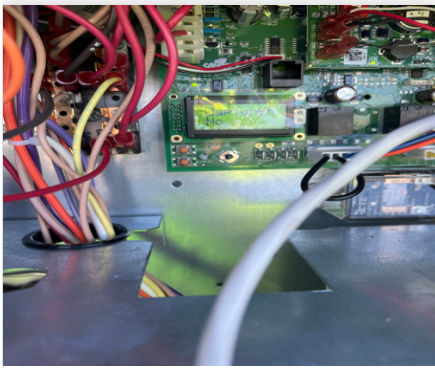
Htgadaptunen  
10/25/2023

**Issue Name :** CONTROLS: HtgAdapTunEn  
**Description :** Heating adap Tun En has not been set to yes for all units  
**Created By :** National TAB                      **Assigned To :** National TAB - Tyler Youells  
**Status :** Open  
**Priority :**    **Asset Tag :**  
**Originated Date :** 10/25/2023 - Tyler Youells - National TAB

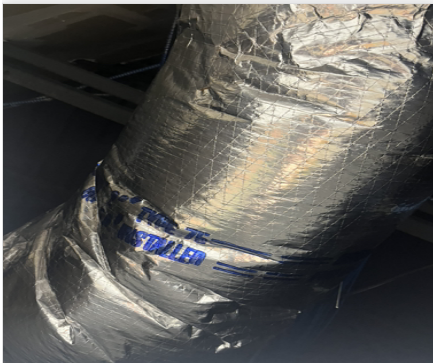
**Missingdamper62  
01/02/2024**

**Issue Name :** DIFFUSER 6-2 NO DAMPER  
**Description :** Diffuser 6-2 does not have a damper installed. Unable to proportionally balance diffusers  
**Created By :** National TAB                      **Assigned To :** National TAB - Tyler Youells  
**Status :** Open  
**Priority :**    **Asset Tag :**  
**Originated Date :** 01/02/2024 - Tyler Youells - National TAB

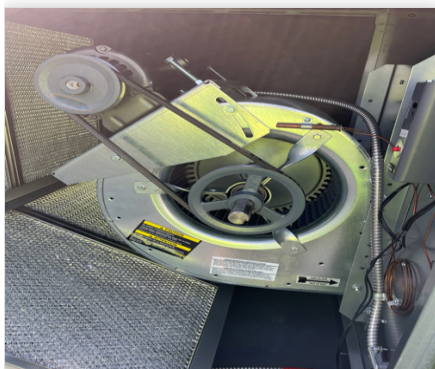
**Blowerwontstayon  
10/26/2023**

**Issue Name :** EH-1 Not running correctly  
**Description :** Found flow was extremely low and blower rotation incorrect. Flipped phases and confirmed correct rotation now blower will kick on for two seconds then shut off, back on then off. Unable to balance unit  
**Created By :** National TAB                      **Assigned To :** National TAB - Tyler Youells  
**Status :** Open  
**Priority :** Urgent                                      **Asset Tag :**  
**Originated Date :** 10/26/2023 - Tyler Youells - National TAB

- **01/03/2024 National TAB - Tyler Youells**
  - On return trip, unit switch was turned back on. unit still would not run. the blower would not turn on and stay on when the contactor was pushed in and made terrible noise. still unable to balance the unit.

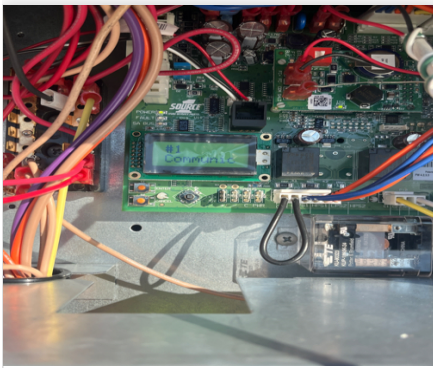
Communicationerror.jp..  
10/25/2023

**Issue Name :** RTU's 2, 4, 5: COMMUNICATION ERROR  
**Description :** Rtu-2, 4, &5 have a stage 4 communication error alarm.  
**Created By :** National TAB                      **Assigned To :** National TAB - Tyler Youells  
**Status :** Open  
**Priority :**    **Asset Tag :**  
**Originated Date :** 10/25/2023 - Tyler Youells - National TAB

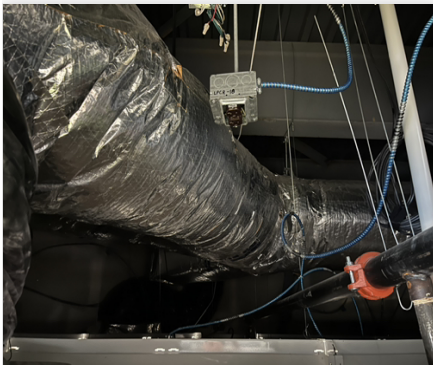
**Nodamper(1)**  
**10/26/2023**

**Issue Name :** RTU-1 Diffuser 3 No damper  
**Description :** Diffusers is attached to the termination of the main trunkline and there is no visible damper. Flow is high above prescribed 700CFM (851/700cfm). Diffuser is located in front of vestibule, so higher airflow may be preferred. Walgreens/Sevan to advise.  
**Created By :** National TAB                      **Assigned To :** National TAB - Tyler Youells  
**Status :** Open  
**Priority :**    **Asset Tag :**  
**Originated Date :** 10/26/2023 - Tyler Youells - National TAB

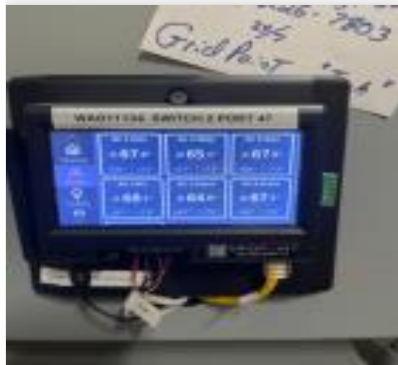
**Tempsetpoints  
01/02/2024**

**Issue Name :** Temperature Setpoints  
**Description :** Temperature setpoints do not match provided ashrae chart. GRIDPOINT does not authorize me to change them. Recommend authorized personnel to adjust the temperature setpoints. Note most setpoints are only off by 1 Degree  
**Created By :** National TAB                      **Assigned To :** National TAB - Tyler Youells  
**Status :** Open  
**Priority :**    **Asset Tag :**  
**Originated Date :** 01/02/2024 - Tyler Youells - National TAB

Temperature setpoints must be set using provided charts are based on state and space that each RTU serves. Confirm with controls company that these are set correctly
