**Report: TAB REPORT**  
**Function: Test, Adjust, & Balance**  
**Date: 06/20/2024**

**PROJECT**  
**06-17-24 CULVERS - STURTEVANT, WI**  
**(REIMAGE)**

Project: 06-17-24 CULVERS - STURTEVANT, WI (REIMAGE)

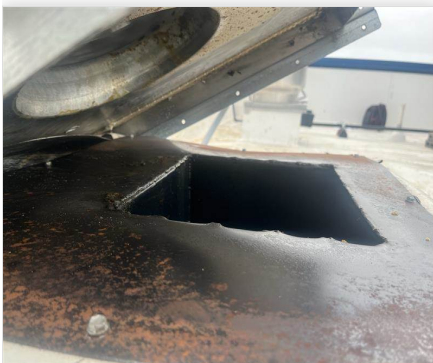
PRV\_2\_MISALIGNED  
06/20/2024

**Description :** Exhaust fans are not centered over the grease exhaust duct / the duct is not centered in the curb. Appears this is from the original installation of the duct. Both exhaust fans are performing at design airflow, but require much higher than typical setpoints due to misalignment. Recommend curb is reconfigured so fan and grease duct properly align.

- **06/20/2024 National TAB - Michael McDonnell**
  - Both exhaust fans are set to much higher than typical setpoints. Once alignment is corrected, exhaust airflow will likely increase significantly. Recommend NTAB is consulted to readjust setpoints.

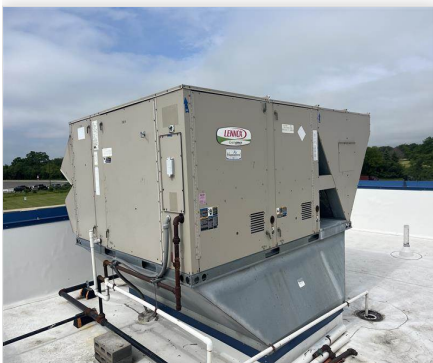
RTU\_2\_kitchen\_  
06/20/2024

The unit is significantly low on airflow, operating at 66% of the airflow it should be providing. The unit could not be sped up during our visit because the motor sheave is locked and frozen in place, unable to be adjusted. There does not appear to be much adjustment left on the pulley, maybe 1 turn, and a pulley change is recommended to bring RTU-2 closer to an efficient airflow. The unit is mounted on a curb adapter, this could be inhibiting airflow, we often find these to be restrictive. The blower wheel was found to be very dirty, and cleaning this effectively will increase airflow.

**Issue Name :** 02. RTU-2 (Kitchen): Low on Supply Airflow  
**Description :** RTU-2 is a 15 ton unit and is supplying 3503 cfm to the kitchen space. For performance and efficiency, blower should operate at around 350 cfm/ton, or 5250 cfm. Per Staff, kitchen is not achieving or maintaining set temp. The RTU is installed with a curb adapter, which may be restricting airflow. Recommend airflow is increased on this unit.

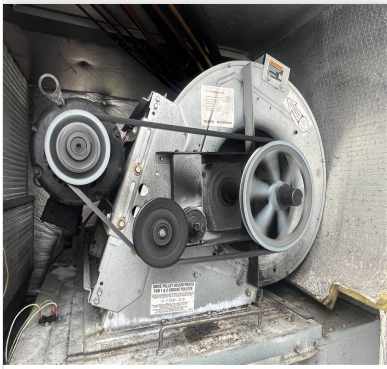
**RTU\_2\_DRIVE**  
**06/20/2024**

- **06/20/2024    National TAB - Michael McDonnell**
  - The motor sheave is frozen at 1-2 turns open and could not be adjusted to increase the speed of the fan. Recommend sheave is broken free and set to 1 turn open. Regardless, a pulley change will be required to bring the RTU closer to an efficient airflow. The motor is operating at 7.8 amps with an FLA rating of 14.6, so there is room to increase fan speed. Recommend pulley change is performed to increase airflow, consult NTAB.

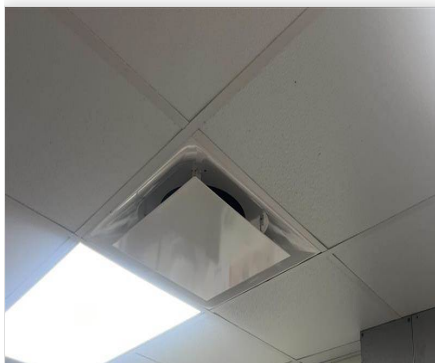
4\_way\_diffuser  
06/21/2024

**Issue Name :** 03. COOKLINE DIFFUSERS  
**Description :** There are three 4-way diffusers installed on the cookline. Recommend these are replaced with perforated diffusers (especially if RTU-1 airflow is increased). Store reports high temps during operation. Recommend 3 additional perforated diffusers are installed on the cookline to increase airflow to cookline, while avoiding hood capture issues.  
**Created By :** National TAB **Assigned To :** National TAB - Brianna Biggs  
**Status :** Open  
**Priority :** High **Asset Tag :**  
**Originated Date :** 06/20/2024 - Michael McDonnell - National TAB

No design. However, 4-way diffusers are installed on the cookline. It is standard for culvers cookline diffusers to be perforated. See issue.

- **06/20/2024 National TAB - Michael McDonnell**
  - Anticipate increasing RTU-2 airflow will cause hood capture issues with 4-ways. Recommend replacing 4-ways with perforated and installing according to Culvers Cookline Diffuser Specification. This entails a rigid elbow and 12-18" of straight rigid duct between the elbow and diffuser. See detail attached.

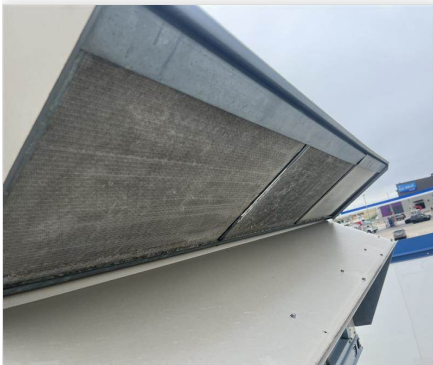
RTU\_2\_OA\_FILTERS  
06/20/2024

**Issue Name :** 04. RTUs: In need of Cleaning / Maintenance  
**Description :** Both RTUs are in need of maintenance/cleaning. Evaporator coils, specifically on RTU-1, are in need of cleaning. Additionally, outside air filters need to be cleaned. See other items in need of attention below:  
**Created By :** National TAB      **Assigned To :** National TAB - Will Turnbough  
**Status :** Open  
**Priority :** High      **Asset Tag :**  
**Originated Date :** 06/20/2024 - Michael McDonnell - National TAB

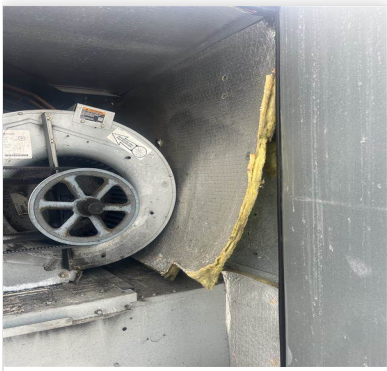
**RTU\_2\_Insulation\_Loose**  
**06/20/2024**

- **06/20/2024    National TAB - Michael McDonnell**
  - Insulation loose in RTU-2 blower compartment. Recommend it is affixed to prevent it from causing future issue.

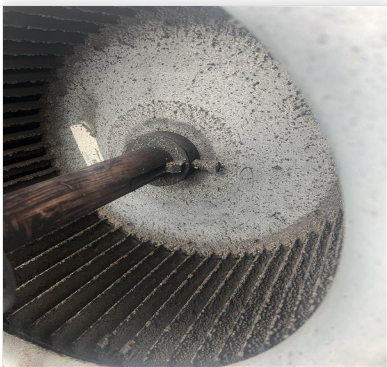
**RTU\_2\_BLOWER\_WHEEL**  
**06/20/2024**

- RTU blower wheels dirty. Recommend blower wheels, especially on RTU-2 are cleaned. This will likely increase airflow.

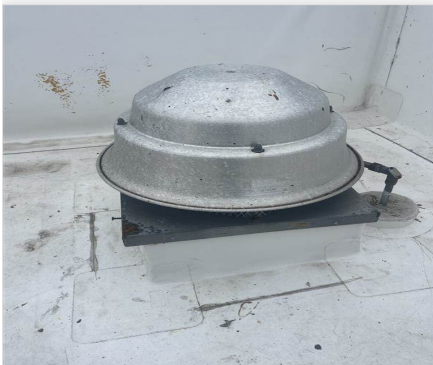
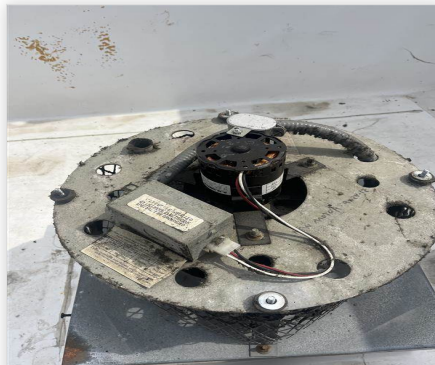
**Issue Name :** 05. PRV-1 (RESTROOM EXHAUST): Not Functional  
**Description :** PRV-1, the restroom exhaust fan, is not operational. Recommend the fan is serviced or replaced so that odor can be effectively removed from restrooms.  
**Created By :** National TAB      **Assigned To :** National TAB - Will Turnbough  
**Status :** Open  
**Priority :** High      **Asset Tag :**  
**Originated Date :** 06/20/2024 - Michael McDonnell - National TAB

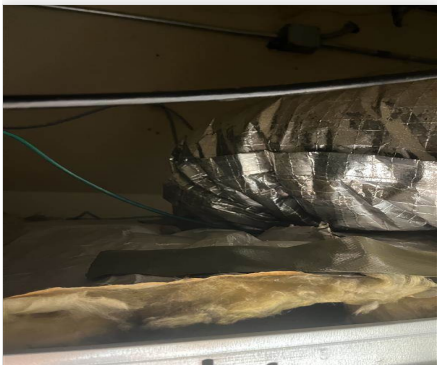
Office\_Diffuser\_Not\_A..  
06/20/2024

**Issue Name :** 06. RTU-2: Office Diffuser NOT Attached  
**Description :** Diffuser tapped off of RTU-2 and serving the office, is not connected, flex was found laying in the ceiling. Recommend flex duct is properly attached to diffuser.  
**Created By :** National TAB                      **Assigned To :** National TAB - Brianna Biggs  
**Status :** Open  
**Priority :** Medium                      **Asset Tag :**  
**Originated Date :** 06/20/2024 - Michael McDonnell - National TAB

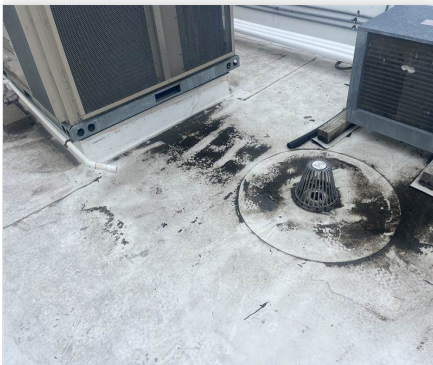
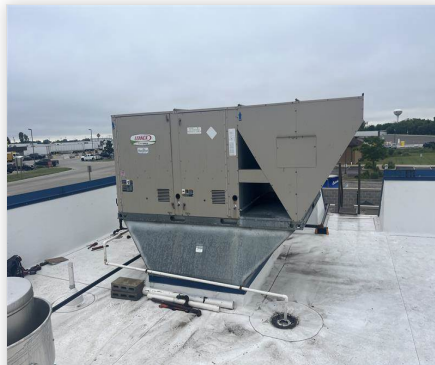
**Issue Name :** 07. RTU-1: Condensate Drain Routing  
**Description :** Condensate drain on RTU-1 is directed toward roof drain. However, drain is easily clogged and water is pooling on the roof. Recommend drain is routed directly into roof drain as with RTU-2 so water does not pool and potentially leak into store space. See photos below.  
**Created By :** National TAB                      **Assigned To :** National TAB - Brianna Biggs  
**Status :** Open  
**Priority :** Low                                      **Asset Tag :**  
**Originated Date :** 06/20/2024 - Michael McDonnell - National TAB

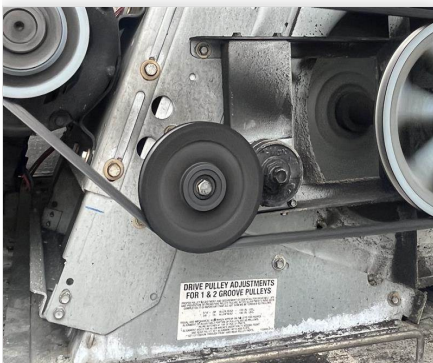
RTU\_2\_BELT\_TENSIONER...  
06/20/2024

**Issue Name :** RTUs: Belt Tensioners Installed  
**Description :** Both RTUs have belt tensioners installed on their drives. While useful in maintaining belt tension, we find these tensioners break easily and cause belts to wear out faster. The tensioner is making considerable noise on RTU-2, and there is significant belt dust in both units. Recommend tensioners are realigned properly with pulleys, or removed.  
**Created By :** National TAB      **Assigned To :** National TAB - Brianna Biggs  
**Status :** Open  
**Priority :** InfoOnly      **Asset Tag :**  
**Originated Date :** 06/20/2024 - Michael McDonnell - National TAB

Drive on RTU-2 making noise, likely due to belt tensioner. Recommend service.

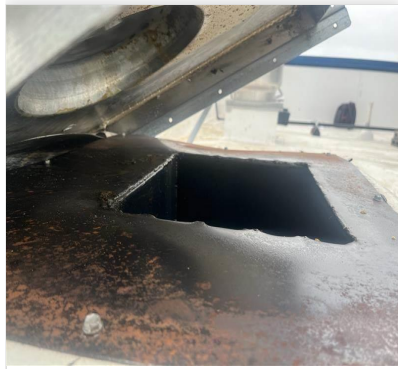
**PRV\_2\_MISALIGNED**  
**06/20/2024**

PRV-1 and 2 are misaligned on their curbs. It appears this is due to the grease duct installation; the duct is not centered.
