Report: TAB REPORT
Function: Test, Adjust, & Balance
Date: 06/20/2024

PROJECT
06-17-24 CULVERS - STURTEVANT, WI
(REIMAGE)

Project: 06-17-24 CULVERS - STURTEVANT, WI (REIMAGE)

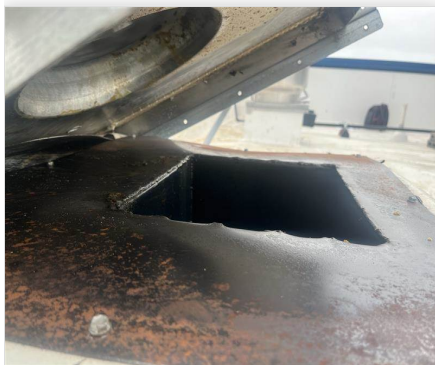
PRV_2_MISALIGNED
06/20/2024

Description : Exhaust fans are not centered over the grease exhaust duct / the duct is not centered in the curb. Appears this is from the original installation of the duct. Both exhaust fans are performing at design airflow, but require much higher than typical setpoints due to misalignment. Recommend curb is reconfigured so fan and grease duct properly align.

PRV-1 and 2 are misaligned on their curbs. It appears this is due to the grease duct installation; the duct is not centered.

- **06/20/2024 National TAB - Michael McDonnell**
 - Both exhaust fans are set to much higher than typical setpoints. Once alignment is corrected, exhaust airflow will likely increase significantly. Recommend NTAB is consulted to readjust setpoints.

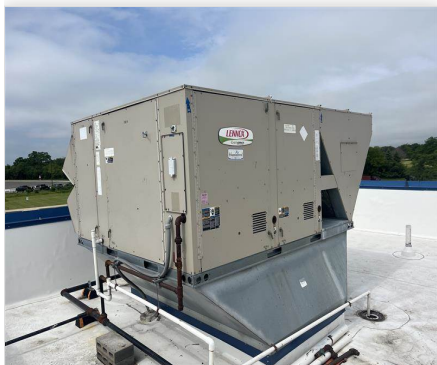
RTU_2_kitchen_
06/20/2024

Issue Name : 02. RTU-2 (Kitchen): Low on Supply Airflow
Description : RTU-2 is a 15 ton unit and is supplying 3503 cfm to the kitchen space. For performance and efficiency, blower should operate at around 350 cfm/ton, or 5250 cfm. Per Staff, kitchen is not achieving or maintaining set temp. The RTU is installed with a curb adapter, which may be restricting airflow. Recommend airflow is increased on this unit.
Created By : National TAB **Assigned To :** National TAB - Will Turnbough
Status : Open
Priority : High **Asset Tag :**
Originated Date : 06/20/2024 - Michael McDonnell - National TAB

Location is experiencing heat wave. Staff reports hot temps (80 F) during operational hours. RTU-2 low on airflow is significantly contributing to this issue. On day of TAB, weather was milder and store was maintaining temp and humidity.

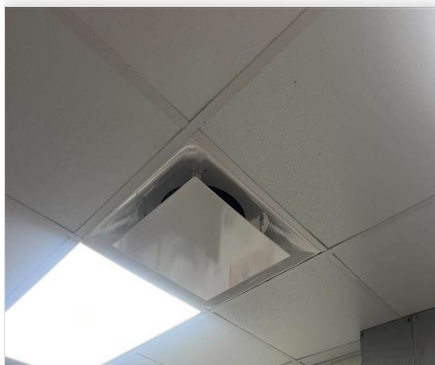
4_way_diffuser
06/21/2024

Issue Name : 03. COOKLINE DIFFUSERS
Description : There are three 4-way diffusers installed on the cookline. Recommend these are replaced with perforated diffusers (especially if RTU-1 airflow is increased). Store reports high temps during operation. Recommend 3 additional perforated diffusers are installed on the cookline to increase airflow to cookline, while avoiding hood capture issues.

No design. However, 4-way diffusers are installed on the cookline. It is standard for culvers cookline diffusers to be perforated. See issue.

- **06/20/2024 National TAB - Michael McDonnell**
 - Anticipate increasing RTU-2 airflow will cause hood capture issues with 4-ways. Recommend replacing 4-ways with perforated and installing according to Culvers Cookline Diffuser Specification. This entails a rigid elbow and 12-18" of straight rigid duct between the elbow and diffuser. See detail attached.

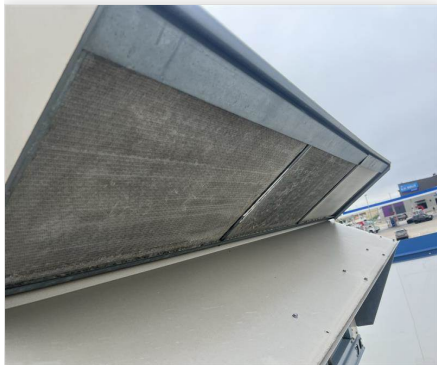
RTU_2_OA_FILTERS
06/20/2024

Issue Name : 04. RTUs: In need of Cleaning / Maintenance
Description : Both RTUs are in need of maintenance/cleaning. Evaporator coils, specifically on RTU-1, are in need of cleaning. Additionally, outside air filters need to be cleaned. See other items in need of attention below:
Created By : National TAB **Assigned To :** National TAB - Will Turnbough
Status : Open
Priority : High **Asset Tag :**
Originated Date : 06/20/2024 - Michael McDonnell - National TAB

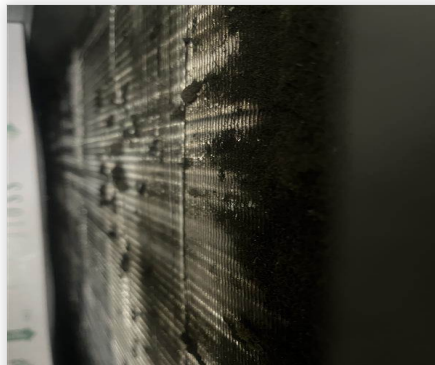
RTU_1_EVAP_COIL
06/20/2024

- [1] EVAPORATOR COIL IN NEED OF CLEANING
- [2] OA FILTERS IN NEED OF CLEANING
- [3] BLOWER IN NEED OF CLEANING
- [4] RECOMMEND CONDENSATE DRAIN ROUTED TO ROOF DRAIN-WATER POOLING ON ROOF.

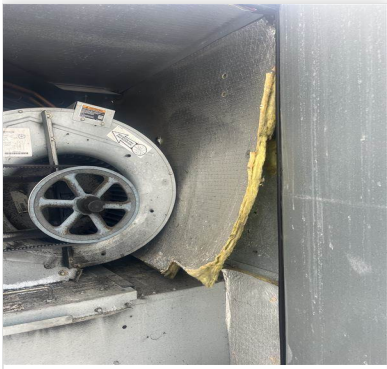
RTU_2_Insulation_Loose
06/20/2024

- **06/20/2024 National TAB - Michael McDonnell**
 - Insulation loose in RTU-2 blower compartment. Recommend it is affixed to prevent it from causing future issue.

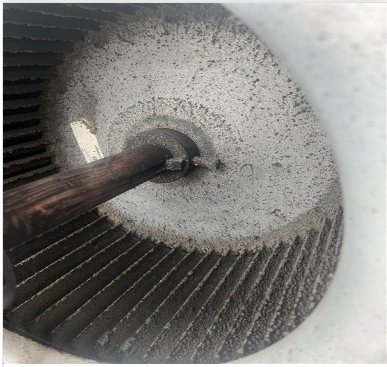
RTU_2_BLOWER_WHEEL
06/20/2024

- RTU blower wheels dirty. Recommend blower wheels, especially on RTU-2 are cleaned. This will likely increase airflow.

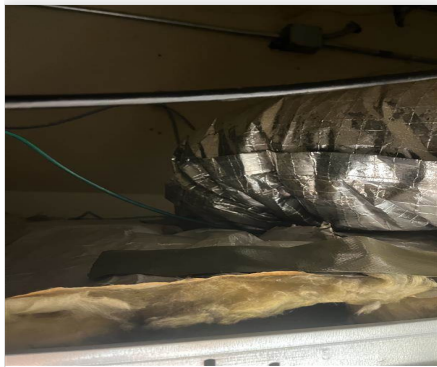
Office_Diffuser_Not_A..
06/20/2024

Issue Name : 06. RTU-2: Office Diffuser NOT Attached
Description : Diffuser tapped off of RTU-2 and serving the office, is not connected, flex was found laying in the ceiling. Recommend flex duct is properly attached to diffuser.
Created By : National TAB **Assigned To :** National TAB - Brianna Biggs
Status : Open
Priority : Medium **Asset Tag :**
Originated Date : 06/20/2024 - Michael McDonnell - National TAB

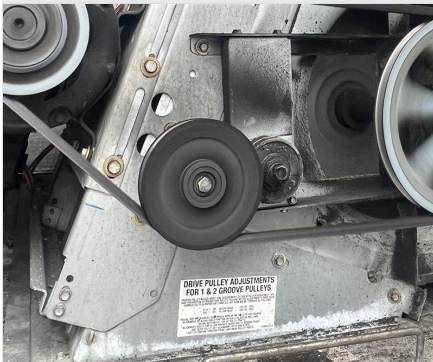
RTU_2_BELT_TENSIONER...
06/20/2024

Issue Name : RTUs: Belt Tensioners Installed
Description : Both RTUs have belt tensioners installed on their drives. While useful in maintaining belt tension, we find these tensioners break easily and cause belts to wear out faster. The tensioner is making considerable noise on RTU-2, and there is significant belt dust in both units. Recommend tensioners are realigned properly with pulleys, or removed.
Created By : National TAB **Assigned To :** National TAB - Brianna Biggs
Status : Open
Priority : InfoOnly **Asset Tag :**
Originated Date : 06/20/2024 - Michael McDonnell - National TAB

Drive on RTU-2 making noise, likely due to belt tensioner. Recommend service.
