Report: TAB REPORT
Function: Test, Adjust, & Balance
Date: 06/20/2024

PROJECT
06-17-24 CULVERS - STURTEVANT, WI
(REIMAGE)

Project: 06-17-24 CULVERS - STURTEVANT, WI (REIMAGE)

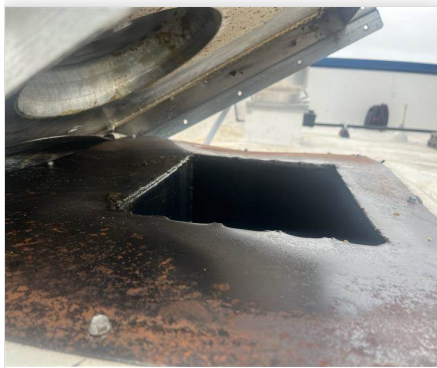
PRV_2_MISALIGNED
06/20/2024

Both the Griddle exhaust hood (HD-1) and the Fryer exhaust Hood (HD-2) are exhausting their design airflow of 1500 cfm. Their respective fans, PRV-2 (griddle) and PRV-3 (fryer), are misaligned on their curbs. It appears this misalignment is due to the original installation of the grease duct; the duct is not centered. As result, the hood exhaust fans had to be set at much higher than typical setpoints to achieve design airflow. This is causing unnecessary energy usage and strain on the exhaust fans. Recommend the fans are properly aligned with the duct. Once corrected, we anticipate the exhaust rates of both hoods to significantly increase. The PRV setpoints will need to be lowered and hoods rebalanced.

Description : Exhaust fans are not centered over the grease exhaust duct / the duct is not centered in the curb. Appears this is from the original installation of the duct. Both exhaust fans are performing at design airflow, but require much higher than typical setpoints due to misalignment. Recommend curb is reconfigured so fan and grease duct properly align.

- **06/20/2024 National TAB - Michael McDonnell**
 - Both exhaust fans are set to much higher than typical setpoints. Once alignment is corrected, exhaust airflow will likely increase significantly. Recommend NTAB is consulted to readjust setpoints.

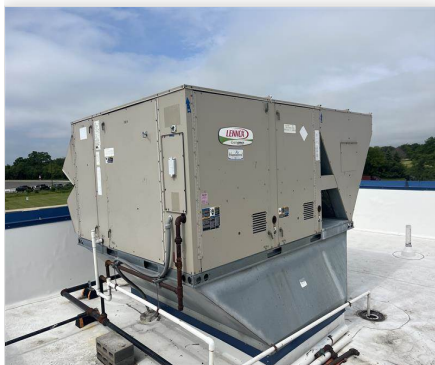
RTU_2_kitchen_
06/20/2024

The unit is significantly low on airflow, operating at 66% of the airflow it should be providing. The unit could not be sped up during our visit because the motor sheave is locked and frozen in place, unable to be adjusted. There does not appear to be much adjustment left on the pulley, maybe 1 turn, and a pulley change is recommended to bring RTU-2 closer to an efficient airflow. The unit is mounted on a curb adapter, this could be inhibiting airflow, we often find these to be restrictive. The blower wheel was found to be very dirty, and cleaning this effectively will increase airflow.

Issue Name : 02. RTU-2 (Kitchen): Low on Supply Airflow
Description : RTU-2 is a 15 ton unit and is supplying 3503 cfm to the kitchen space. For performance and efficiency, blower should operate at around 350 cfm/ton, or 5250 cfm. Per Staff, kitchen is not achieving or maintaining set temp. The RTU is installed with a curb adapter, which may be restricting airflow. Recommend airflow is increased on this unit.

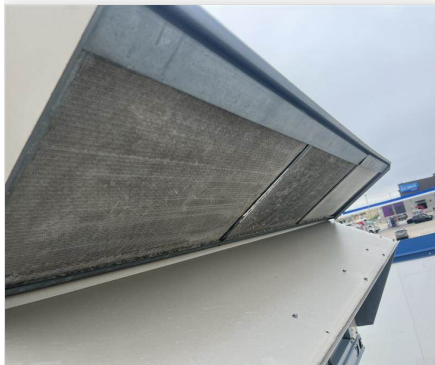
RTU_2_OA_FILTERS
06/20/2024

Issue Name : 04. RTUs: In need of Cleaning / Maintenance
Description : Both RTUs are in need of maintenance/cleaning. Evaporator coils, specifically on RTU-1, are in need of cleaning. Additionally, outside air filters need to be cleaned. See other items in need of attention below:
Created By : National TAB **Assigned To :** National TAB - Will Turnbough
Status : Open
Priority : High **Asset Tag :**
Originated Date : 06/20/2024 - Michael McDonnell - National TAB

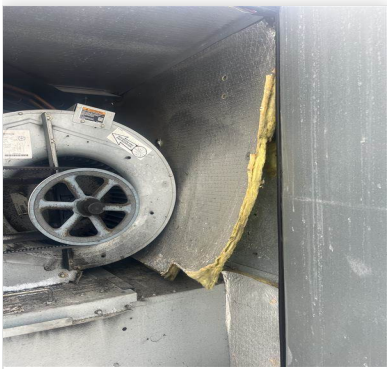
RTU_2_Insulation_Loose
06/20/2024

- **06/20/2024 National TAB - Michael McDonnell**
 - Insulation loose in RTU-2 blower compartment. Recommend it is affixed to prevent it from causing future issue.

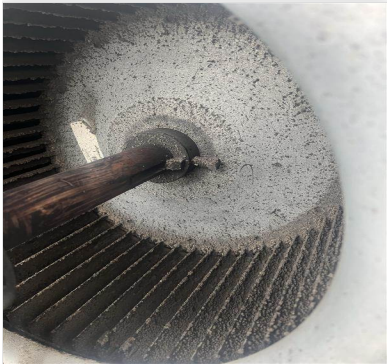
RTU_2_BLOWER_WHEEL
06/20/2024

- RTU blower wheels dirty. Recommend blower wheels, especially on RTU-2 are cleaned. This will likely increase airflow.

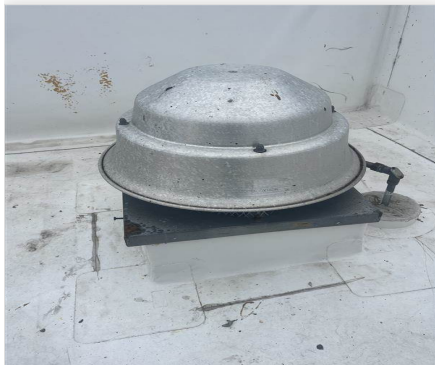
**PRV_1_RR_
06/20/2024**

Issue Name : 05. PRV-1 (RESTROOM EXHAUST): Not Functional
Description : PRV-1, the restroom exhaust fan, is not operational. Recommend the fan is serviced or replaced so that odor can be effectively removed from restrooms.
Created By : National TAB **Assigned To :** National TAB - Will Turnbough
Status : Open
Priority : High **Asset Tag :**
Originated Date : 06/20/2024 - Michael McDonnell - National TAB

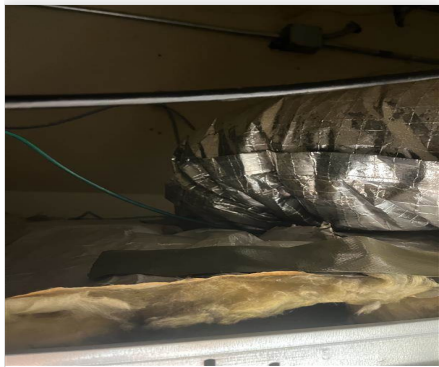
Office_Diffuser_Not_A..
06/20/2024

Issue Name : 06. RTU-2: Office Diffuser NOT Attached
Description : Diffuser tapped off of RTU-2 and serving the office, is not connected, flex was found laying in the ceiling. Recommend flex duct is properly attached to diffuser.
Created By : National TAB **Assigned To :** National TAB - Brianna Biggs
Status : Open
Priority : Medium **Asset Tag :**
Originated Date : 06/20/2024 - Michael McDonnell - National TAB

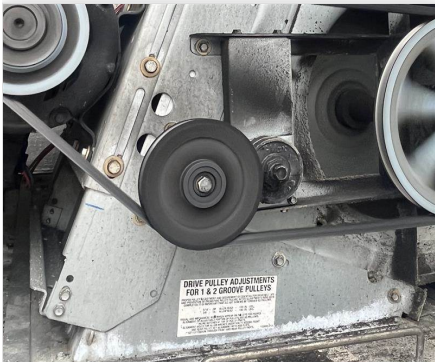
RTU_2_BELT_TENSIONER...
06/20/2024

Issue Name : RTUs: Belt Tensioners Installed
Description : Both RTUs have belt tensioners installed on their drives. While useful in maintaining belt tension, we find these tensioners break easily and cause belts to wear out faster. The tensioner is making considerable noise on RTU-2, and there is significant belt dust in both units. Recommend tensioners are realigned properly with pulleys, or removed.
Created By : National TAB **Assigned To :** National TAB - Brianna Biggs
Status : Open
Priority : InfoOnly **Asset Tag :**
Originated Date : 06/20/2024 - Michael McDonnell - National TAB

Drive on RTU-2 making noise, likely due to belt tensioner. Recommend service.

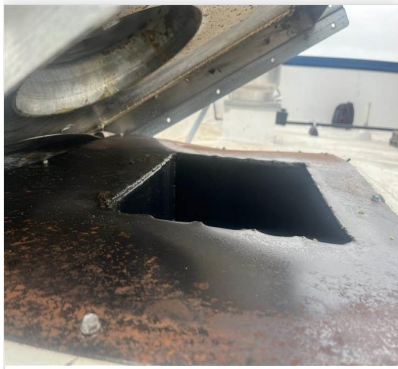
PRV_2_MISALIGNED
06/20/2024

Lean fan back. Is grease duct installation adequate and is duct ran all the way to the base of the fan? Fail

PRV-1 and 2 are misaligned on their curbs. It appears this is due to the grease duct installation; the duct is not centered.
