Report: TAB REPORT
Function: Test, Adjust, & Balance
Date: 06/20/2024

PROJECT
06-17-24 CULVERS - STURTEVANT, WI
(REIMAGE)

Project: 06-17-24 CULVERS - STURTEVANT, WI (REIMAGE)

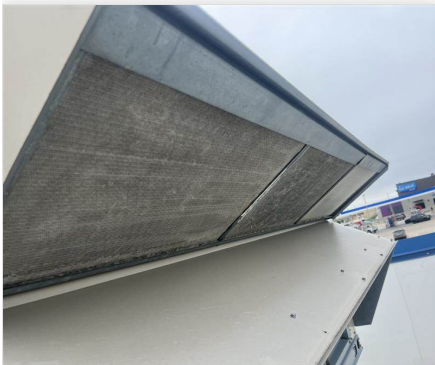
RTU_2_OA_FILTERS
06/20/2024

Issue Name : 04. RTUs: In need of Cleaning / Maintenance
Description : Both RTUs are in need of maintenance/cleaning. Evaporator coils, specifically on RTU-1, are in need of cleaning. Additionally, outside air filters need to be cleaned. See other items in need of attention below:
Created By : National TAB **Assigned To :** National TAB - Will Turnbough
Status : Open
Priority : High **Asset Tag :**
Originated Date : 06/20/2024 - Michael McDonnell - National TAB

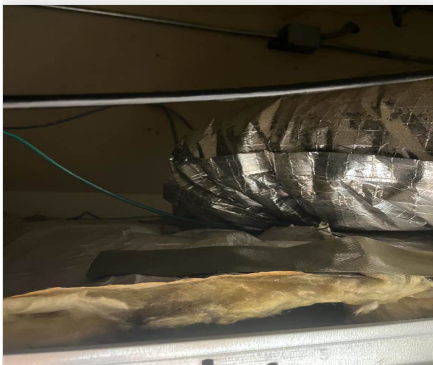
Office_Diffuser_Not_A..
06/20/2024

Issue Name : 06. RTU-2: Office Diffuser NOT Attached
Description : Diffuser tapped off of RTU-2 and serving the office, is not connected, flex was found laying in the ceiling. Recommend flex duct is properly attached to diffuser.

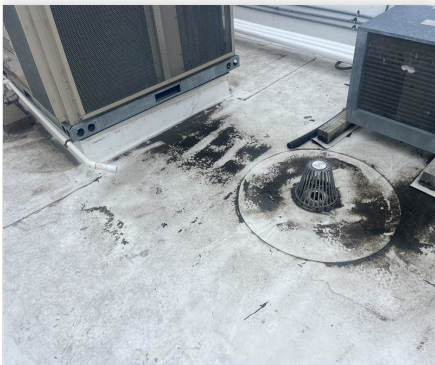
**RTU_1_Condensate
06/20/2024**

Issue Name : 07. RTU-1: Condensate Drain Routing
Description : Condensate drain on RTU-1 is directed toward roof drain. However, drain is easily clogged and water is pooling on the roof. Recommend drain is routed directly into roof drain as with RTU-2 so water does not pool and potentially leak into store space. See photos below.
