**Report: TAB REPORT
Function: Test, Adjust, & Balance
Date: 12/29/2022**

12-26 CULVERS - GREEN BAY, WI (FACILITY TAB)

Project: 12-26 CULVERS - GREEN BAY, WI (FACILITY TAB)

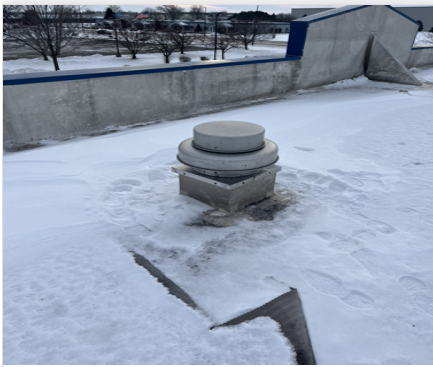
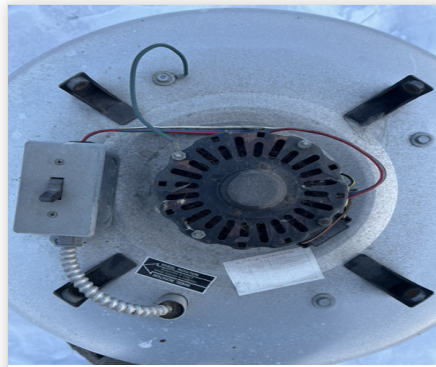
Issue Name : 1. PRV-1 (Restrooms) Fan is Not Operational.

Description : Fan is not operational. Motor may need replacement. Recommend service.

Notes: [1] FAN NOT OPERATIONAL. NEEDS SERVICE. MAY NEED MOTOR REPLACEMENT. TURNED OFF AT ROOF DISCONNECT.

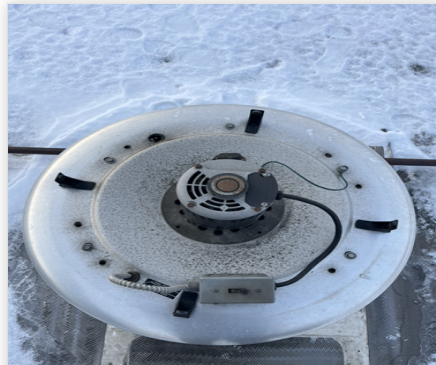
Notes: [1] FAN NOT OPERATIONAL. NEEDS SERVICE. TURNED OFF DISCONNECT AT ROOF.

[1] Balanced RTU outside air to high end of design to accommodate PRV-1, PRV-4, and EF-1A exhaust should these fans be repaired. Recommend PRV-4 be tied into dishwasher operation to keep building pressure positive if all fans are repaired.

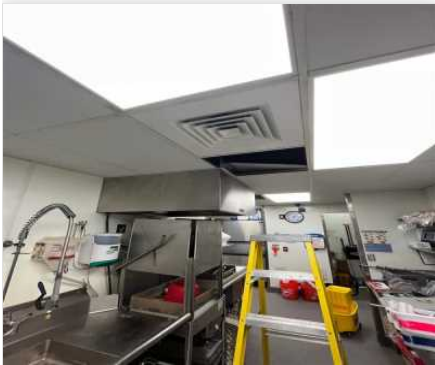
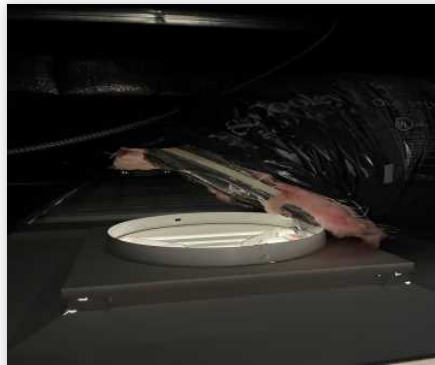
Issue Name : 3. Kitchen Diffuser not Connected

Description : A diffuser positioned in front of the dishwasher exhaust hood is not connected to ductwork. Diffuser was temporarily connected for balance. Recommend the flex run to this diffuser is reattached and properly secured.

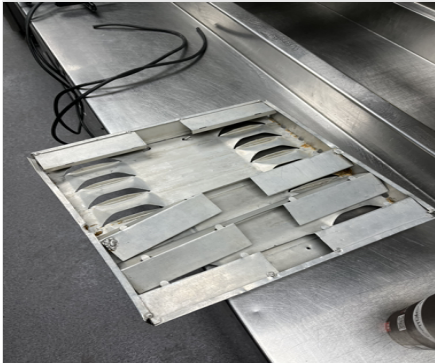
Issue Name : 5. HD-1 (fryer) filter damaged.

Description : Several hood filters have significant wear. One filter on HD-1 is fairly damaged and needs replacement. Recommend all filters are evaluated and replaced as necessary.

Notes: [1] UNIT LABEL WORN OFF. [2] FILTER DAMAGED AND IN NEED OF REPLACEMENT.

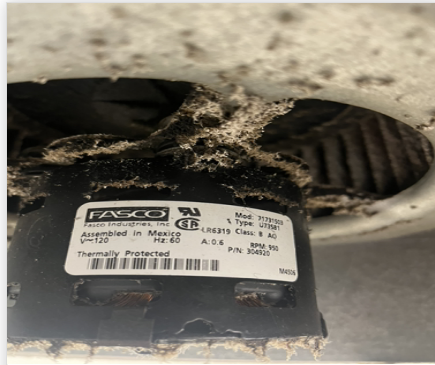
Issue Name : 7. EF-1A (Mop Room) Fan Not Operational.

Description : Fan is not operational. Could not determine how fan is controlled. Needs service.

Notes: [1] FAN IS NOT OPERATIONAL.

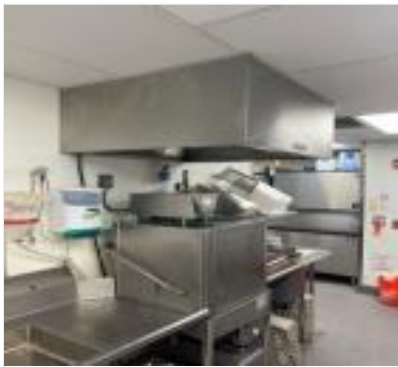
HOOD 3

Notes: [1] EXHAUST HOOD NOT OPERATIONAL. FAN NEEDS SERVICE.
