**Report: TAB REPORT  
Function: Test, Adjust, & Balance  
Date: 12/29/2022**

## **12-26 CULVERS - GREEN BAY, WI (FACILITY TAB)**

2945 Voyager Dr

McCon Building Corporation  
1059 Circle Drive  
PO Box 247  
Highland, WI 53543

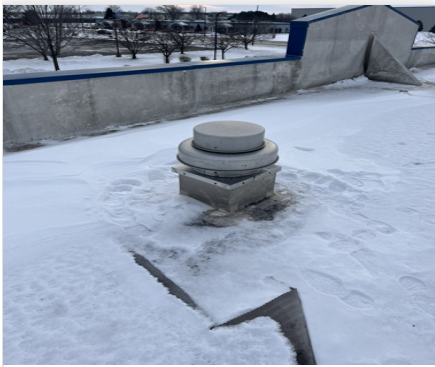
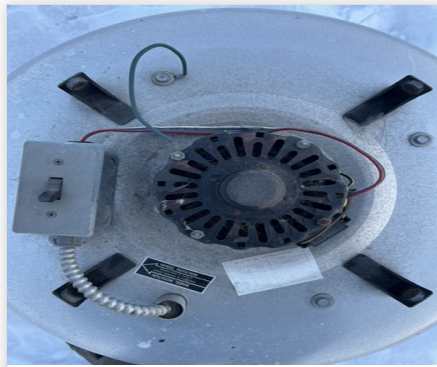
**Issue Name :** 1. PRV-1 (Restrooms) Fan is Not Operational.

**Description :** Fan is not operational. Motor may need replacement. Recommend service.

Notes: [1] FAN NOT OPERATIONAL. NEEDS SERVICE. MAY NEED MOTOR REPLACEMENT. TURNED OFF AT ROOF DISCONNECT.

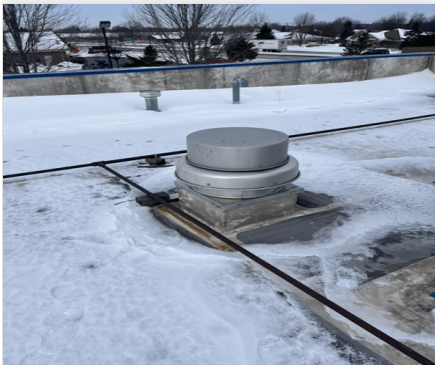
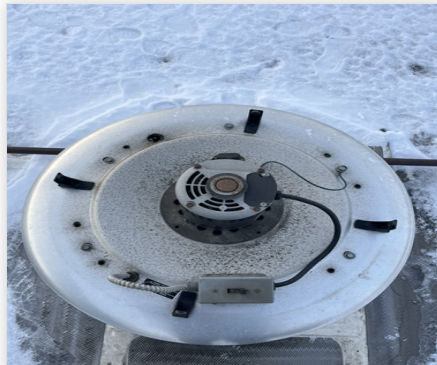
Notes: [1] FAN NOT OPERATIONAL. NEEDS SERVICE. TURNED OFF DISCONNECT AT ROOF.

Notes: [1] EXHAUST HOOD NOT OPERATIONAL. FAN NEEDS SERVICE.

[1] Balanced RTU outside air to high end of design to accommodate PRV-1, PRV-4, and EF-1A exhaust should these fans be repaired. Recommend PRV-4 be tied into dishwasher operation to keep building pressure positive if all fans are repaired.

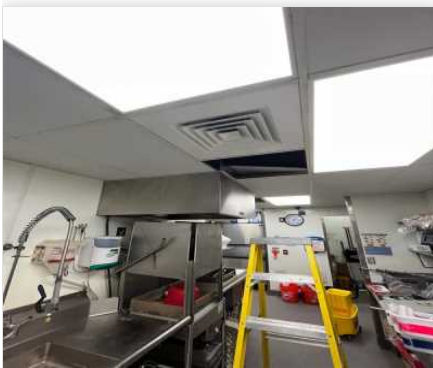
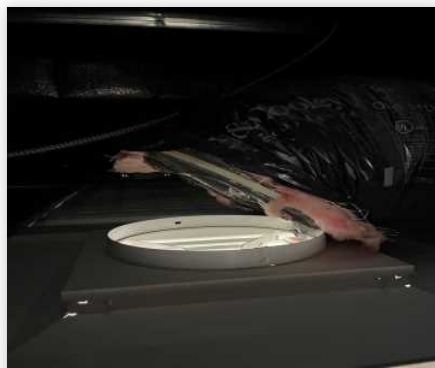
**Issue Name :** 3. Kitchen Diffuser not Connected

**Description :** A diffuser positioned in front of the dishwasher exhaust hood is not connected to ductwork. Diffuser was temporarily connected for balance. Recommend the flex run to this diffuser is reattached and properly secured.

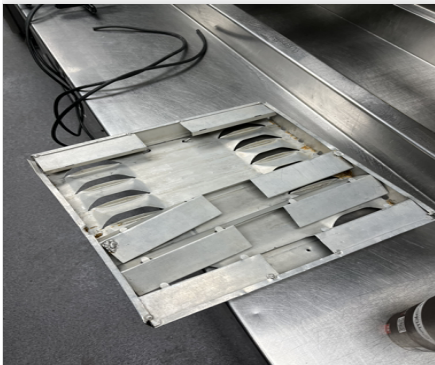
**Issue Name :** 5. HD-1 (fryer) filter damaged.

**Description :** Several hood filters have significant wear. One filter on HD-1 is fairly damaged and needs replacement. Recommend all filters are evaluated and replaced as necessary.

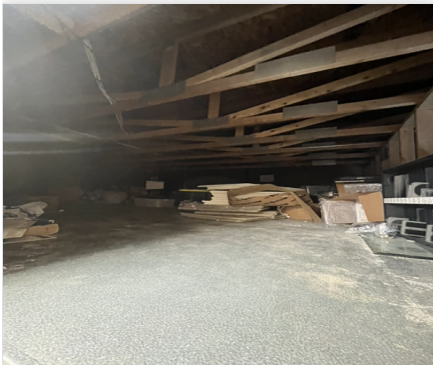
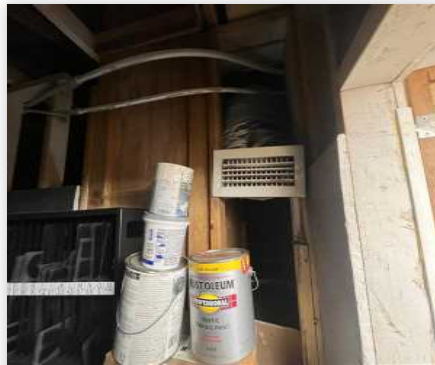
**Issue Name :** 6. Kitchen Supply Grille Serving Attic Space.

**Description :** A sidewall grille is installed and was supplying air to the attic space above the Walk-in coolers. The grille was dampened shut to push more air into the kitchen space. No further action required.

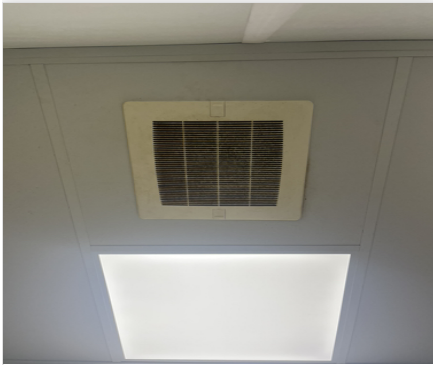
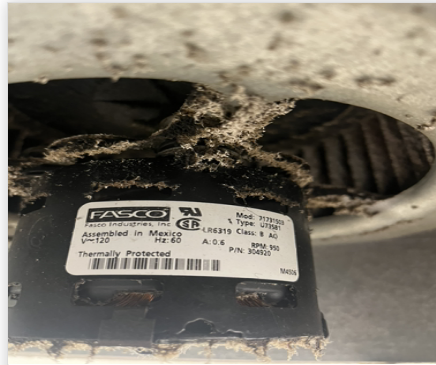
**Issue Name :** 7. EF-1A (Mop Room) Fan Not Operational.

**Description :** Fan is not operational. Could not determine how fan is controlled. Needs service.
