**Report: TAB REPORT
Function: Test, Adjust, & Balance
Date: 12/29/2022**

12-26 CULVERS - GREEN BAY, WI (FACILITY TAB)

McCon Building Corporation
1059 Circle Drive
PO Box 247
Highland, WI 53543

Project: 12-26 CULVERS - GREEN BAY, WI (FACILITY TAB)

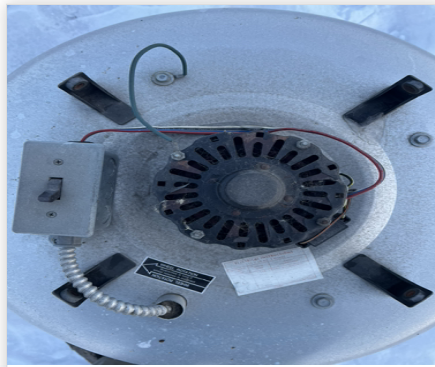
Issue Name : 1. PRV-1 (Restrooms) Fan is Not Operational.

Description : Fan is not operational. Motor may need replacement. Recommend service.

Notes: [1] FAN NOT OPERATIONAL. NEEDS SERVICE. MAY NEED MOTOR REPLACEMENT. TURNED OFF AT ROOF DISCONNECT.

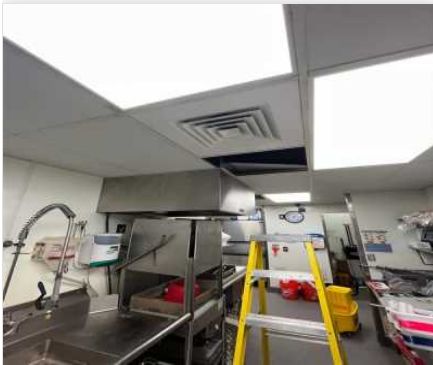
Issue Name : 3. Kitchen Diffuser not Connected

Description : A diffuser positioned in front of the dishwasher exhaust hood is not connected to ductwork. Diffuser was temporarily connected for balance. Recommend the flex run to this diffuser is reattached and properly secured.
