**Report: TAB REPORT
Function: Test, Adjust, & Balance
Date: 12/29/2022**

**PROJECT
12-26 CULVERS - GREEN BAY, WI (FACILITY
TAB)**

Project: 12-26 CULVERS - GREEN BAY, WI (FACILITY TAB)

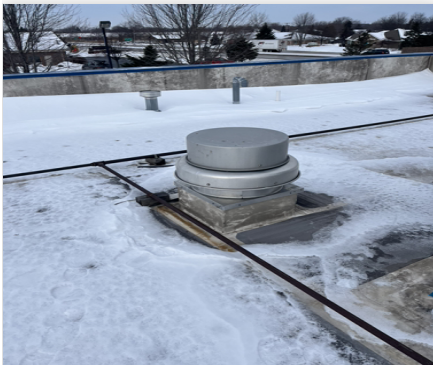
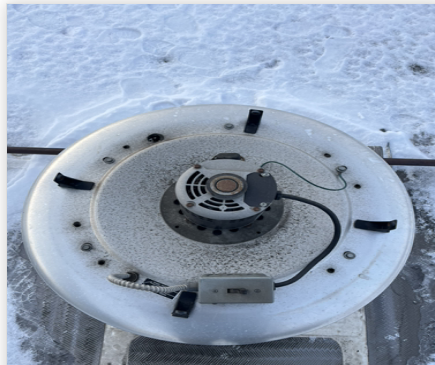
Issue Name : 2. PRV-4 (Dish Hood HD-3) Fan Not Operational

Description : Fan is not operational. Needs service. Recommend fan operation is tied into dishwasher operation if repaired to help maintain building pressure.

Notes: [1] FAN NOT OPERATIONAL. NEEDS SERVICE. TURNED OFF DISCONNECT AT ROOF.

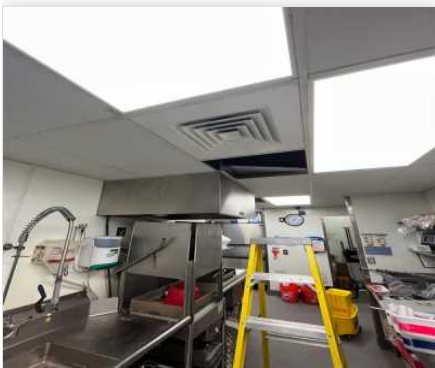
Issue Name : 3. Kitchen Diffuser not Connected

Description : A diffuser positioned in front of the dishwasher exhaust hood is not connected to ductwork. Diffuser was temporarily connected for balance. Recommend the flex run to this diffuser is reattached and properly secured.

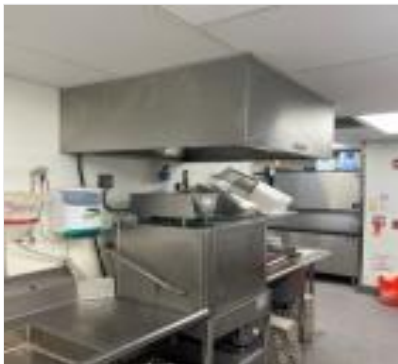
HOOD 3

Notes: [1] EXHAUST HOOD NOT OPERATIONAL. FAN NEEDS SERVICE.
