**Report: TAB REPORT
Function: Test, Adjust, & Balance
Date: 12/29/2022**

12-26 CULVERS - GREEN BAY, WI (FACILITY TAB)

Project: 12-26 CULVERS - GREEN BAY, WI (FACILITY TAB)

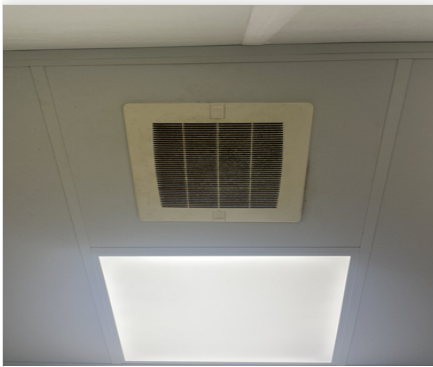
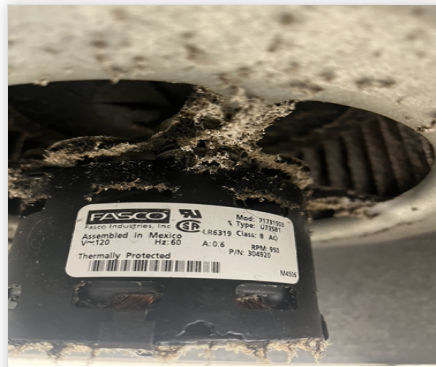
Issue Name : 7. EF-1A (Mop Room) Fan Not Operational.

Description : Fan is not operational. Could not determine how fan is controlled. Needs service.

Notes: [1] FAN IS NOT OPERATIONAL.
