Report: TAB Report
Function: Test, Adjust, & Balance
Date: 02/02/2026
Completed By: National TAB

02-02-26 WAWA #8241 ALLENTOWN, PA

Wawa
260 West Baltimore Pike
Wawa, PA 19063

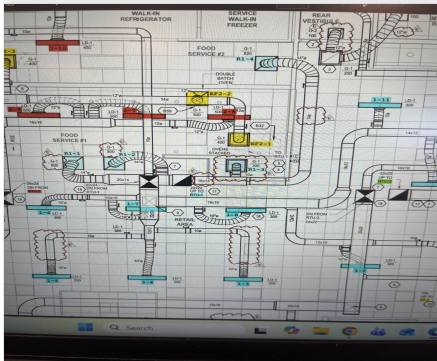
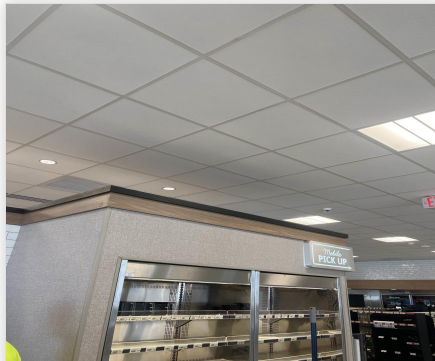
Issue Name : Return Grille R1-3
Description : Return Grille 1-3 is not installed per the revision E. NTab balanced per pre revision plans. Review and rectify if return is to be installed or excepted as-is. Return is intended to be located above the express case.
Created By : National TAB **Assigned To :** National TAB - Will Turnbough
Status : Open
Priority : Medium **Asset Tag :**
Originated Date : 02/02/2026 - Tyler Youells - National TAB

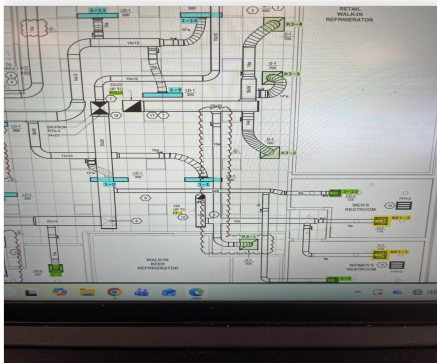
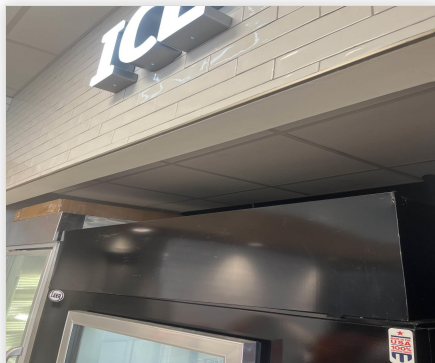
Issue Name : Return Grille R3-1
Description : Return Grille 3-1 is not installed per the revision E. NTab balanced per pre revision plans. Review and rectify if return is to be installed or excepted as-is. Return is intended to be located above the ice machine.
Created By : National TAB **Assigned To :** National TAB - Will Turnbough
Status : Open
Priority : **Medium** **Asset Tag :**
Originated Date : 02/02/2026 - Tyler Youells - National TAB
