**Report: TAB Report**  
**Function: Test, Adjust, & Balance**  
**Date: 02/02/2026**  
**Completed By: National TAB**

**PROJECT**  
**02-02-26 WAWA #8241 ALLENTOWN, PA**

Project: 02-02-26 WAWA #8241 ALLENTOWN, PA

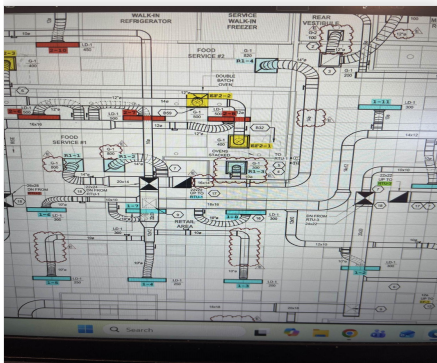
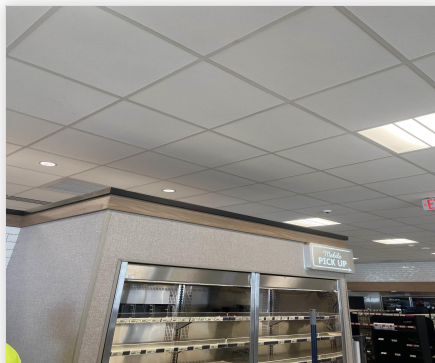
**Issue Name :** Return Grille R1-3  
**Description :** Return Grille 1-3 is not installed per the revision E. NTab balanced per pre revision plans. Review and rectify if the return is to be installed or excepted as-is. Return is intended to be located above the express case.  
**Created By :** National TAB                      **Assigned To :** National TAB - Will Turnbough  
**Status :** Open  
**Priority :** Medium                                      **Asset Tag :**  
**Originated Date :** 02/02/2026 - Tyler Youells - National TAB

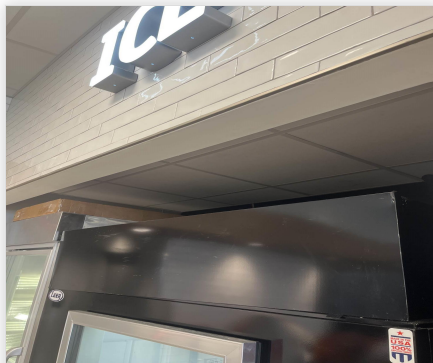
**Issue Name :** Return Grille R3-1  
**Description :** Return Grille 3-1 is not installed per the revision E. NTab balanced per pre revision plans. Review and rectify if the return is to be installed or excepted as-is. Return is intended to be located above the ice machine.  
**Created By :** National TAB                      **Assigned To :** National TAB - Will Turnbough  
**Status :** Open  
**Priority :** Medium                                      **Asset Tag :**  
**Originated Date :** 02/02/2026 - Tyler Youells - National TAB
