Report: TAB Survey
Function: Test, Adjust, & Balance
Date: 11/11/2025
Completed By: National TAB

11-10-25 APPLEBEES - MACON, GA (Tab Survey)

The scope of this project is to perform a survey of the existing RTU's, EF's, MUA, and hoods. This includes measuring as-is airflows, inspecting the equipment for maintenance issues, and providing additional insight as to the performance and condition.

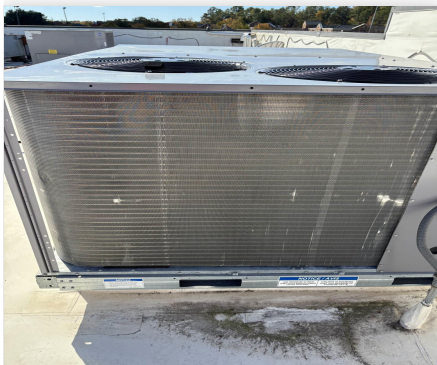
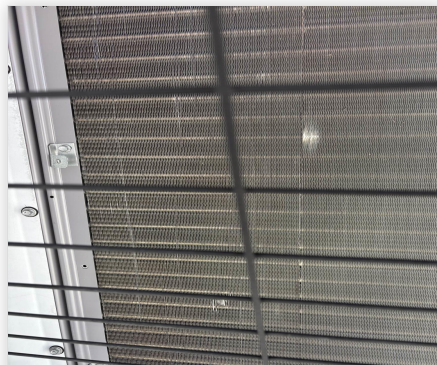
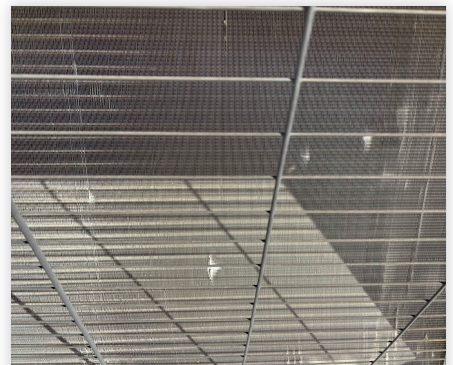
Issue Name : ALL RTUs: CONDENSER FINS DAMAGED AND DIRTY
Description : The condenser fins on all RTUs are damaged and dirty. Recommend they get repaired/ replaced and cleaned.
Created By : National TAB **Assigned To :** National TAB - Dan Hertenstein
Status : Open
Priority : Medium **Asset Tag :**
Originated Date : 11/10/2025 - Sagar Patel - National TAB

All condenser coils need cleaning and show damage.

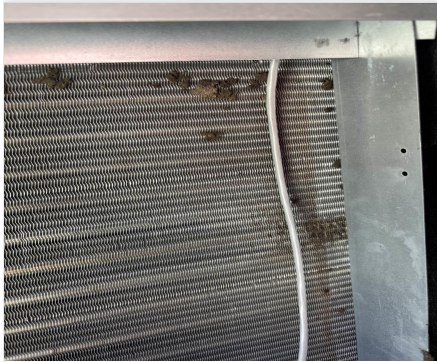
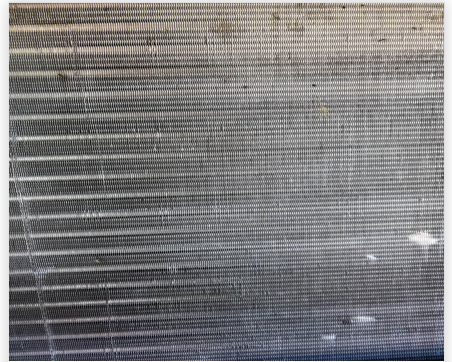
Issue Name : ALL RTUs: EVAPORATOR COILS DIRTY AND DAMAGED
Description : The evaporator coils in all RTUs are dirt and show signs of damage.
Created By : National TAB **Assigned To :** National TAB - Dan Hertenstein
Status : Open
Priority : High **Asset Tag :**
Originated Date : 11/11/2025 - Sagar Patel - National TAB

All are dirty and have some damage

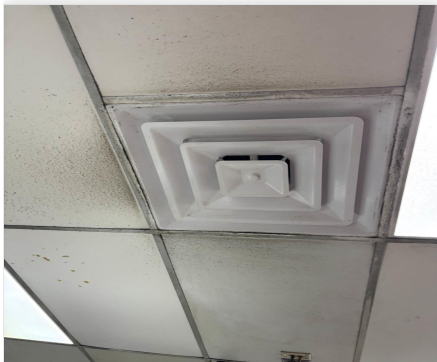
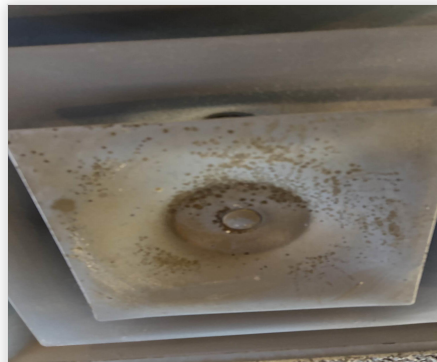
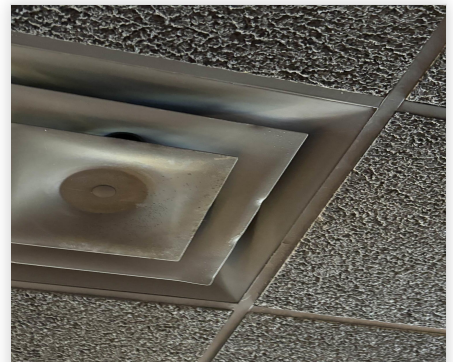
Issue Name : DAMAGED TO SOME DIFFUSERS IN KITCHEN AND DINING AREA
Description : There is damage to some of the diffusers in the kitchen and dining area.
Created By : National TAB **Assigned To :** National TAB - Dan Hertenstein
Status : Open
Priority : **Medium** **Asset Tag :**
Originated Date : 11/10/2025 - Sagar Patel - National TAB

Are all diffusers free of damage and rust? Fail

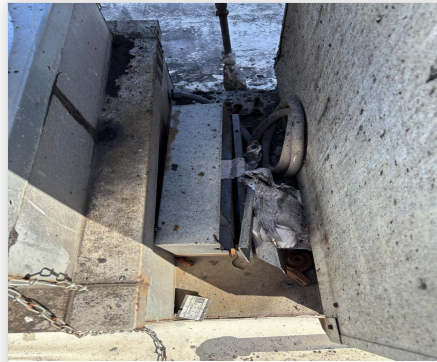
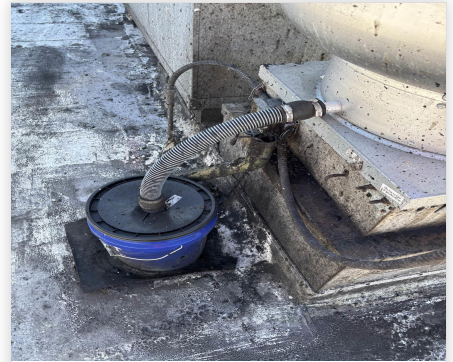
Issue Name : EF 1 AND 2: INCORRECT GREASE CATCH
Description : The grease catch is a plastic bucket. The metal catch for both exhaust fans are behind EF 2.
Created By : National TAB **Assigned To :** National TAB - Dan Hertenstein
Status : Open
Priority : High **Asset Tag :**
Originated Date : 11/10/2025 - Sagar Patel - National TAB

Grease surrounding base of exhaust fan 1 and 2.

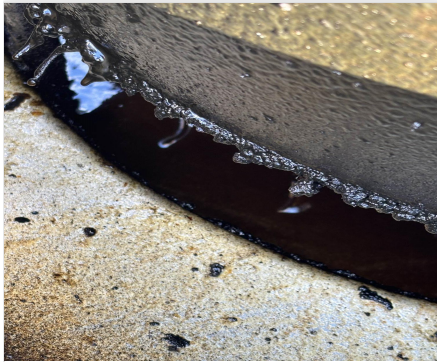
Issue Name : EF 1: GREASE BUILDING UP IN FAN
Description : Grease is building up in the exhaust fan, Possibly grease bucket is full or tube connecting is clogged.
Created By : National TAB **Assigned To :** National TAB - Dan Hertenstein
Status : Open
Priority : High **Asset Tag :**
Originated Date : 11/10/2025 - Sagar Patel - National TAB

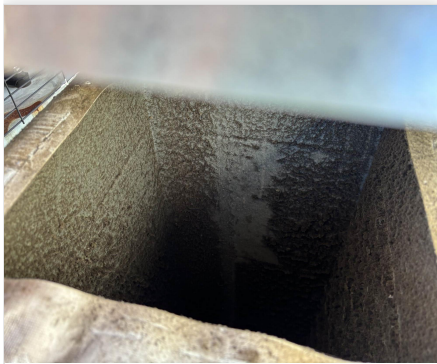
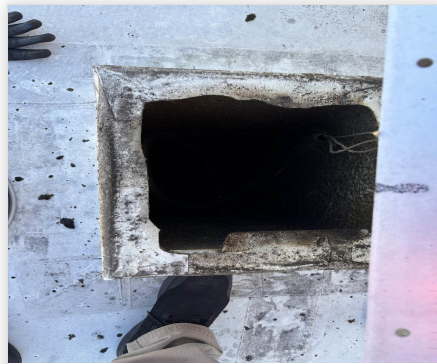
Issue Name : EF 3 AND 4: NO BACKDRAFT DAMPER INSTALLED
Description : A back draft damper is not installed into either exhaust fan.
Created By : National TAB **Assigned To :** National TAB - Dan Hertenstein
Status : Open
Priority : Medium **Asset Tag :**
Originated Date : 11/11/2025 - Sagar Patel - National TAB

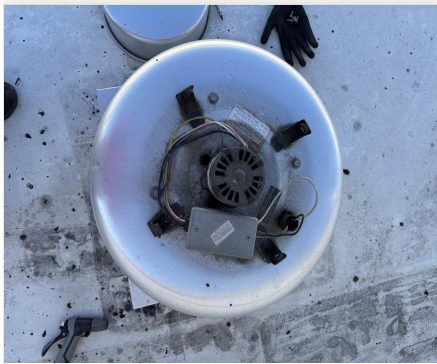
Issue Name : EF 4: NO SPEED CONTROL
Description : A speed control is not installed to the exhaust fan
Created By : National TAB **Assigned To :** National TAB - Dan Hertenstein
Status : Open
Priority : High **Asset Tag :**
Originated Date : 11/11/2025 - Sagar Patel - National TAB

EF 4 does not have speed control.

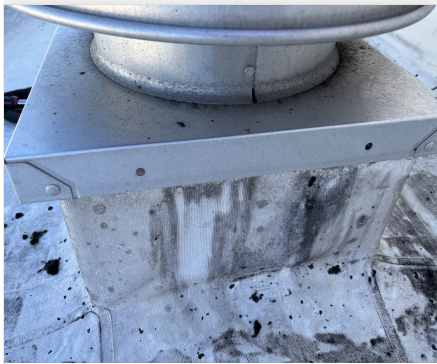
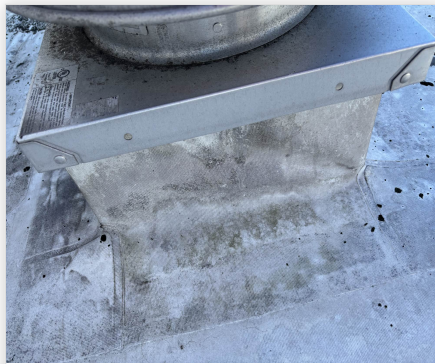
Issue Name : EF 4: NOT SECURED TO CURB
Description : The exhaust fan is not secured to the curb.
Created By : National TAB **Assigned To :** National TAB - Dan Hertenstein
Status : Open
Priority : Medium **Asset Tag :**
Originated Date : 11/11/2025 - Sagar Patel - National TAB

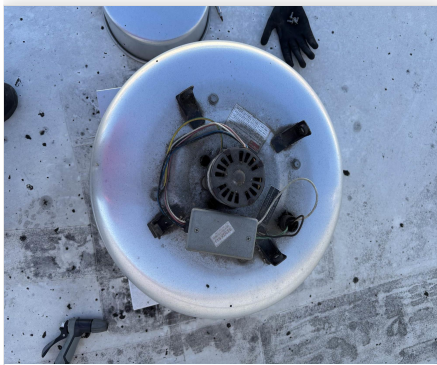
Issue Name : EF4: MOTOR NOT FUNCTIONING
Description : The motor is not starting when dishwasher is on. Breaker for fan is switched on.
Created By : National TAB **Assigned To :** National TAB - Dan Hertenstein
Status : Open
Priority : High **Asset Tag :**
Originated Date : 11/11/2025 - Sagar Patel - National TAB

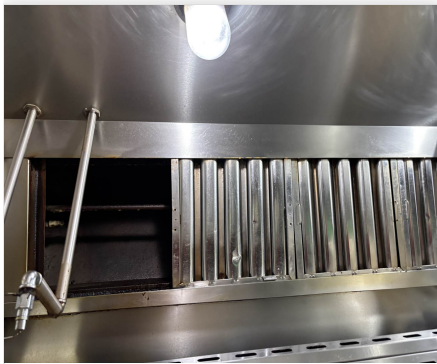
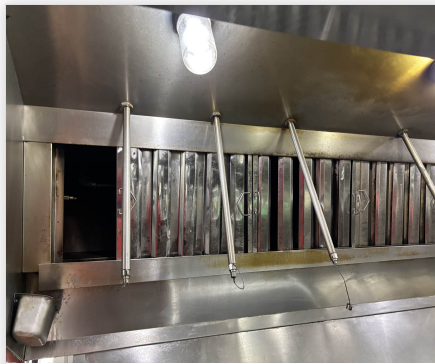
Issue Name : HOOD 1 AND 2: FILTERS ARE DIRTY, DAMAGED, AND HAS GAPS

Description : The hood filters are damaged and has gaps.

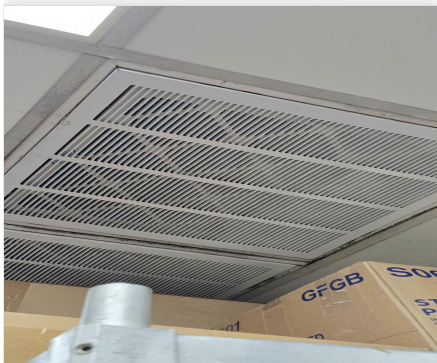
Issue Name : KITCHEN RETURN
Description : Filters in the return cause low air flow. They are not needed, recommend filters are removed.
Created By : National TAB **Assigned To :** National TAB - Dan Hertenstein
Status : Open
Priority : High **Asset Tag :**
Originated Date : 11/11/2025 - Sagar Patel - National TAB

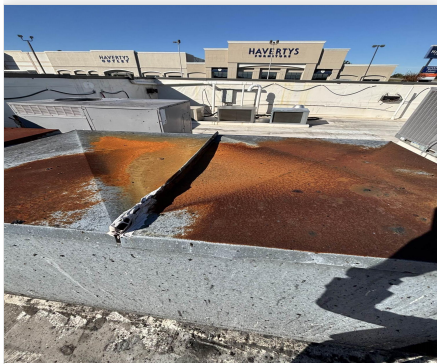
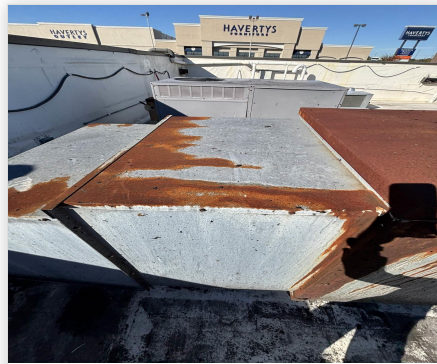
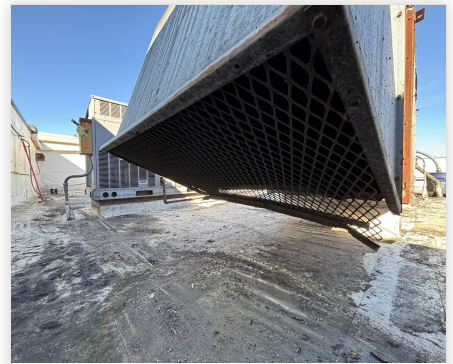
Issue Name : MAU: DAMAGE TO TOP AND FILTER
Description : There is damage to to top of the make-up air and the filter on the outside
Created By : National TAB **Assigned To :** National TAB - Dan Hertenstein
Status : Open
Priority : High **Asset Tag :**
Originated Date : 11/11/2025 - Sagar Patel - National TAB

Rust on top of unit and dented inwards.

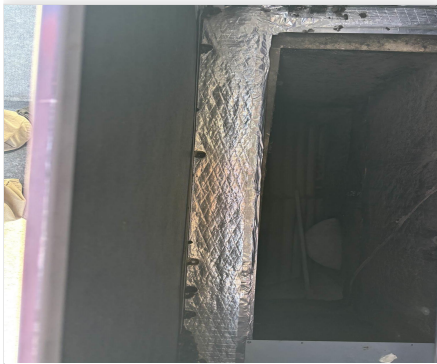
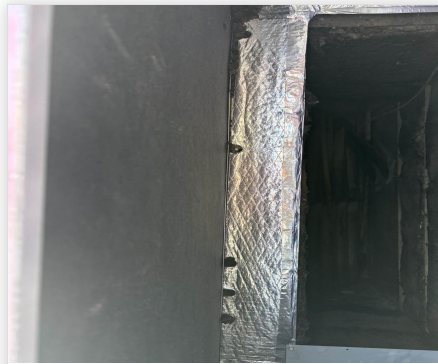
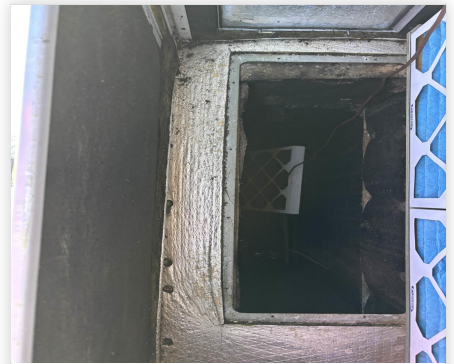
Issue Name : RTU 1, 2 AND 5, NEED OA INSTALLED
Description : RTUs 1, 2, and 5 need an outside air installed along with an economizer.
Created By : National TAB **Assigned To :** National TAB - Dan Hertenstein
Status : Open
Priority : High **Asset Tag :**
Originated Date : 11/11/2025 - Sagar Patel - National TAB

RTU 3 and 4 are the only one to have an economizer. All other unit do not have an outside air.

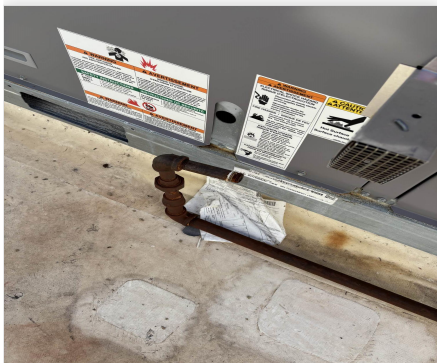
Issue Name : RTU 2: GAS LINE IS NOT CONNECTED
Description : The gas line to RTU 2 is not connected to the unit. There is no gas smell around unit and no sound from exposed pipe. Possibly had been closed at gas valve. Recommended to be checked out and properly sealed.
Created By : National TAB **Assigned To :** National TAB - Dan Hertenstein
Status : Open
Priority : Urgent **Asset Tag :**
Originated Date : 11/10/2025 - Sagar Patel - National TAB

RTU 2 has gas line disconnected. All other RTUs are functioning.

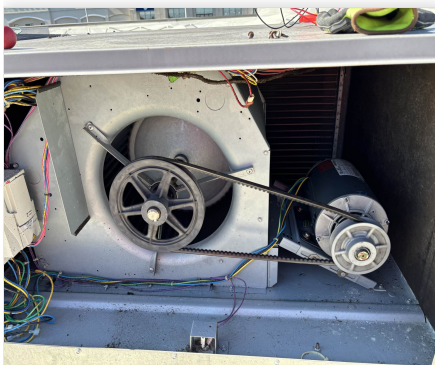
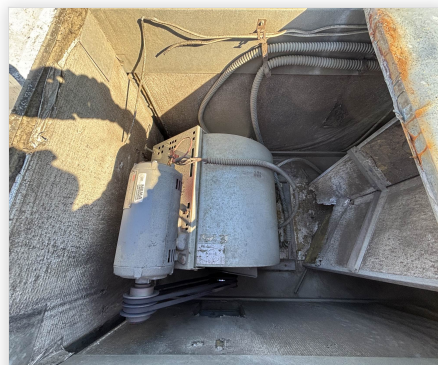
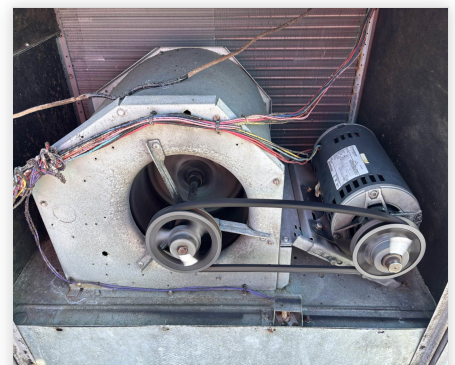
Issue Name : RTU 3, 4, 5, AND MAU: MOTOR COMPARTMENT DIRTY
Description : The motor compartment is dirty is each of the listed units
Created By : National TAB **Assigned To :** National TAB - Dan Hertenstein
Status : Open
Priority : Medium **Asset Tag :**
Originated Date : 11/11/2025 - Sagar Patel - National TAB

RTU 1 and 2 are clean. RTU 3, 4, and 5 are dirty.

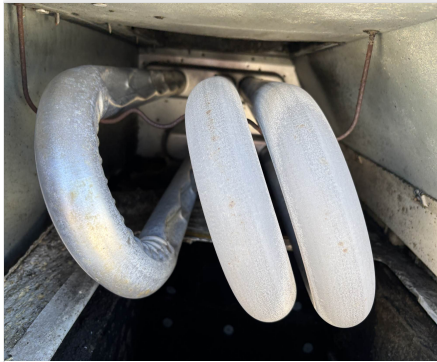
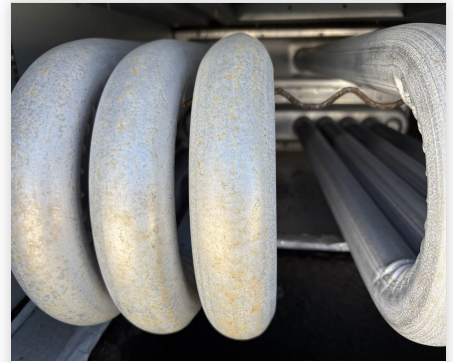
Issue Name : RTU 3, 4, AND 5: HEAT EXCHANGERS ARE DIRTY
Description : The evaporator coils on RTU 3, 4, and 5 are dirty and recommended to be clean.
Created By : National TAB **Assigned To :** National TAB - Dan Hertenstein
Status : Open
Priority : High **Asset Tag :**
Originated Date : 11/10/2025 - Sagar Patel - National TAB

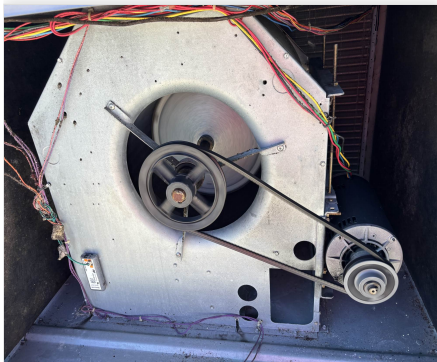
Issue Name : RTU 4 AND 5: LOOSE BELT
Description : The belt in RTUs 4 and 5 are loose and recommended to be tighten.
Created By : National TAB **Assigned To :** National TAB - Dan Hertenstein
Status : Open
Priority : High **Asset Tag :**
Originated Date : 11/10/2025 - Sagar Patel - National TAB

RTU 4, and 5 belts are in good condition, but not tight.

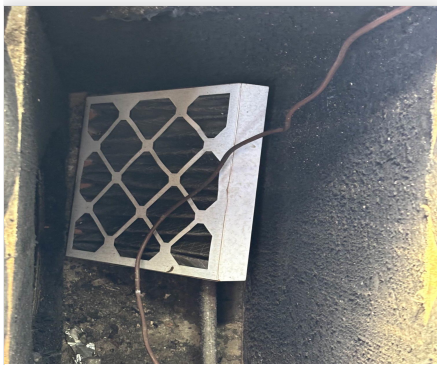
Issue Name : RTU 5: FILTER HAS FALLEN IN RETURN DUCT
Description : A filter is in the return duct. Possibly fell when filters were getting replaced.
Created By : National TAB **Assigned To :** National TAB - Dan Hertenstein
Status : Open
Priority : High **Asset Tag :**
Originated Date : 11/10/2025 - Sagar Patel - National TAB

RTU 1 to 4 are clear and clean. RTU 5 has a filter in return duct.

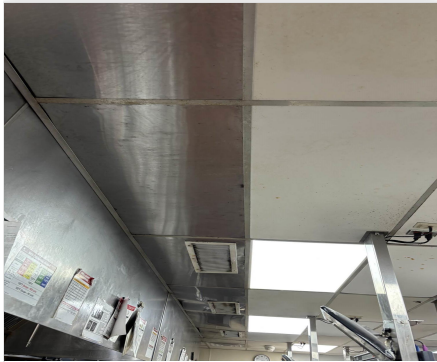
Issue Name : STAINED CEILING TILES AROUND HOOD AND KITCHEN DIFFUSERS
Description : Ceiling tiles in the kitchen are stained and recommended to be cleaned or replaced
Created By : National TAB **Assigned To :** National TAB - Dan Hertenstein
Status : Open
Priority : Medium **Asset Tag :**
Originated Date : 11/10/2025 - Sagar Patel - National TAB

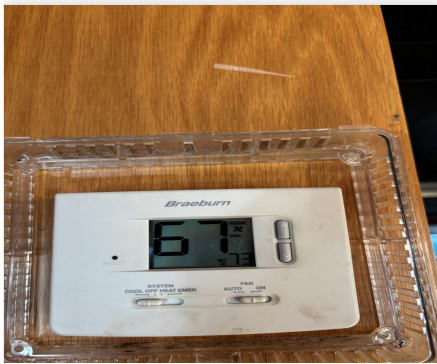
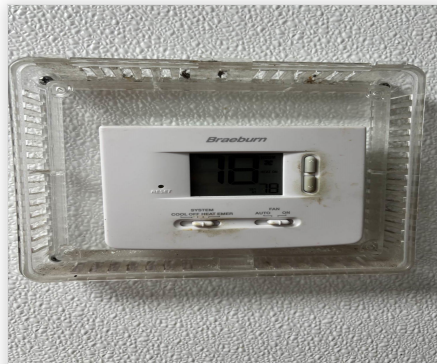
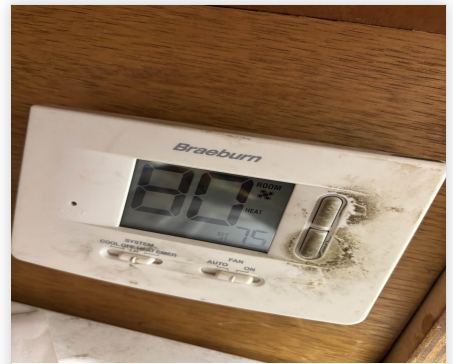
Issue Name : THERMOSTATS ARE NOT PROGRAMMABLE
Description : The thermostats are not programmable in order to do a final TAB
Created By : National TAB **Assigned To :** National TAB - Dan Hertenstein
Status : Open
Priority : High **Asset Tag :**
Originated Date : 11/11/2025 - Sagar Patel - National TAB
