Report: TAB REPORT
Function: Test, Adjust, & Balance
Date: 08/14/2025
Completed By: National TAB

PROJECT
08-11-25 CULVERS ROCKWALL REVIVE

Project: 08-11-25 CULVERS ROCKWALL REVIVE

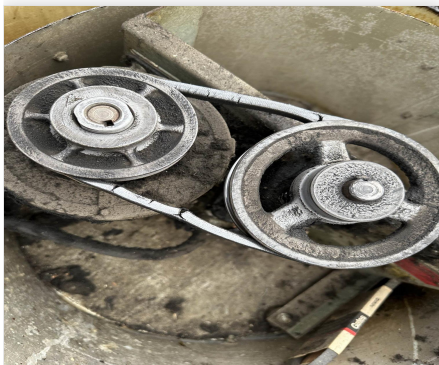
Issue Name : Cracked Belt (Fryer KEF2)
Description : Cracked belt on kitchen fryer exhaust fan.
Created By : National TAB **Assigned To :** National TAB - Dan Hertenstein
Status : Closed
Priority : Medium **Asset Tag :**
Originated Date : 08/14/2025 - Cavin Van - National TAB

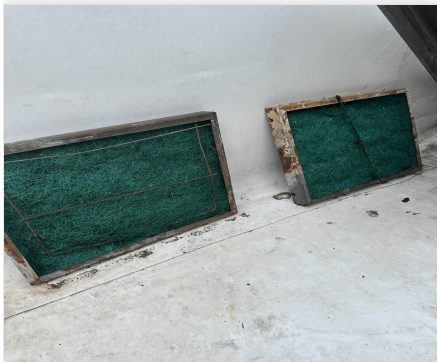
Issue Name : MUA Filter Replacement
Description : Recommend replacing filter mesh.
Created By : National TAB **Assigned To :** National TAB - Dan Hertenstein
Status : Open
Priority : Urgent **Asset Tag :**
Originated Date : 08/14/2025 - Cavin Van - National TAB

1. **MUA Filters:** The owner stated that when the MUA filters get dirty or clogged it makes smoke capture worse and they go up to the roof to remove them. The filters are a media type filter that will accumulate dirt more frequently. Recommend these are replaced with metal mesh filters which are more typical for a MUA application and won't clog as frequently. They also need to be cleaned on a quarterly basis.

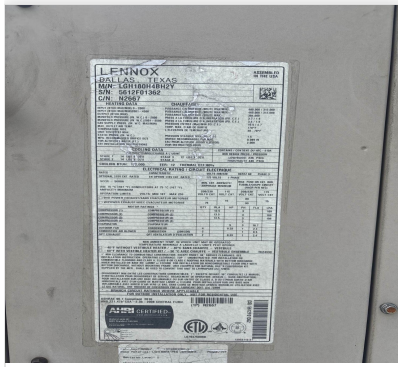
SUPPLY RTU-1

3845 CFM

- The kitchen RTU belt was tightened, which corrected fan slippage and increased supply airflow significantly. Airflow increased from 3845 CFM to 6582 CFM.
- Outdoor air dampers were cracked opened to introduce outside air to both RTUs. The dampers had to be manually opened since they weren't functional.
- The fryer MUA PSP was cleaned, improving airflow to the fryer hood.
- The fryer exhaust (KEF2) fan speed was increased by adjusting the motor pulley one turn inward.
- All exhaust fans were verified for correct rotation and proper operation.
- Hood capture tests confirmed satisfactory hood capture at both the grill and fryer hoods after adjustments.
- Overall airflows after balancing:

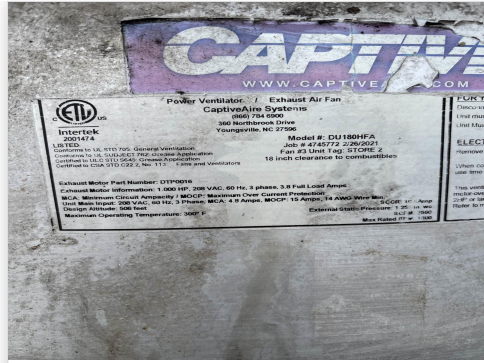
Asset: KEF1

Notes:
GRIDDLE
Unable to lean fan back to get static pressure
