**Report: TAB REPORT**  
**Function: Test, Adjust, & Balance**  
**Date: 08/14/2025**  
**Completed By: National TAB**

**PROJECT**  
**08-11-25 CULVERS ROCKWALL REVIVE**

An air balance was performed at Culver's Rockwall, TX, to address hood capture issues (primarily on the grill) and comfort issues in the office. The scope of work included verification and adjustment of the kitchen and dining RTUs, make-up air (MUA) systems, and exhaust fans.

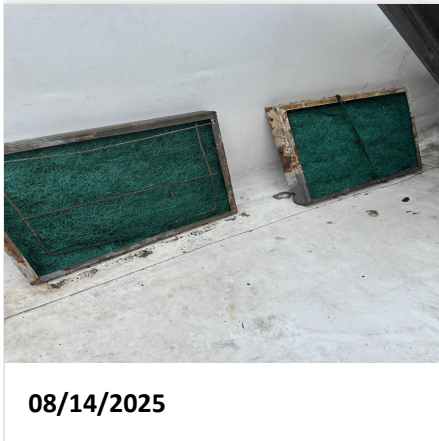
- 1. MUA Filters:** The owner stated that when the MUA filters get dirty or clogged it makes smoke capture worse and they go up to the roof to remove them. The filters are a media type filter that will accumulate dirt more frequently. Recommend these are replaced with metal mesh filters which are more typical for a MUA application and won't clog as frequently. They also need to be cleaned on a quarterly basis.

**Issue Name :** MUA Filter Replacement  
**Description :** Recommend replacing filter mesh.  
**Created By :** National TAB                      **Assigned To :** National TAB - Dan Hertenstein  
**Status :** Open  
**Priority :** Urgent                                      **Asset Tag :**  
**Originated Date :** 08/14/2025 - Cavin Van - National TAB

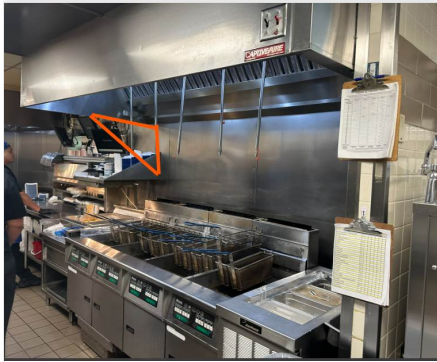
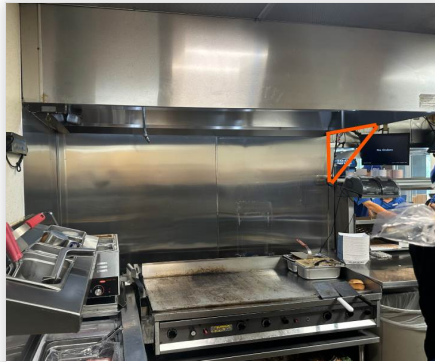
- 4. Hood End Panels:** Quarter end panels are recommended on both hoods to further improve capture.

**Issue Name :** Recommend End Panels  
**Description :** Recommend adding additional end panels to further improve hood performance.  
**Created By :** National TAB                      **Assigned To :** National TAB - Dan Hertenstein  
**Status :** Open  
**Priority :** Medium                                      **Asset Tag :**  
**Originated Date :** 08/14/2025 - Cavin Van - National TAB

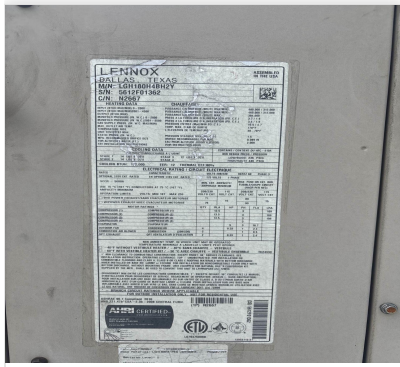
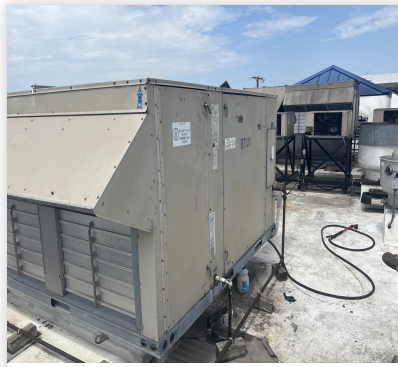
**SUPPLY RTU-1**

- The kitchen RTU belt was tightened, which corrected fan slippage and increased supply airflow significantly. Airflow increased from 3845 CFM to 6582 CFM.
- Outdoor air dampers were cracked opened to introduce outside air to both RTUs. The dampers had to be manually opened since they weren't functional.
- The fryer MUA PSP was cleaned, improving airflow to the fryer hood.
- The fryer exhaust (KEF2) fan speed was increased by adjusting the motor pulley one turn inward.
- All exhaust fans were verified for correct rotation and proper operation.
- Hood capture tests confirmed satisfactory hood capture at both the grill and fryer hoods after adjustments.
- Overall airflows after balancing:

3845 CFM

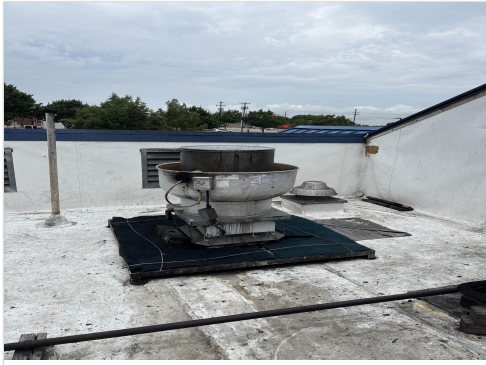
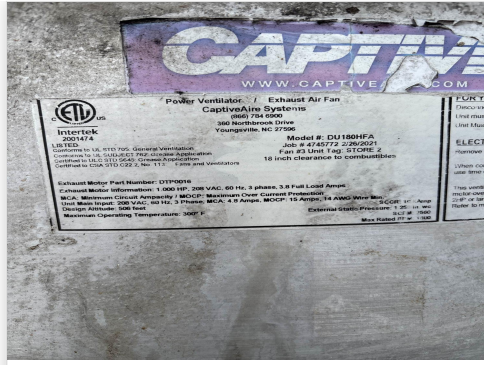
Asset: KEF1

Not able to find speed controller for KEF1.

Kitchen exhaust fan serving the grill does not have a hinge kit installed.

Notes:  
GRIDDLE  
Unable to lean fan back to get static pressure

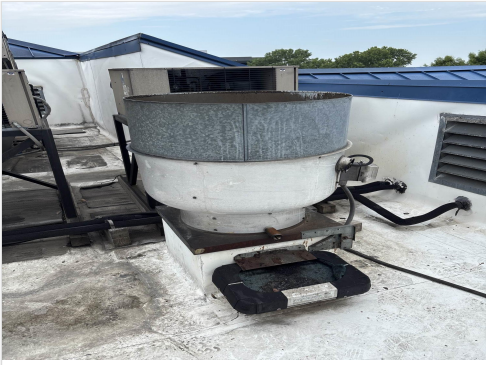
Asset: KEF2

No, Kitchen RTU is not tight and Fryer KEF2 has a cracked belt.
