Report: TAB REPORT
Function: Test, Adjust, & Balance
Date: 08/14/2025
Completed By: National TAB

PROJECT
08-11-25 CULVERS ROCKWALL REVIVE

Project Summary

An air balance was performed at Culver's Rockwall, TX, to address hood capture issues and temperature imbalance within the building. Reported symptoms included smoke escaping from the grill hood and excessive heat in the office area. The scope of work included verification and adjustment of the kitchen and dining RTUs, make-up air (MUA) systems, and exhaust fans.

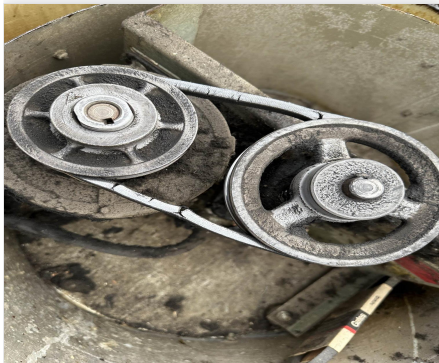
Issue Name : Cracked Belt (Fryer KEF2)
Description : Cracked belt on kitchen fryer exhaust fan.
Created By : National TAB **Assigned To :** National TAB - Dan Hertenstein
Status : Closed
Priority : Medium **Asset Tag :**
Originated Date : 08/14/2025 - Cavin Van - National TAB

No, Kitchen RTU is not tight and Fryer KEF2 has a cracked belt.

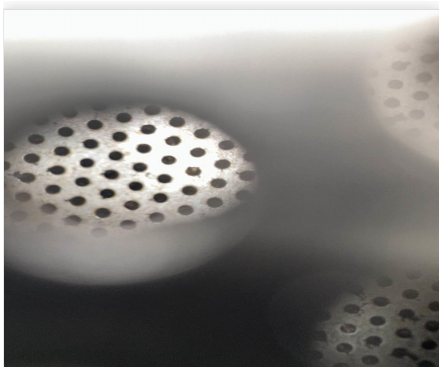
Issue Name : FRYER MUA PSP CLOGGED
Description : MUA PSP has low airflow due to PSP being clogged.
Created By : National TAB **Assigned To :** National TAB - Dan Hertenstein
Status : Closed
Priority : Urgent **Asset Tag :**
Originated Date : 08/14/2025 - Cavin Van - National TAB

- The **kitchen RTU belt was tightened**, which corrected fan slippage and increased supply airflow significantly.
- **Outdoor air dampers** were partially opened to introduce ventilation air to both RTUs.
- The **fryer MUA PSP was cleaned**, restoring airflow to the fryer hood system.
- The **fryer exhaust (KEF2) fan speed** was increased by adjusting the motor pulley one turn inward.
- All exhaust fans were verified for correct rotation and proper operation.
- Hood capture tests confirmed **100% smoke capture** at both the grill and fryer hoods after adjustments.
- Overall airflows after balancing:

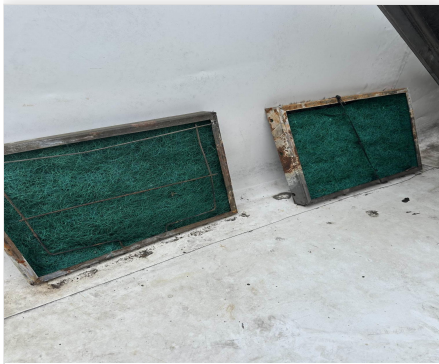
Issue Name : MUA Filter Replacement
Description : Recommend replacing filter mesh.
Created By : National TAB **Assigned To :** National TAB - Dan Hertenstein
Status : Open
Priority : Urgent **Asset Tag :**
Originated Date : 08/14/2025 - Cavin Van - National TAB

- **MUA Filters:** Filter mesh replacement is still recommended to maintain proper airflow.
- **RTU Economizers:** Both remain non-functional and require service to enable automatic outdoor air control.
- **Occupancy Control:** Thermostats should be properly wired for scheduled occupancy.
- **Hood End Panels:** Additional end panels are recommended to improve smoke containment at the grill

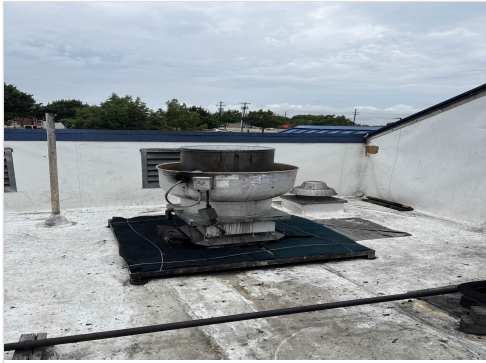
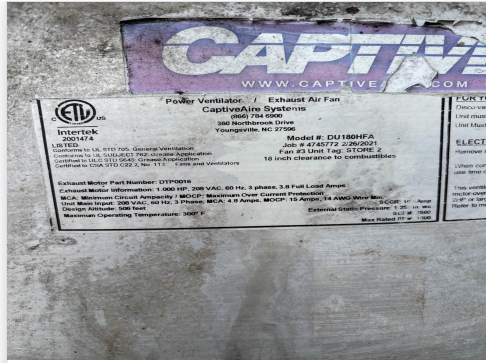
Asset: KEF1

Not able to find speed controller for KEF1.

Kitchen exhaust fan serving the grill does not have a hinge kit installed.

Notes:
GRIDDLE
Unable to lean fan back to get static pressure
