Report: TAB REPORT
Function: Test, Adjust, & Balance
Date: 08/14/2025
Completed By: National TAB

PROJECT
08-11-25 CULVERS ROCKWALL REVIVE

Project Summary

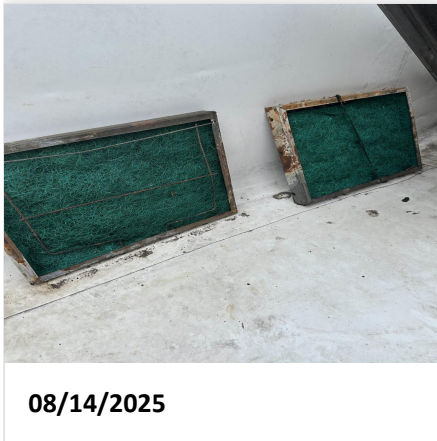
1. **MUA Filters:** The owner stated that when the MUA filters get dirty or clogged it makes smoke capture worse and they go up to the roof to remove them. The filters are a media type filter that will accumulate dirt more frequently. Recommend these are replaced with metal mesh filters which are more typical for a MUA application and won't clog as frequently. They also need to be cleaned on a quarterly basis.

Issue Name : MUA Filter Replacement
Description : Recommend replacing filter mesh.
Created By : National TAB **Assigned To :** National TAB - Dan Hertenstein
Status : Open
Priority : Urgent **Asset Tag :**
Originated Date : 08/14/2025 - Cavin Van - National TAB

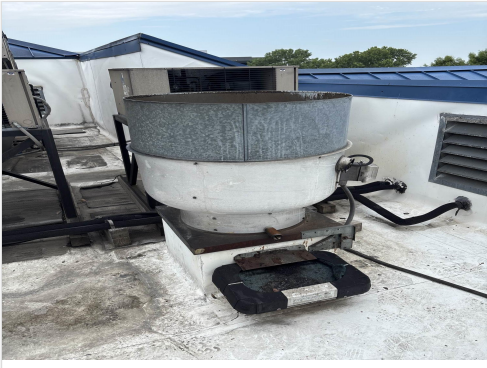
Asset: KEF2

Notes:
FRYER
